### **Stream Assessment Report, Feasibility Road Design Phase 2, Telkwa Metallurgical Coal Project, prepared by DWB Consulting Services Ltd., 2018**

# Stream Assessment Report

## Feasibility Road Design Phase 2 Telkwa Metallurgical Coal Project

Date: 19.11.2018 | DWB file: 18364-204 | Revisions: 2

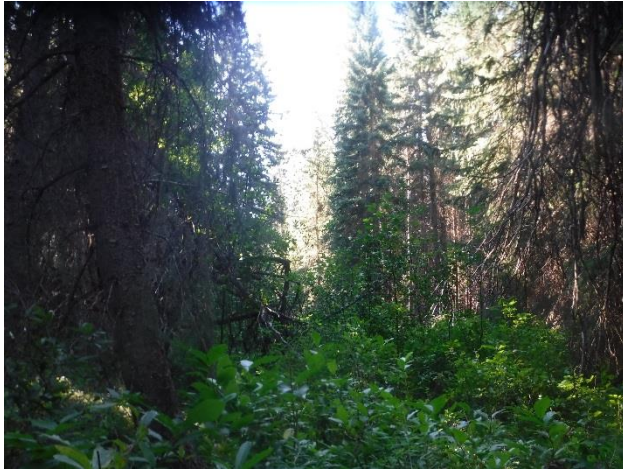
**Photo 1.** Highly vegetated area.

As this watercourse is not considered fish-bearing, an appropriately sized closed bottom structure can be installed at this location.

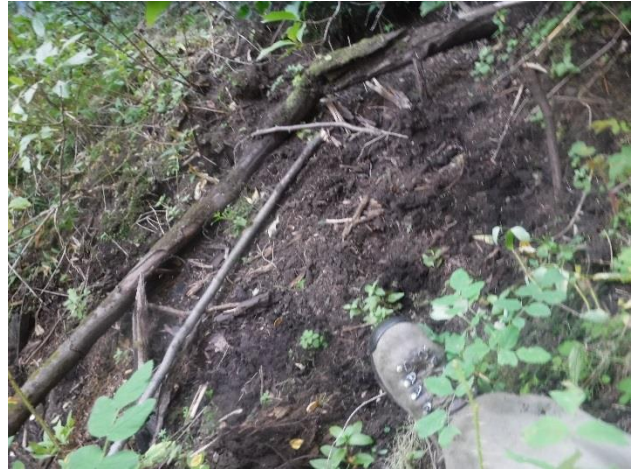
**Photo 2.** Lack of defined channel and presence of water.

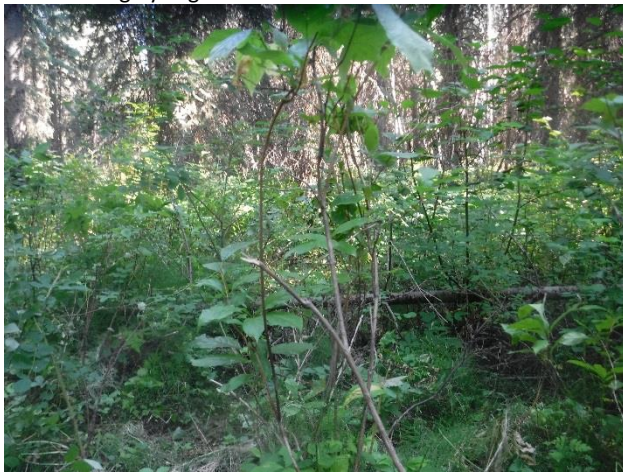
**Photo 3.** No consistent scour or alluvium.

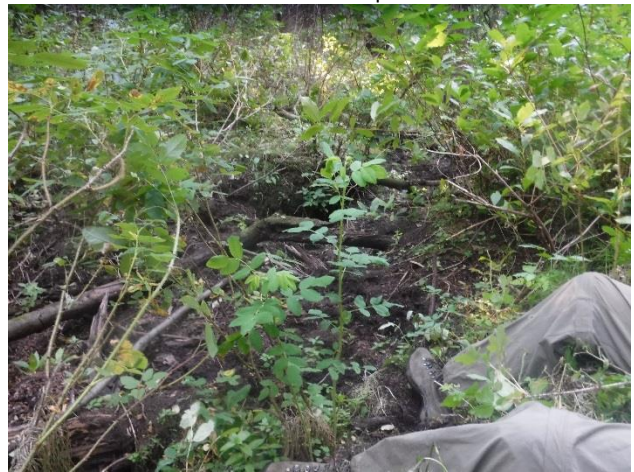
**Photo 4.** Predominantly organic substrate.

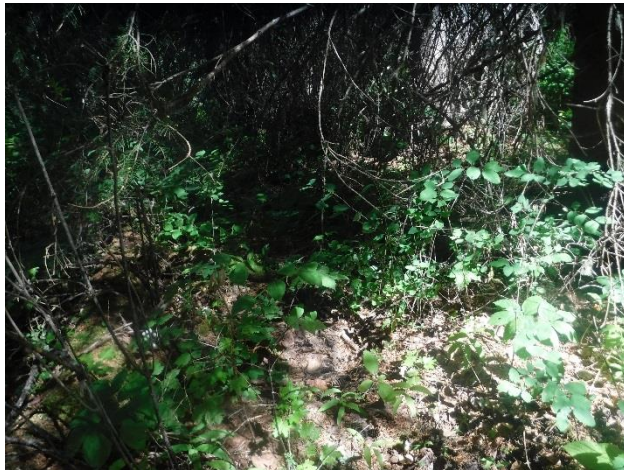
**Photo 5.** No defined channel or water present.

The lack of a feature in this area indicates that a crossing structure will not be required.

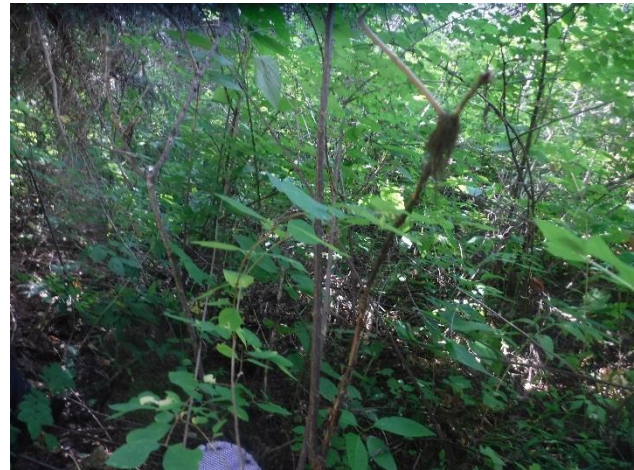
**Photo 6.** No vegetation change or scouring present.

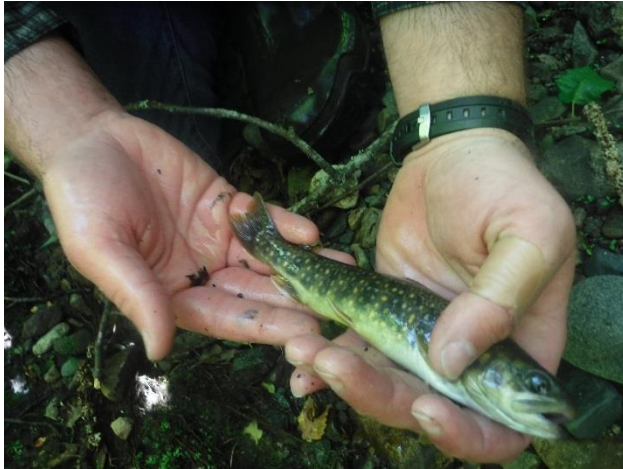
**Photo 7.** Dolly Varden caught along reach.

Based on information provided (important habitat rating and size of existing channel), it is recommended that an appropriate size open-bottom structure be installed at the crossing as per the Fish-stream Crossing Guidebook (MoF 2012). The structure size should be confirmed with hydrotechnical analysis.

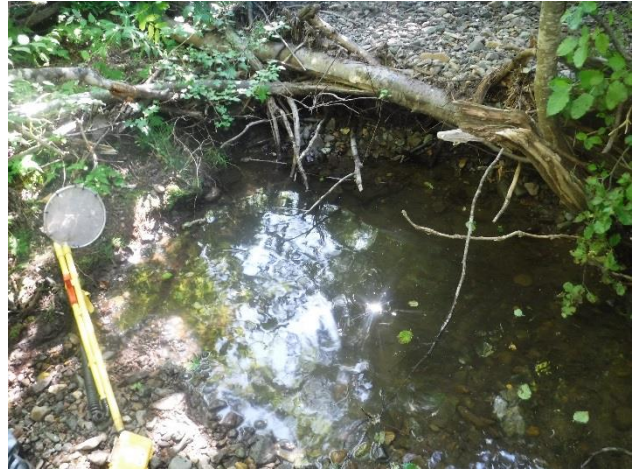
**Photo 8.** Deep pool with fish present.

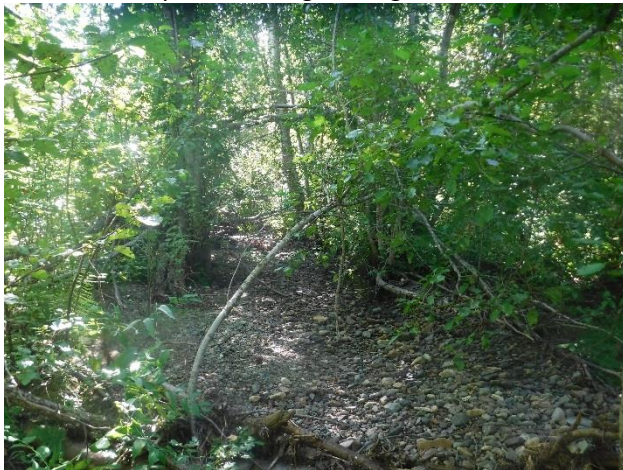
**Photo 9.** Gravel and cobble substrate. Dry at time of survey.

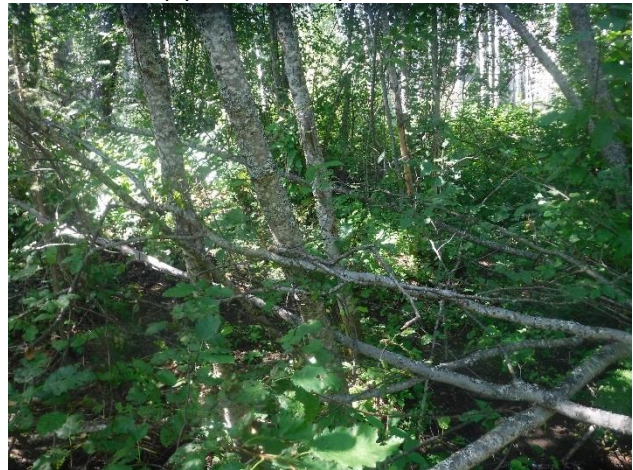
**Photo 10.** Moderate cover with SWD and over-hanging vegetation.

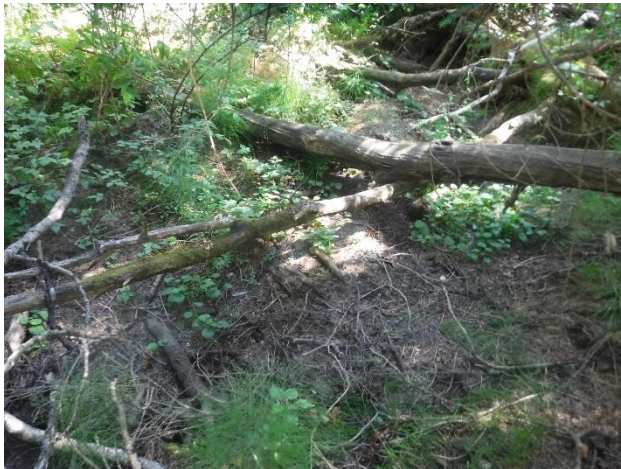
Photo 11. Highly organic substrate.

As this watercourse is not considered fish-bearing, an appropriately sized closed bottom structure can be installed at this location.

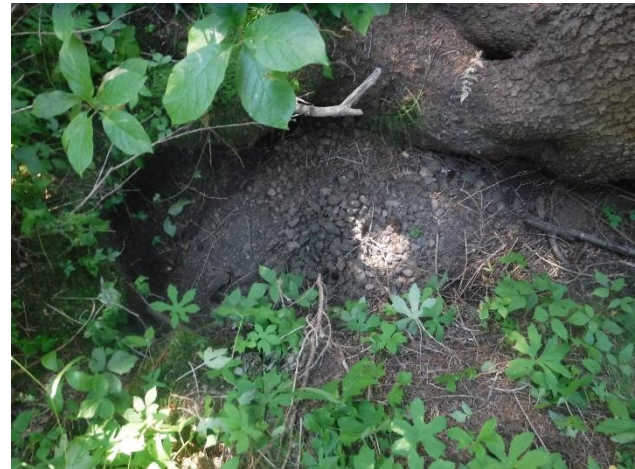
Photo 12. Small section of scour and alluvium (< 1m).

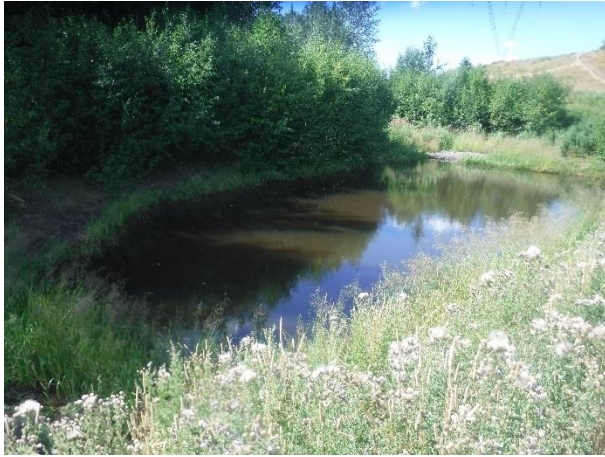
**Photo 13.** Pond downstream of proposed road crossing.

Based on information provided it is recommended that an appropriate size open-bottom structure be installed at the crossing as per the Fish-stream Crossing Guidebook (MoF 2012). The structure size should be confirmed with hydrotechnical analysis.

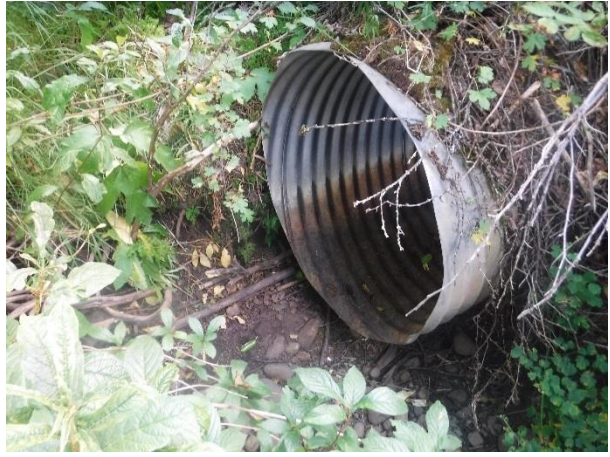
**Photo 14.** 900 mm culvert downstream of the proposed crossing.

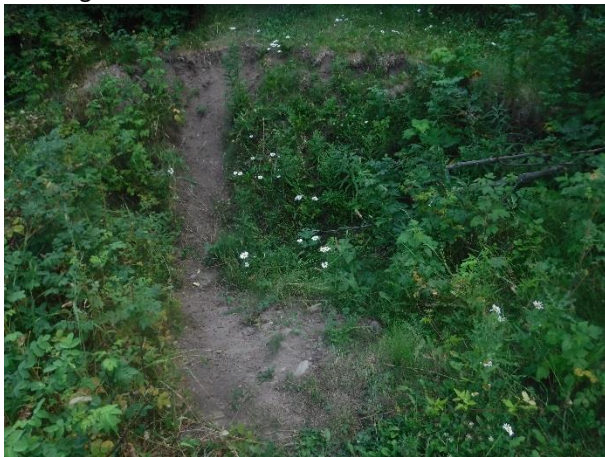
**Photo 15.** Deactivation at crossing.

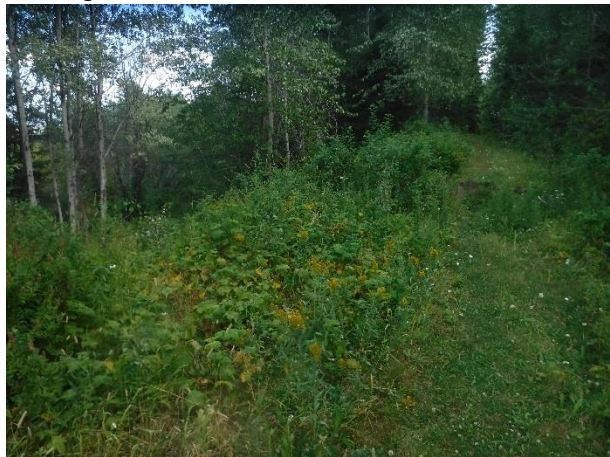
**Photo 16.** Deactivation at crossing from road side.

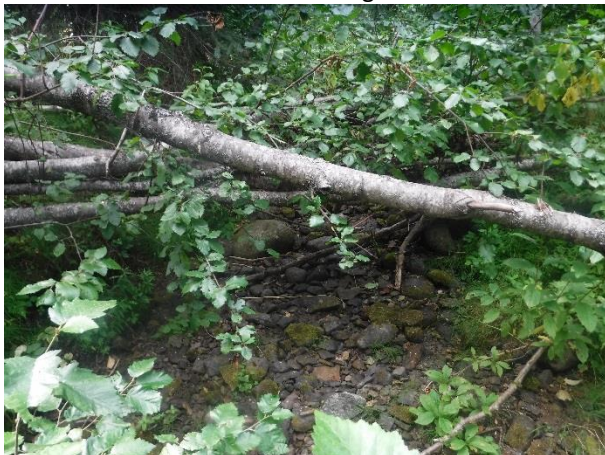
**Photo 17.** Cobble and gravel substrate with overhanging vegetation.

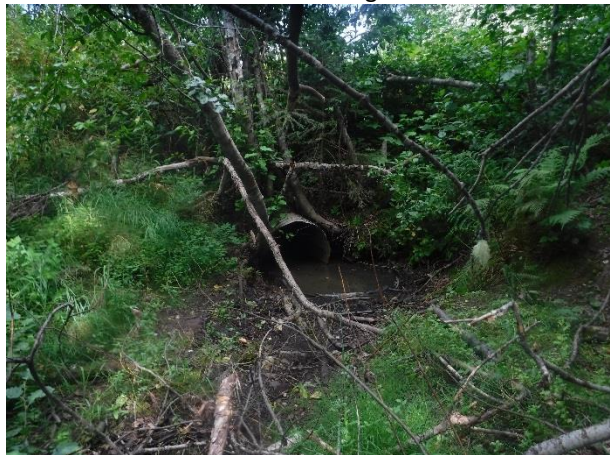
**Photo 18.** Abundant cover along reach.

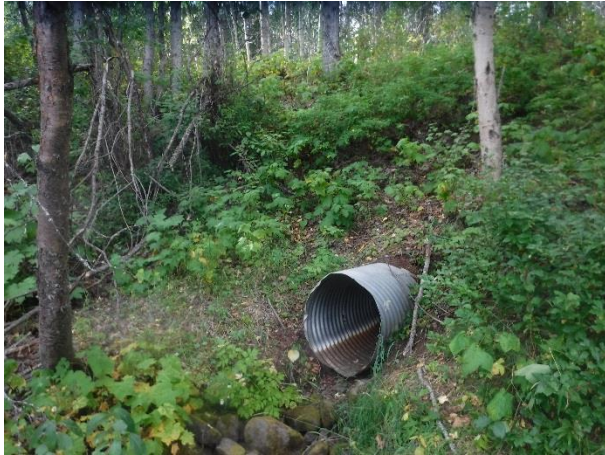
**Photo 19.** Downstream view of 900 mm culvert with small plunge pool and cobbles.

Based on information provided it is recommended that an appropriate size open-bottom structure be installed at the crossing as per the Fish-stream Crossing Guidebook (MoF 2012) should a replacement be required. The structure size should be confirmed with hydrotechnical analysis.

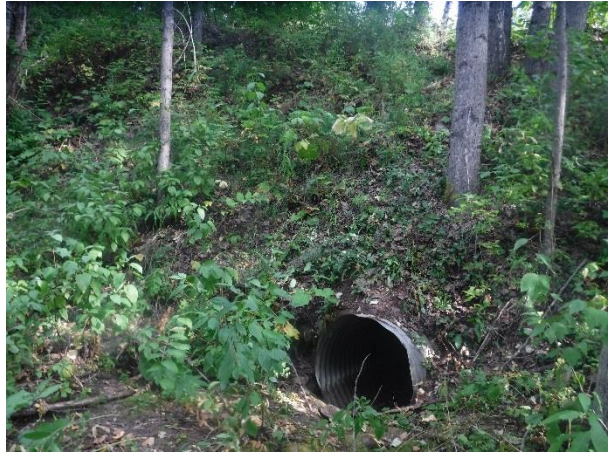
**Photo 20.** Upstream view of 900 mm culvert with overhanging vegetation present as cover.

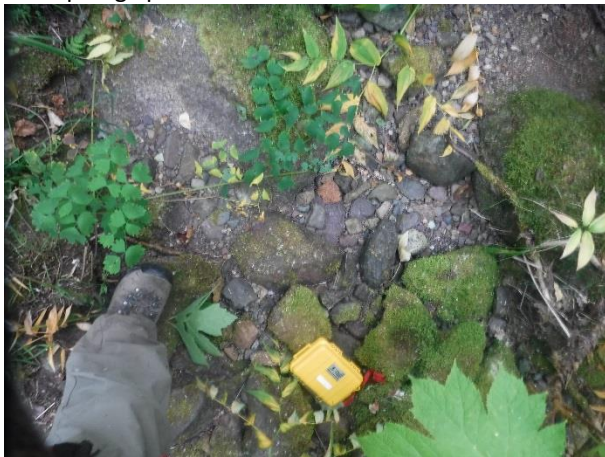
**Photo 21.** Substrate mostly cobbles with some gravels.

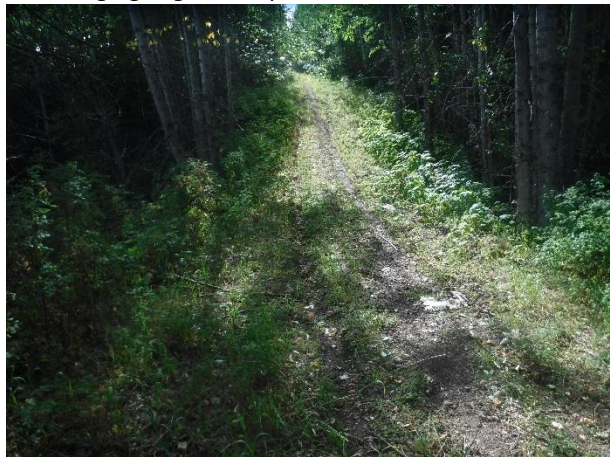
**Photo 22.** Site location along road from high chain approach.

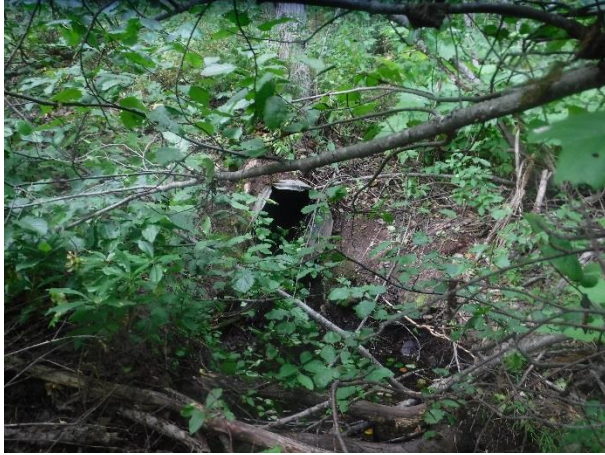
The habitat potential in this reach is primarily for rearing, while spawning and overwintering habitat appears limited as the stream has seasonal flow (isolated pools present during assessment). Bed substrate is slightly embedded gravels and cobbles. There are a few deep pools along the assessed reach with an average residual pool depth of 0.33 m. Moderate total cover for fish was provided by overhanging vegetation, undercut banks, LWD, SWD, boulders, instream vegetation, and a few deep pools. The culvert at the crossing appears to be damaged and is perched which result in a barrier to fish migration

**Photo 23.** Outlet of 900 mm culvert showing perched outlet.

Based on information provided (important habitat rating and size of existing channel), it is recommended that an appropriate size open-bottom structure be installed at the crossing as per the Fish-stream Crossing Guidebook (MoF 2012) should a replacement be required. The structure size should be confirmed with hydrotechnical analysis.

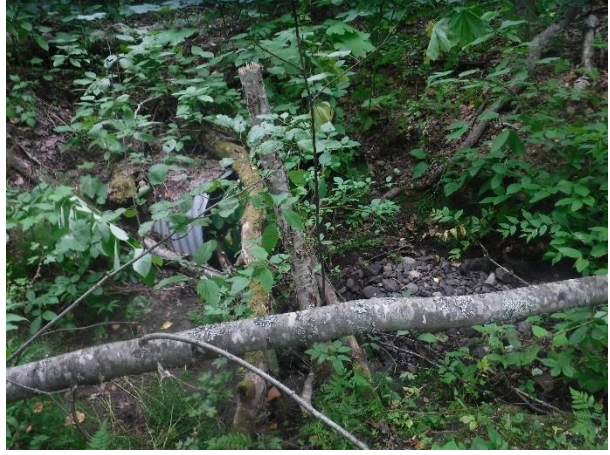
**Photo 24.** Inlet habitat at 900 mm culvert.

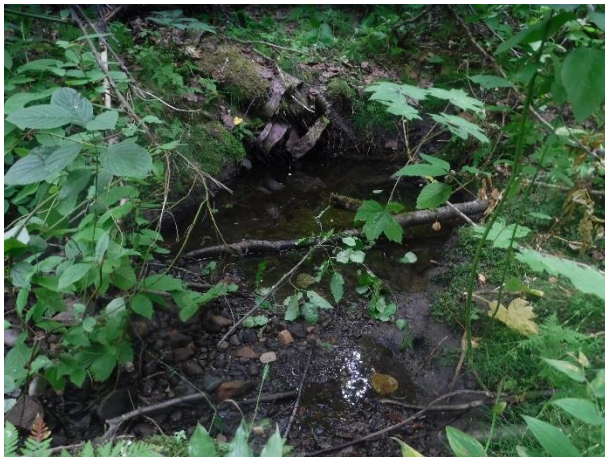
**Photo 25.** Deep pool upstream from crossing.

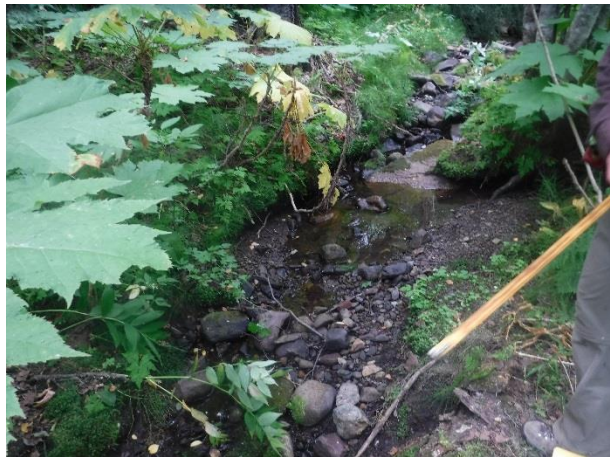
**Photo 26.** Gravel and cobble substrate with overhanging vegetation and undercut banks.

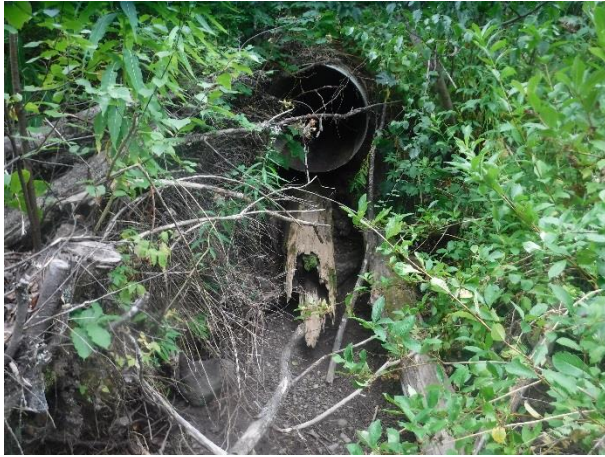
**Photo 27.** Downstream view of 900 mm culvert with 0.60 m perch at powerline access crossing.

Based on information provided it is recommended that an appropriate size open-bottom structure be installed at the crossing as per the Fish-stream Crossing Guidebook (MoF 2012) should a replacement be required. The structure size should be confirmed with hydrotechnical analysis.

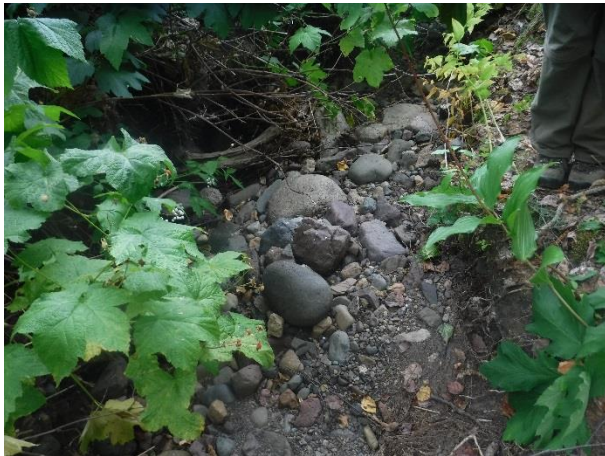
**Photo 29.** Cobble and gravel substrate.

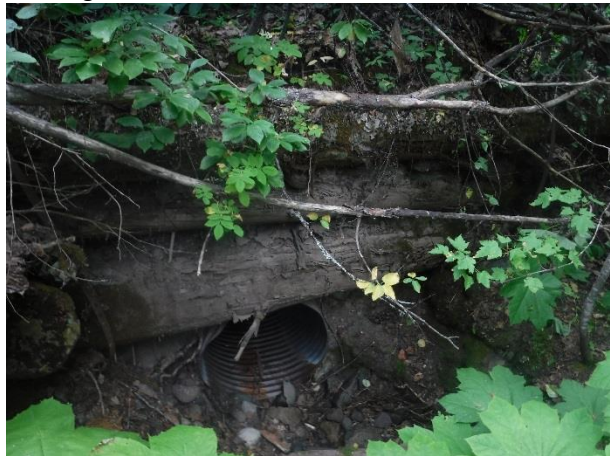
**Photo 30.** Upstream 900 mm culvert at proposed access crossing with log bundle on top.

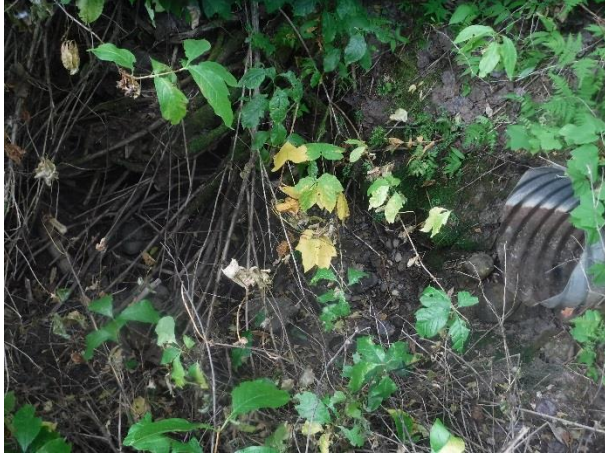
**Photo 31.** Downstream view of 450 mm culvert with 0.70 m perch.

Based on information provided it is recommended that an appropriate size open-bottom structure be installed at the crossing as per the Fish-stream Crossing Guidebook (MoF 2012) should a replacement be required. The structure size should be confirmed with hydrotechnical analysis.

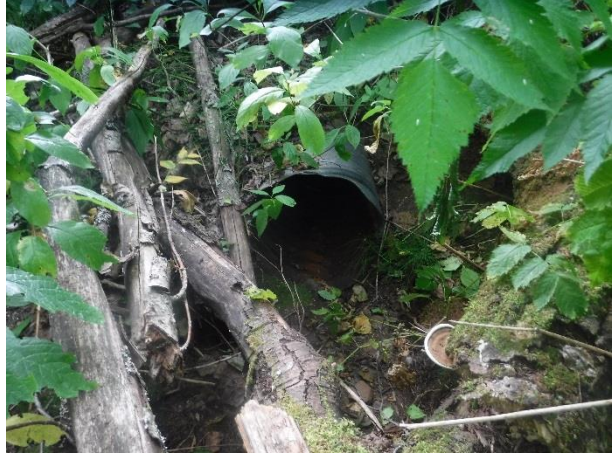
**Photo 32.** Upstream view of 450 mm culvert. Abundant SWD.

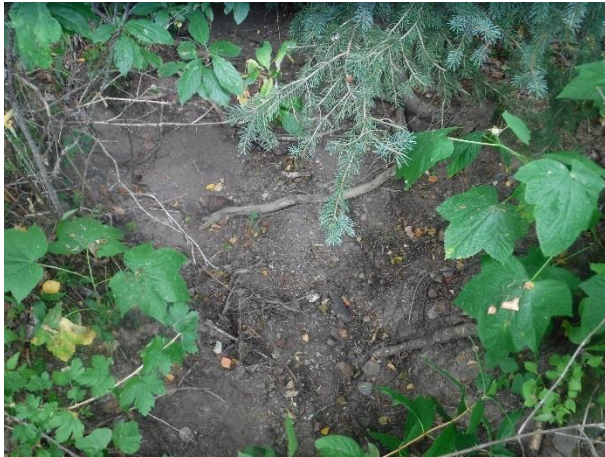
**Photo 33.** Sandy substrate.

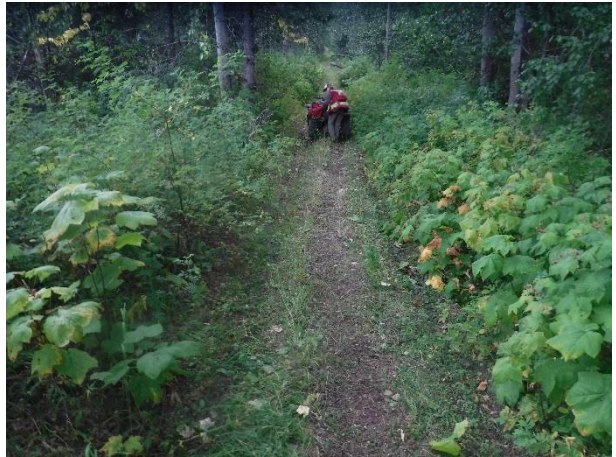
**Photo 34.** Site center from high chain along proposed road (old road present in this location).

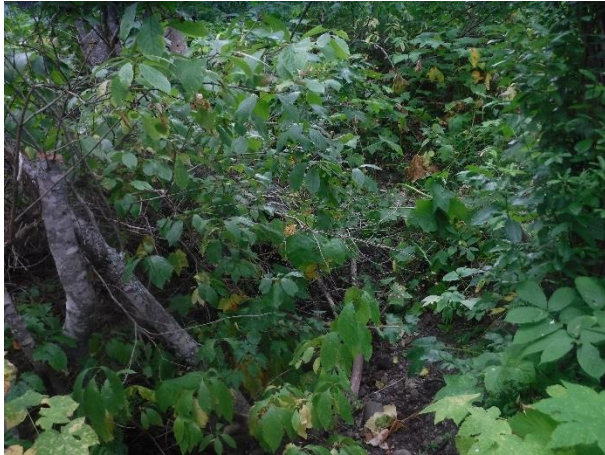
**Photo 35.** Abundant overhanging vegetation obscuring the 500 mm culvert present at the crossing. Downstream view.

Based on information provided it is recommended that an appropriate size open-bottom structure be installed at the crossing as per the Fish-stream Crossing Guidebook (MoF 2012) should a replacement be required. The structure size should be confirmed with hydrotechnical analysis.

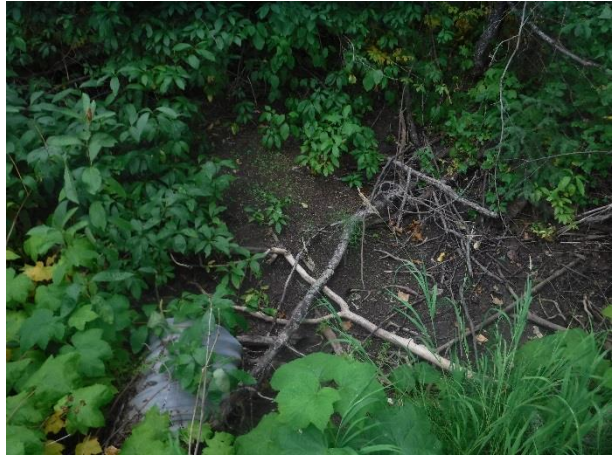
**Photo 36.** Upstream view of 500 mm culvert. Abundant fines.

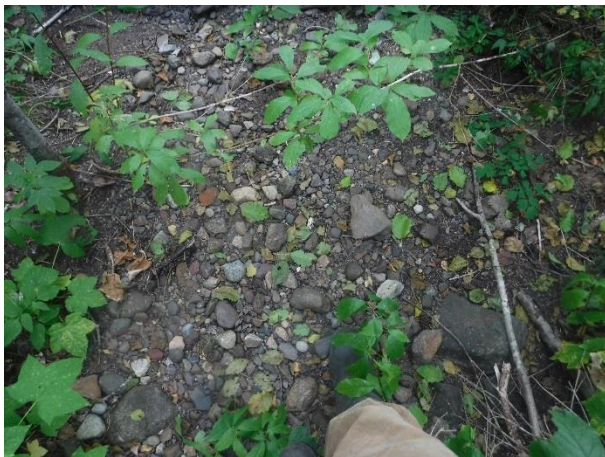
**Photo 37.** Sandy and gravel substrate.

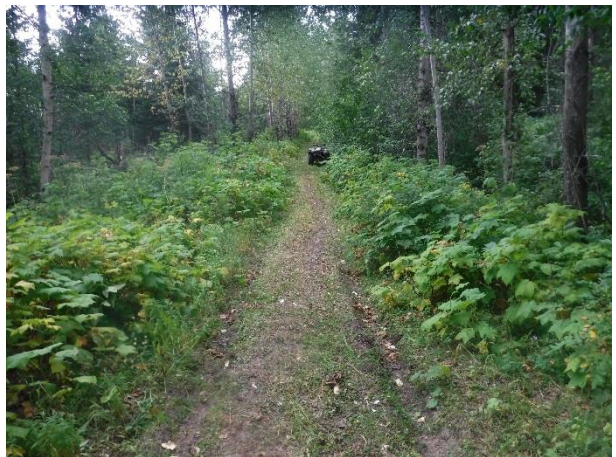
**Photo 38.** Site center from high chain along proposed road (old road present in this location).

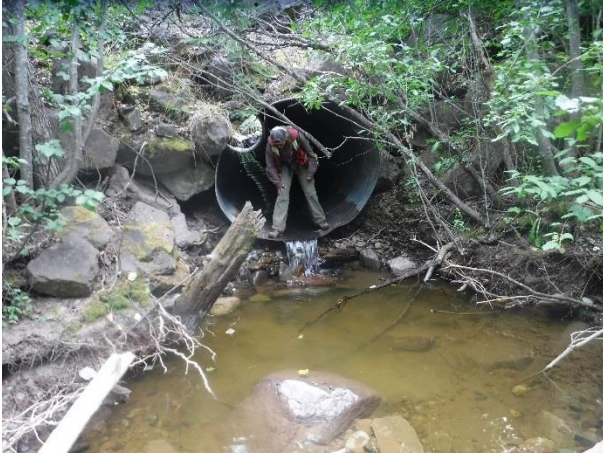
**Photo 39.** Downstream view of 1800 mm culvert present at the crossing. Nice pool located in foreground with human for scale.

Based on information provided (important habitat rating and size of existing channel), it is recommended that an appropriate size open-bottom structure be installed at the crossing as per the Fish-stream Crossing Guidebook (MoF 2012) should a replacement be required. The structure size should be confirmed with hydrotechnical analysis.

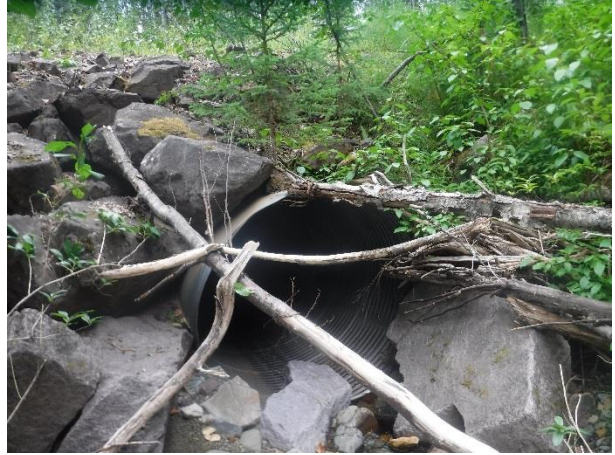
**Photo 40.** Upstream view of 1800 mm culvert.

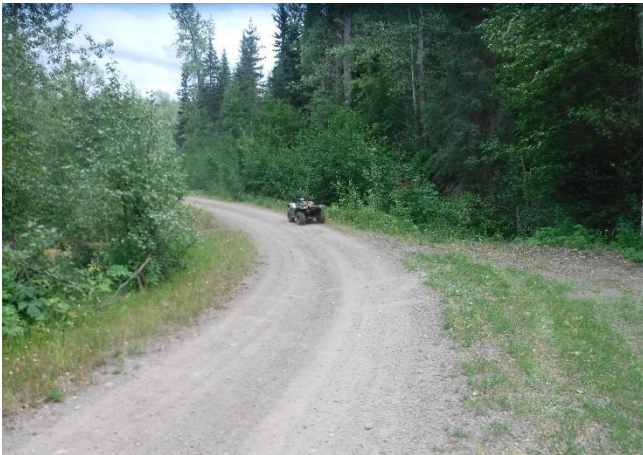
**Photo 41.** Site center from high chain along existing Coalmine Road.

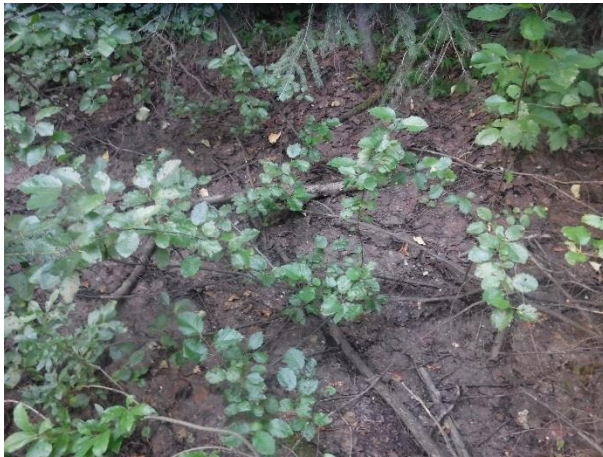
**Photo 42.** Matted leaf litter layer at the site center. Little evidence of historic water presence.

As this watercourse is not considered fish-bearing, an appropriately sized closed bottom structure can be installed at this location.

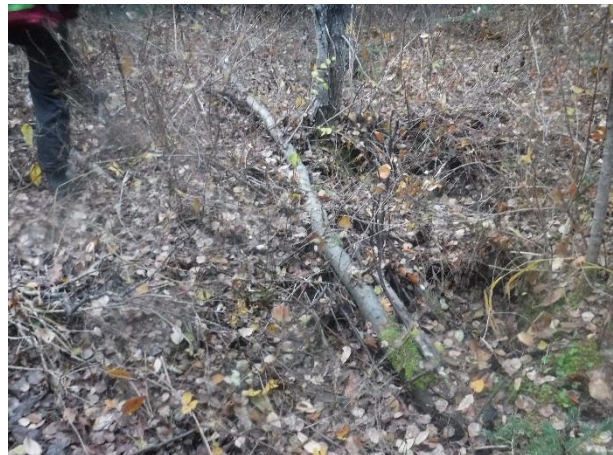
**Photo 44:** Ill-defined channel with highly organic substrate.

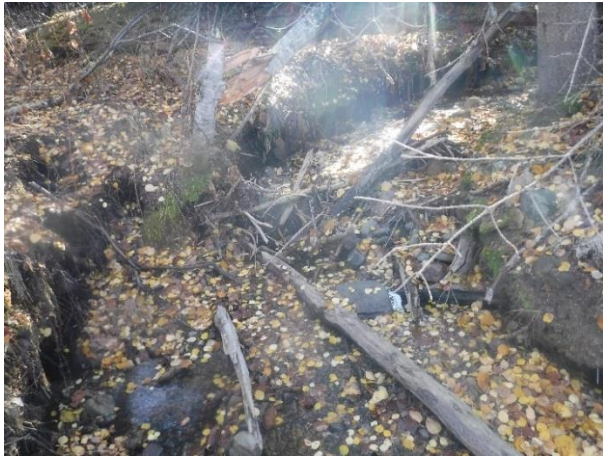
**Photo 45:** Defined channel/scour upstream of crossing with abundant LWD.

Based on information provided (marginal habitat rating and size of existing channel), an appropriately-sized close-bottomed structure can be installed at the crossing as per the Fish-stream Crossing Guidebook (MoF 2012). The structure should be embedded to allow for fish passage. A hydrotechnical analysis is highly recommended to determine the structure size and whether or not a channel should be constructed through the access corridor to prevent further braiding and erosion.

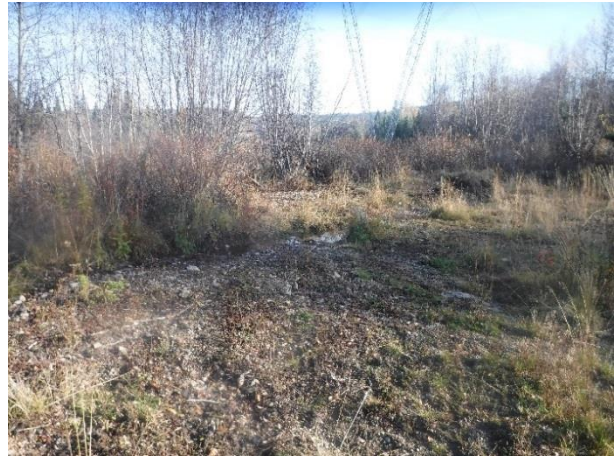
**Photo 46:** The channel braids excessively throughout the access corridor.

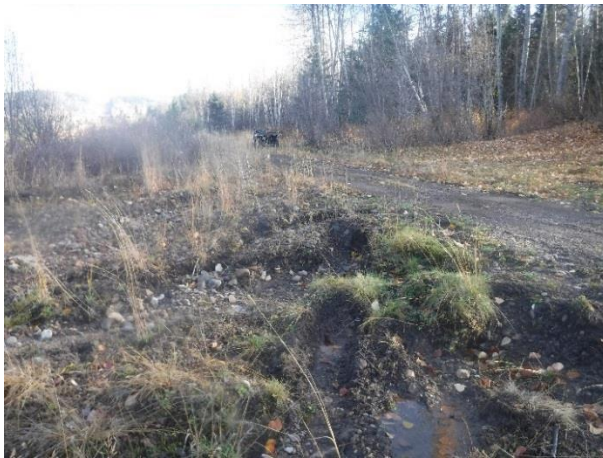
**Photo 47:** Built BC Hydro road along access corridor is being eroded by excessive braiding.

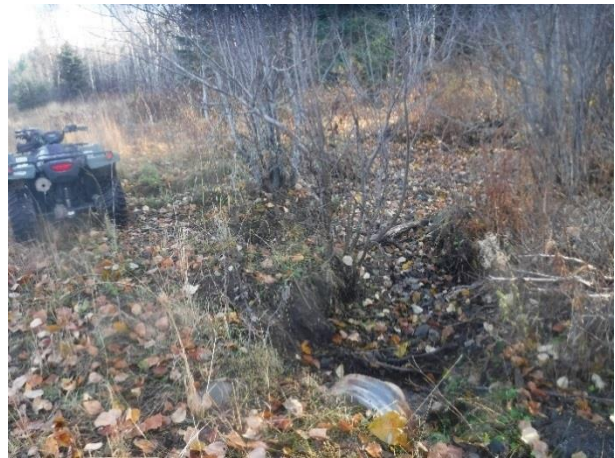
**Photo 48:** The 600 mm CMP on the BC Hydro road is too small and erosion occurs during peak flow.

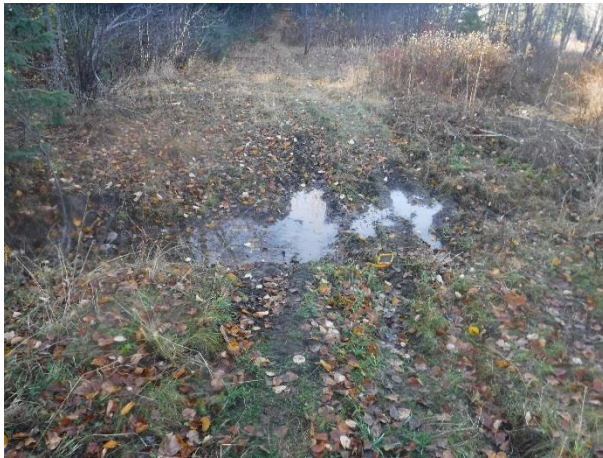
**Photo 49:** Crossditch at road crossing.

Since this is a low spot in the road, it will likely need a close-bottomed culvert of appropriate size depending on the drainage needs of the upgraded road.

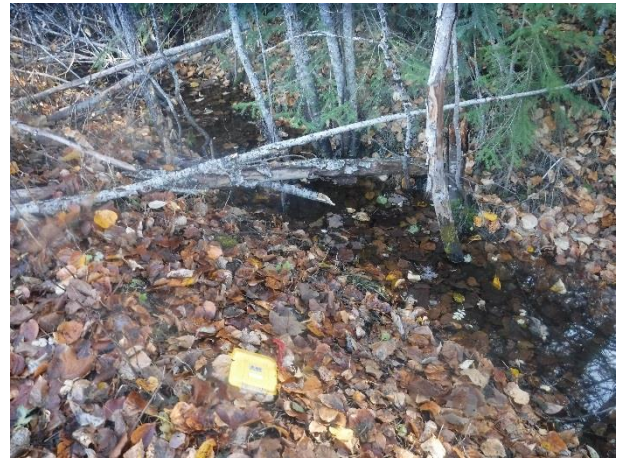
**Photo 50:** Ditch-water/drainage above the road crossing along the ditch.

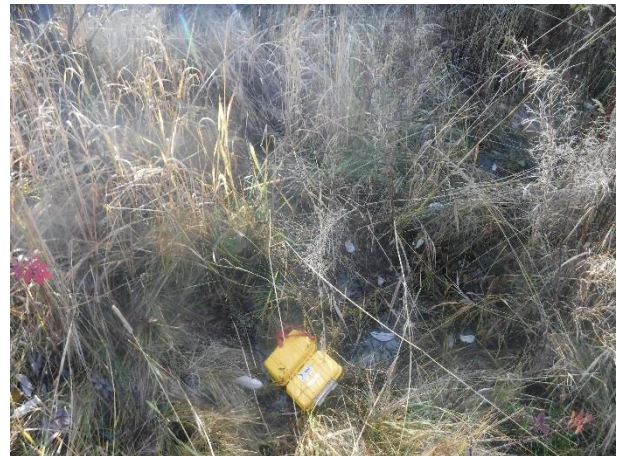
**Photo 52:** Overland flow through tall grass roughly 75 m downslope of crossing.

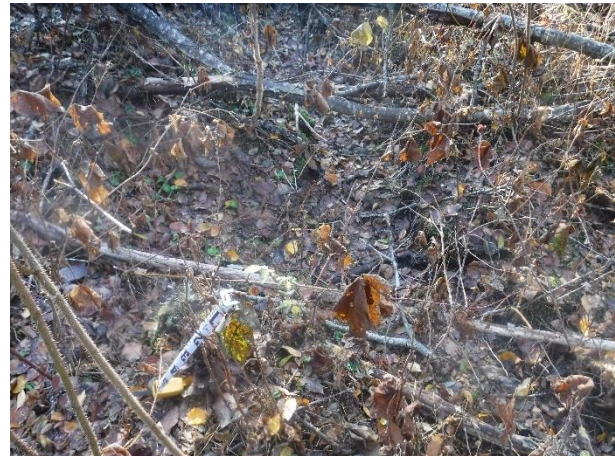
**Photo 54:** Some discontinues scour/channel in an isolated area upslope from the road.

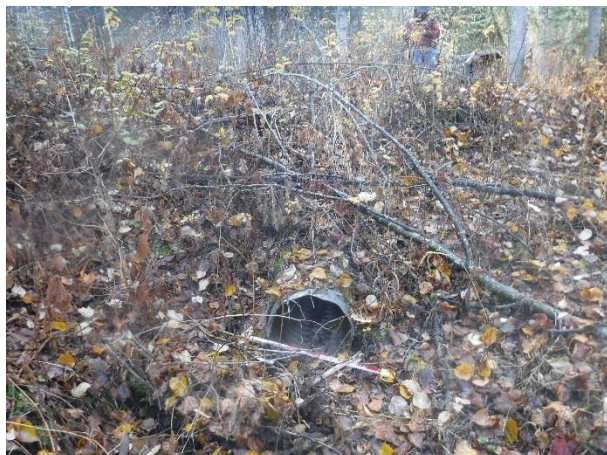
**Photo 55:** Functional 500 mm culvert (from upstream). Approximately 1 m fill.

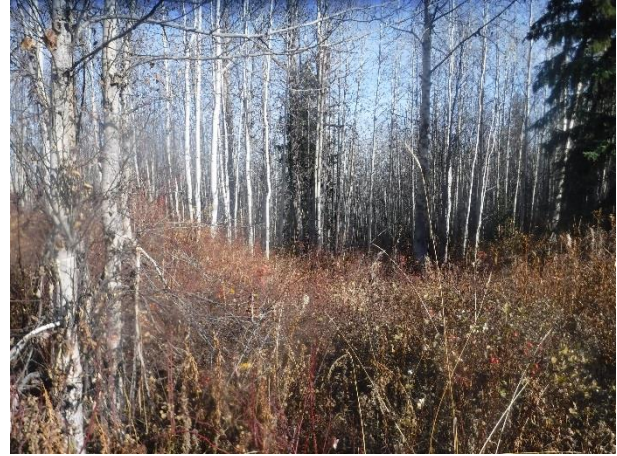
**Photo 58:** Downslope approximately 50 m of crossing. Small, fully vegetated draw.

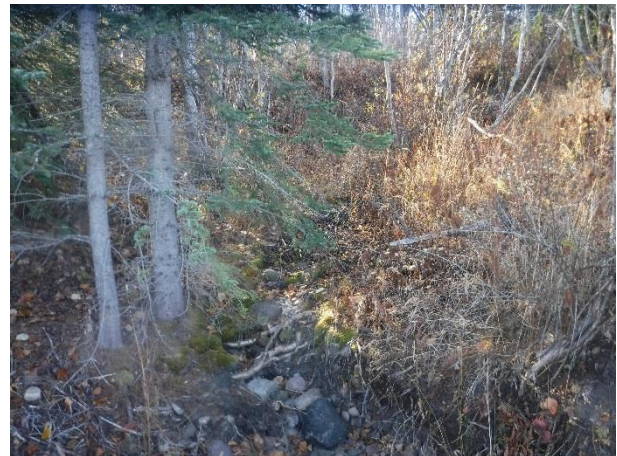
**Photo 60:** Upslope approximately 10 m from the crossing. Discontinuous section of scour.

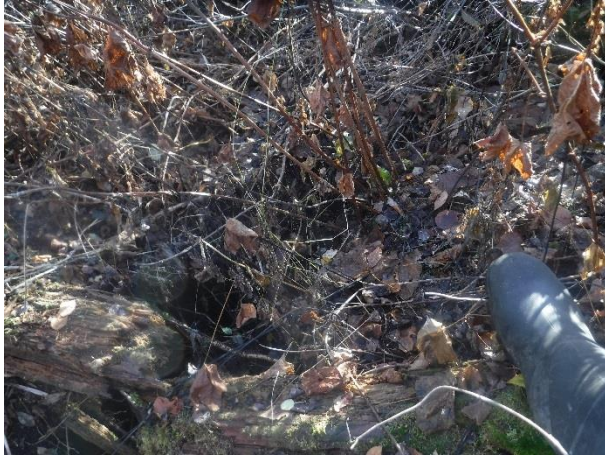
**Photo 61:** Scoured bowl but organic/discontinuous above the drop.

As this watercourse is not considered fish-bearing, an appropriately sized closed bottom structure can be installed at this location.

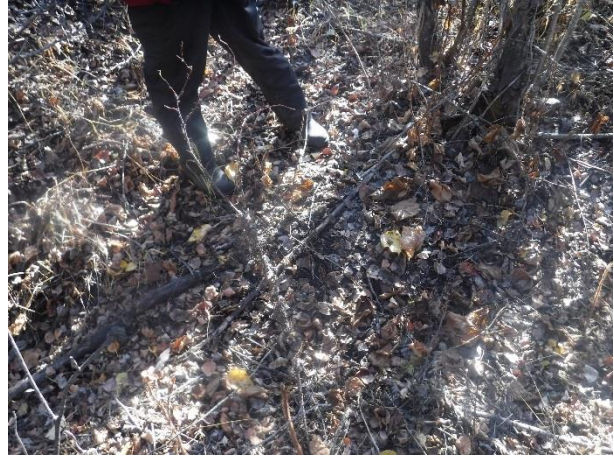
**Photo 62:** Lack of channel roughly 60 m below the crossing.

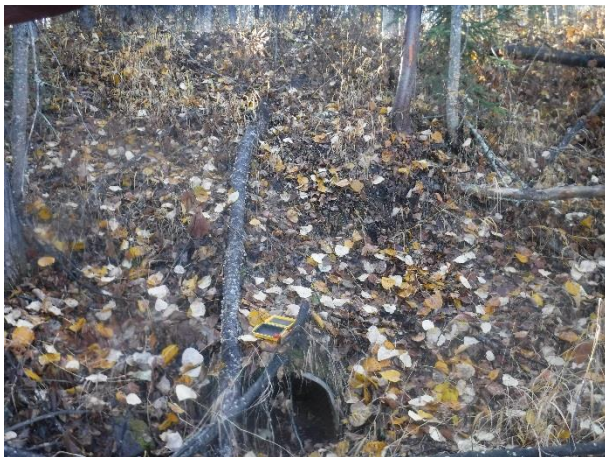
**Photo 63:** Crossing with functional 700 mm culvert and roughly 2.5-3 m of gravel fill.

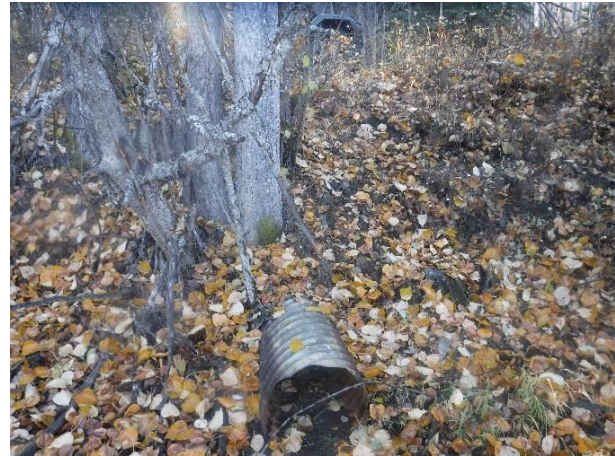
**Photo 65:** Dilapidated 500 mm culvert below the road. Approximately 1.5 m fill.

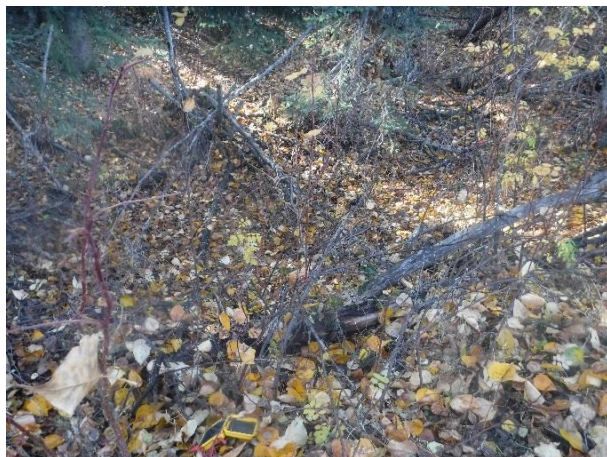
**Photo 66:** Upslope wetted area above road crossing.

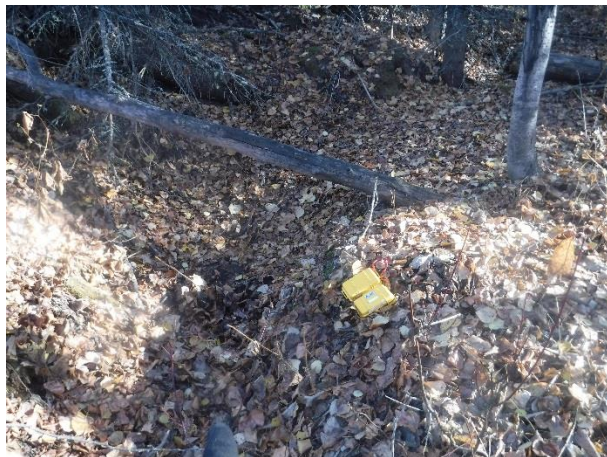
**Photo 67:** Small draw with no scour located above the road approximately 30 m.

As this watercourse is not considered fish-bearing, an appropriately sized closed bottom structure can be installed at this location.

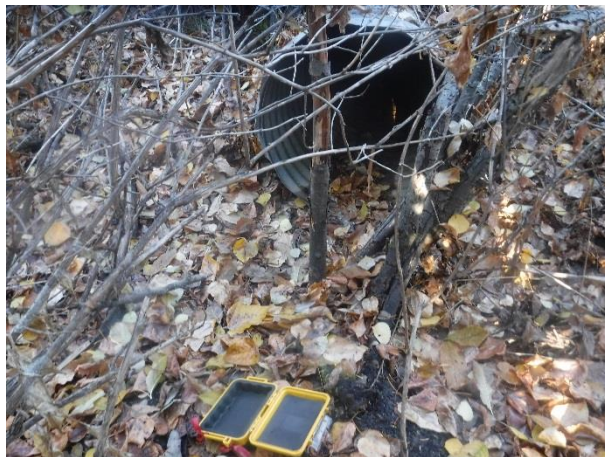
**Photo 68:** Upslope side of 600 mm culvert.

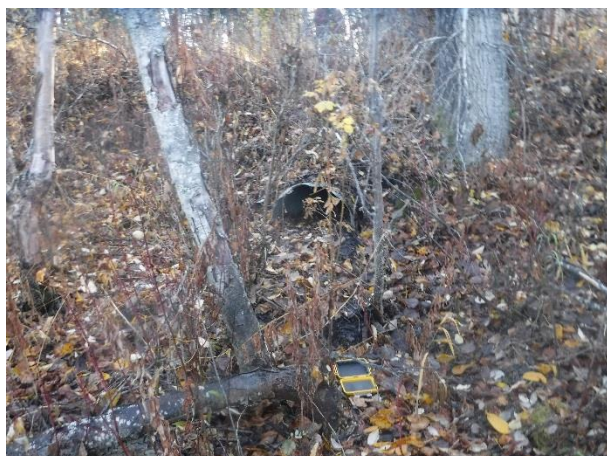
**Photo 69:** Facing upslope from below road. Culvert is half clogged. Fill over culvert is roughly 1 m.

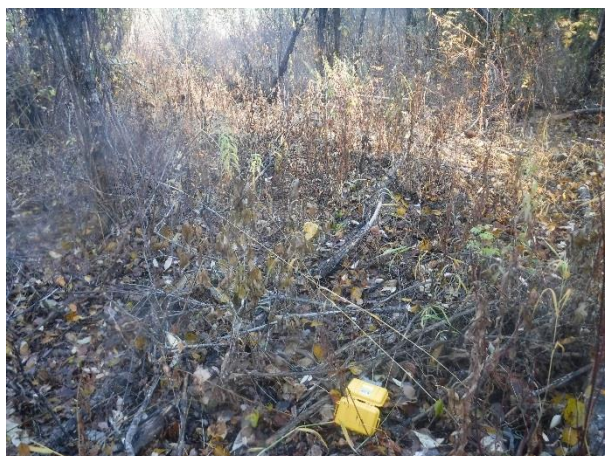
**Photo 70:** Wetted (seasonally/ephemerally) area below the road. No channel.

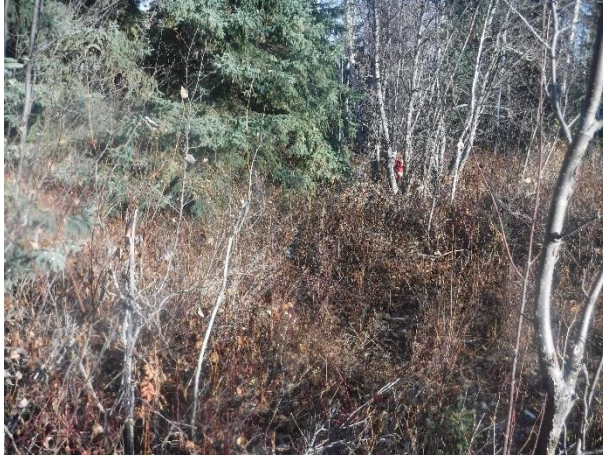
**Photo 71:** Very shallow/vegetated draw below proposed crossing.

As this watercourse is not considered fish-bearing, an appropriately sized closed bottom structure can be installed at this location.

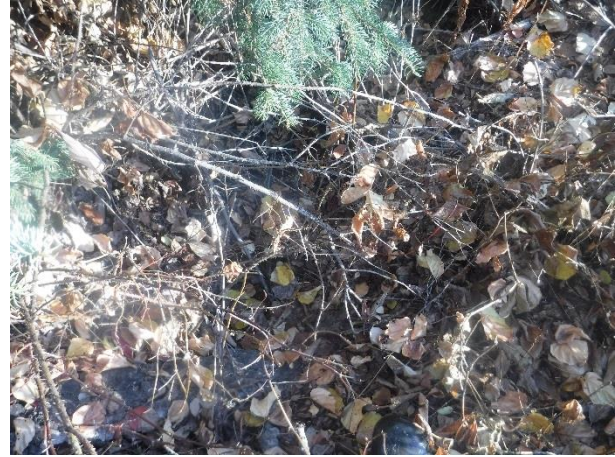
**Photo 72:** Overall lack of defined channel. Minimal and discontinuous scour.

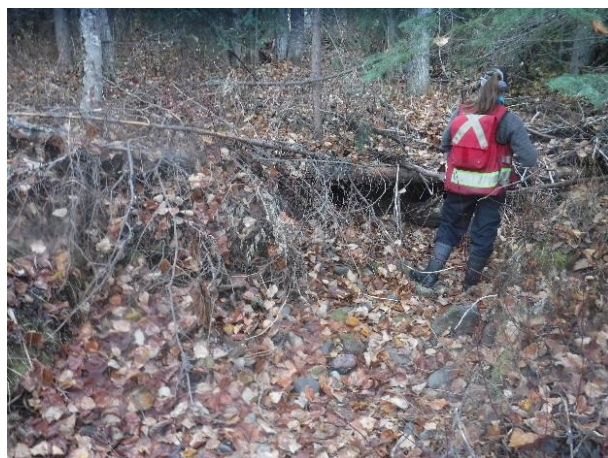
**Photo 73:** Dry stream channel with gravels visible under leaves.

Based on information provided (important habitat rating and size of existing channel), it is recommended that an appropriate size open-bottom structure be installed at the crossing as per the Fish-stream Crossing Guidebook (MoF 2012) replacing the current, partially functional structure. The current structure has become clogged due to the erosion caused by its poor orientation, resulting in most of the water in this system being diverted down the ditch, causing erosion elsewhere. The structure size should be confirmed with hydrotechnical analysis.

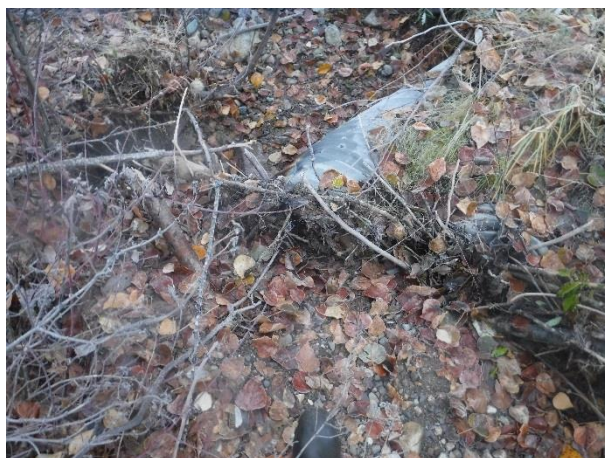
**Photo 74:** Two plugged 600 mm culverts at the crossing.

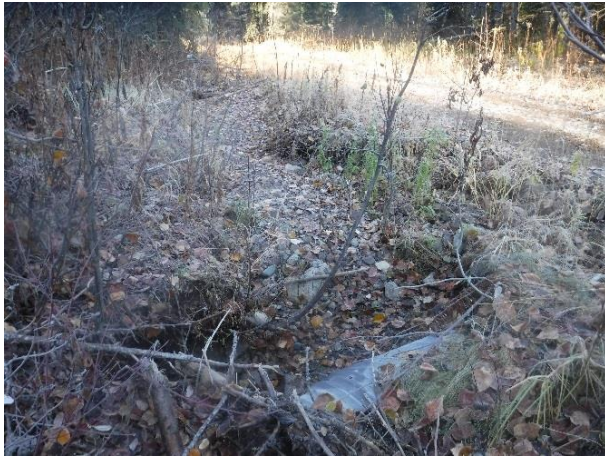
**Photo 75:** Poorly oriented culverts have been clogged by erosion, directing water down ditch.

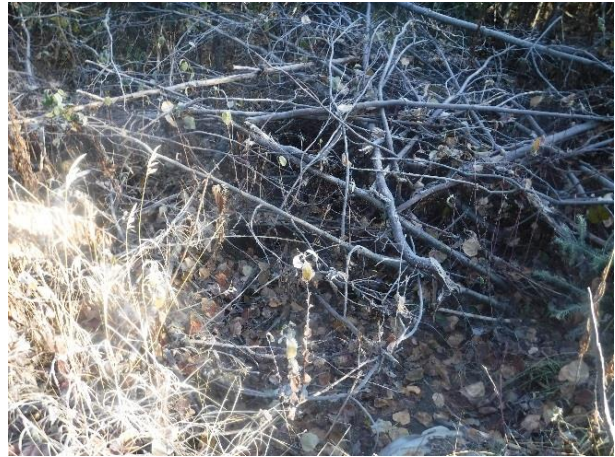
**Photo 76:** Downstream side of crossing. Some water still uses this old channel.
