# Tenas Project

## Terrain and Soil Baseline Report

**December 2021**

VERSION 3.6.1

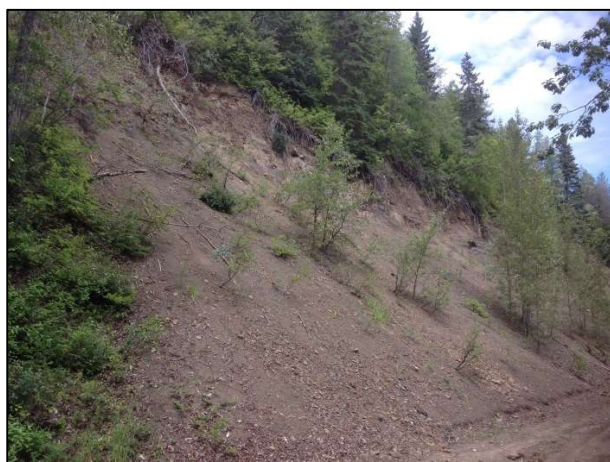
Bedrock outcrop occurs along the valley walls and the valley floor of Goathorn Creek. An outcrop of thinly-bedded siltstone above the Caribou FSR forms a 5 m high cliff band with a 15 m high colluvial slope below (Plate 2-1). Mudstone weathers readily in-situ to 0.5 m to 1 m depth and forms small, angular particles with 2 to 3 cm diameter in a silty matrix (Plate 2-2). Thinly-bedded, coal-bearing sandstone and conglomerate is exposed in stream banks and on the Goathorn Creek valley wall, reaching 2 to 30 m height above the valley bottom (Plate 2-3). The rock fractures easily forming small to foot-sized platy particles. Coal bearing sedimentary rock is also exposed along the recently eroded streambanks of Goathorn Creek (Plate 2-4).

**Plate 2-1:** Bedrock cliff and ravelling colluvial slope along the Caribou FSR, fieldsite IW122.

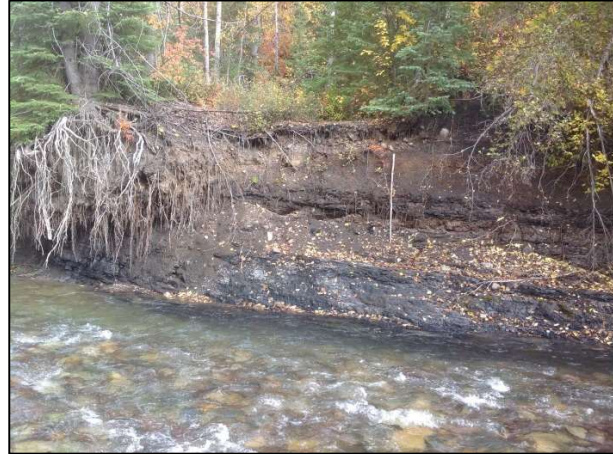
**Plate 2-4:** Bedrock outcrop, recent erosion, Goathorn Creek streambank, field site IW247.

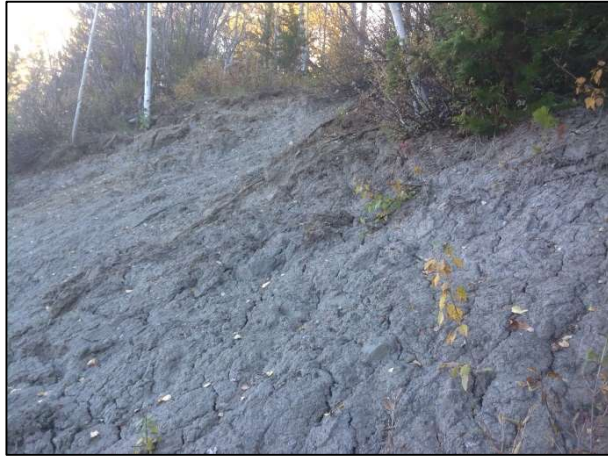
**Plate 2-5:** Basal till (M1) exposed in a landslide upslope of the Goathorn Bridge location, fieldsite IW256.

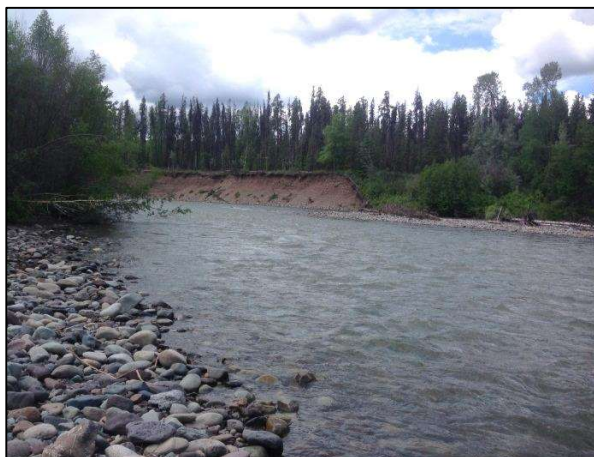
Plate 2-14: Telkwa River, eroding fluvial terrace, field site IW308a, IW326.

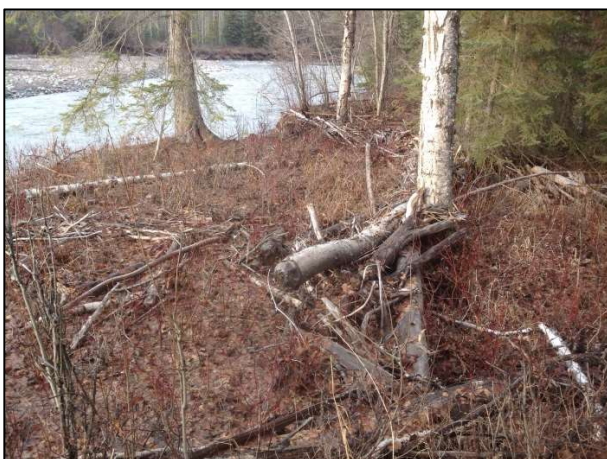
Overbank flooding along the Telkwa River has deposited coarse woody debris and logjams in several areas, with some of the deposits affecting stream bank stability (Plate 2-16 and Plate 2-17).

Plate 2-16: Telkwa River, coarse woody debris deposited by overbank flooding; field site IW322.

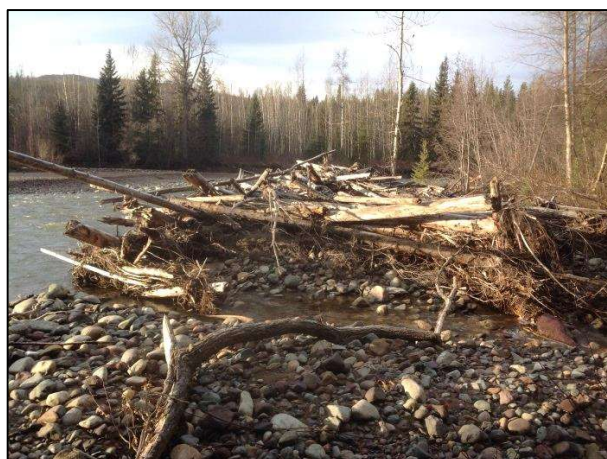
Plate 2-17: Telkwa River, logjam affecting stream bank stabilization; field site IW323.

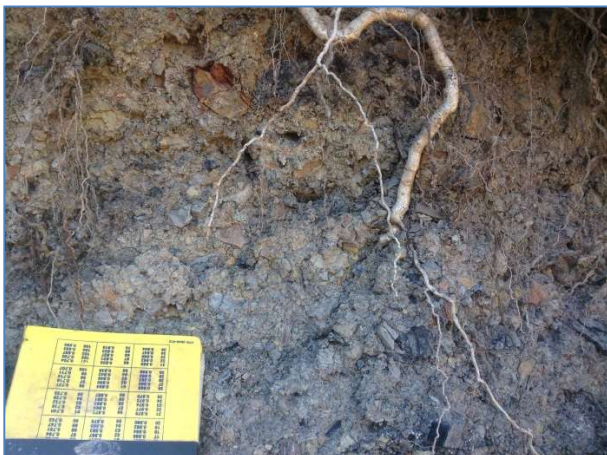
**Plate 2-22:** Past mine waste material exposed in an eroding streambank along Goathorn Creek; field site IW270.

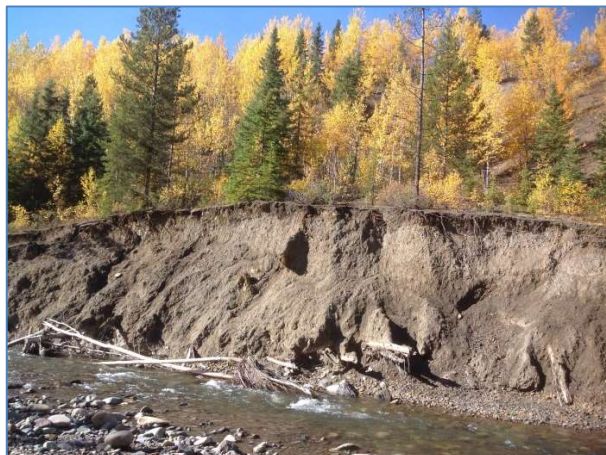
(Westrek Geotechnical Services Ltd. 2019b<sup>28</sup>). Where the material is undercut by Goathorn Creek, it is prone to sliding, flowing and creep (Plate 2-23). Deposits containing mainly coal fragments and coal dust, interbedded with fluvial material were encountered on 3 to 4 m high terraces along Goathorn Creek at and near the BV Horsemans' Camp, a former coal loading site operated by Bulkley Valley Collieries in the 1960s, where the deposits are now being eroded by Goathorn Creek (Plate 2-24; field site IW060a).

**Plate 2-23:** Goathorn Creek, undercut streambank exposing mine waste; field site IW240.

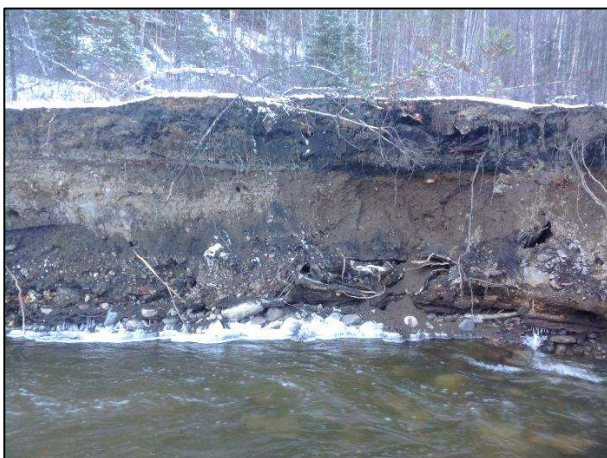
**Plate 2-24:** Mine waste material at the BV Horsemans' Camp, former BV Collieries operation; field site IW060a.

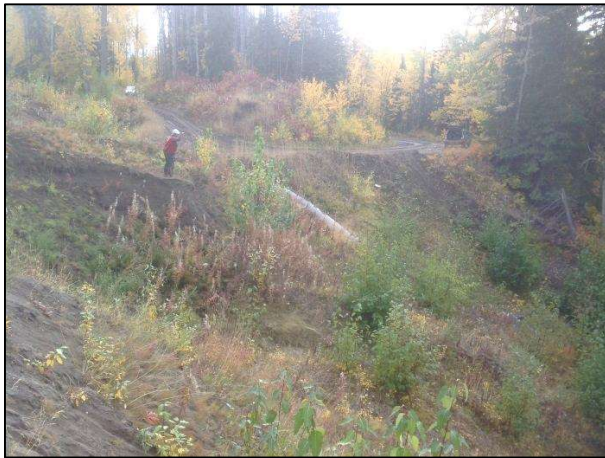
**Plate 2-26:** Start zone of the Coalmine Road landslide; field sites IW065, IW235.

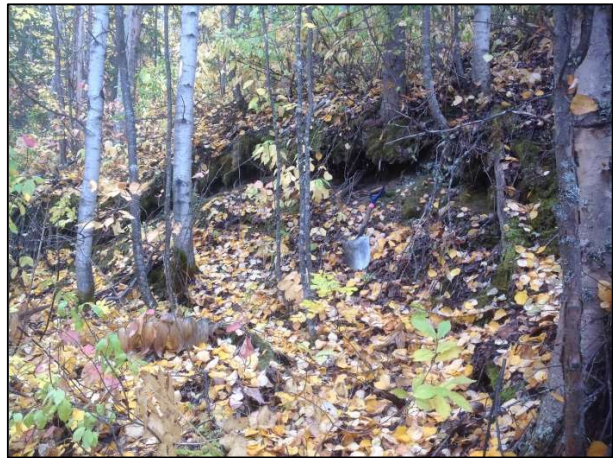
**Plate 2-27:** Shallow slide and soil creep above Coalmine Road; field site IW251.

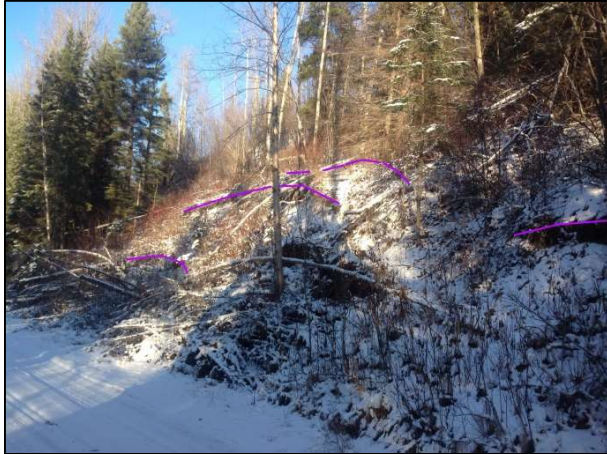
**Plate 2-28:** Soil creep and tension cracks (purple mark-up) on the steep slope above Coalmine Road; field site IW064.

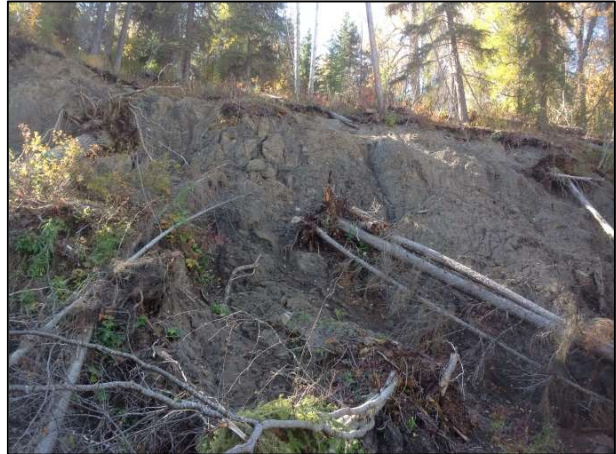
Slow mass movement continues at the present time as creep (**-Fc**) at several valley wall sites of Goathorn Creek and Tenas Creek, including upslope of Coalmine Road, locally creating wide open, 1 m deep tension cracks in glacial till (Plate 2-27, Plate 2-28; field sites IW251, IW064). Creep also occurs in clay-rich mining waste material which starts to flow (**-Fe**) on slope gradients as low as 40 to 50% (21 to 27°) when saturated and undercut by Goathorn Creek (field site IW275; Plate 2-29).

**Plate 2-29:** Debris slide in till, weathered rock and mine waste along Goathorn Creek; field site IW275.

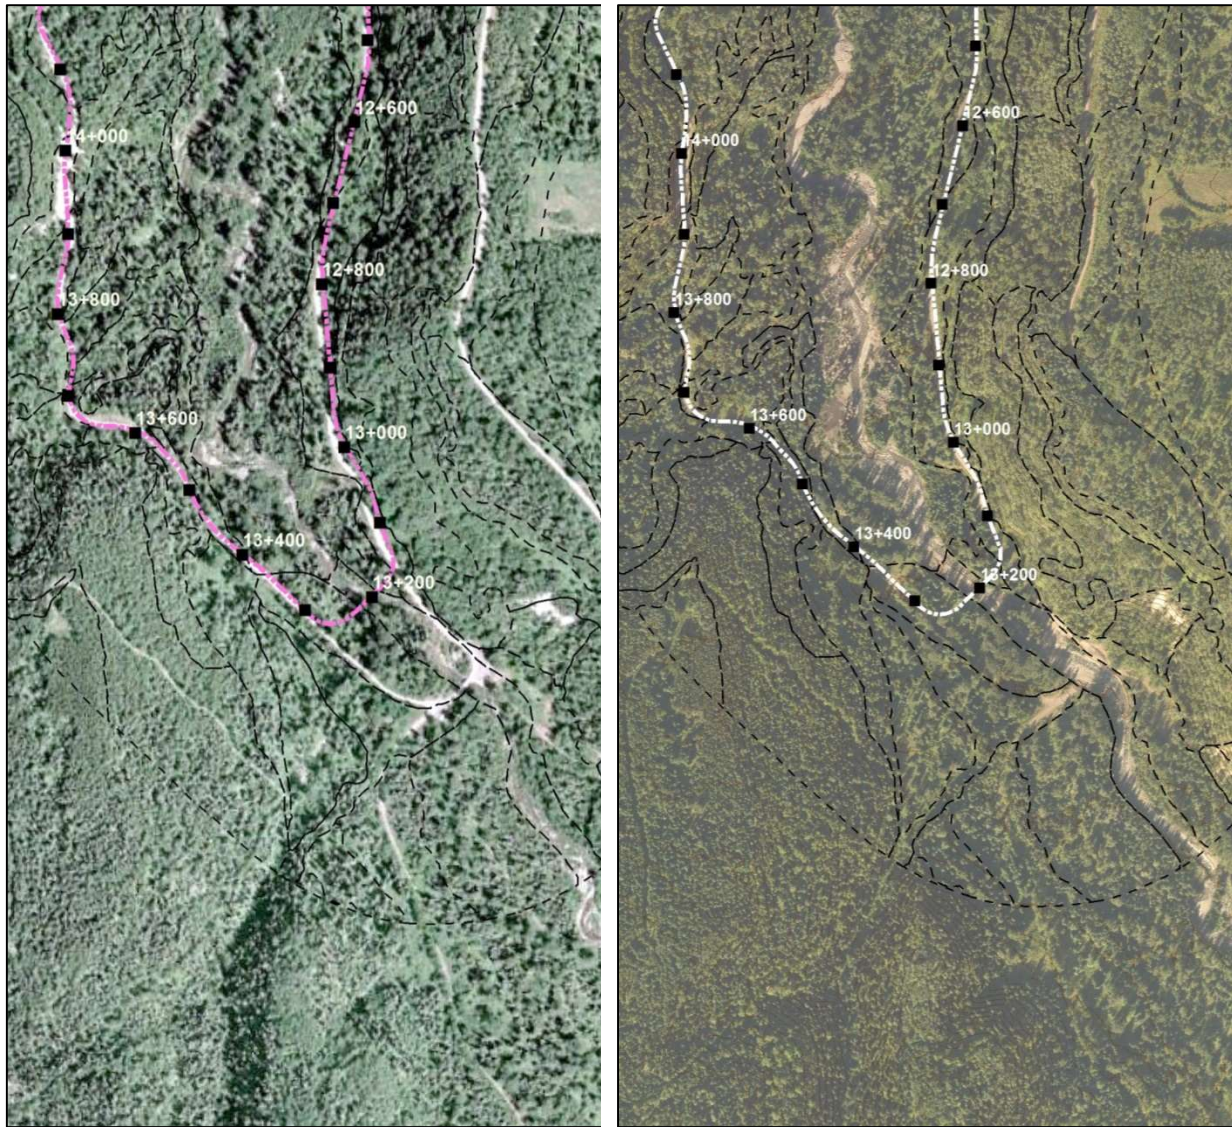
High rates of sediment transport from upstream channel sections to the proposed bridge site are likely to continue for several years or decades, causing channel migration and avulsions on the Goathorn Creek floodplain.

**Figure 2-12: Goathorn Creek near the proposed bridge site in 2006 (left image) and 2017 (right image). Note the channel widening following the flood in June 2013.**

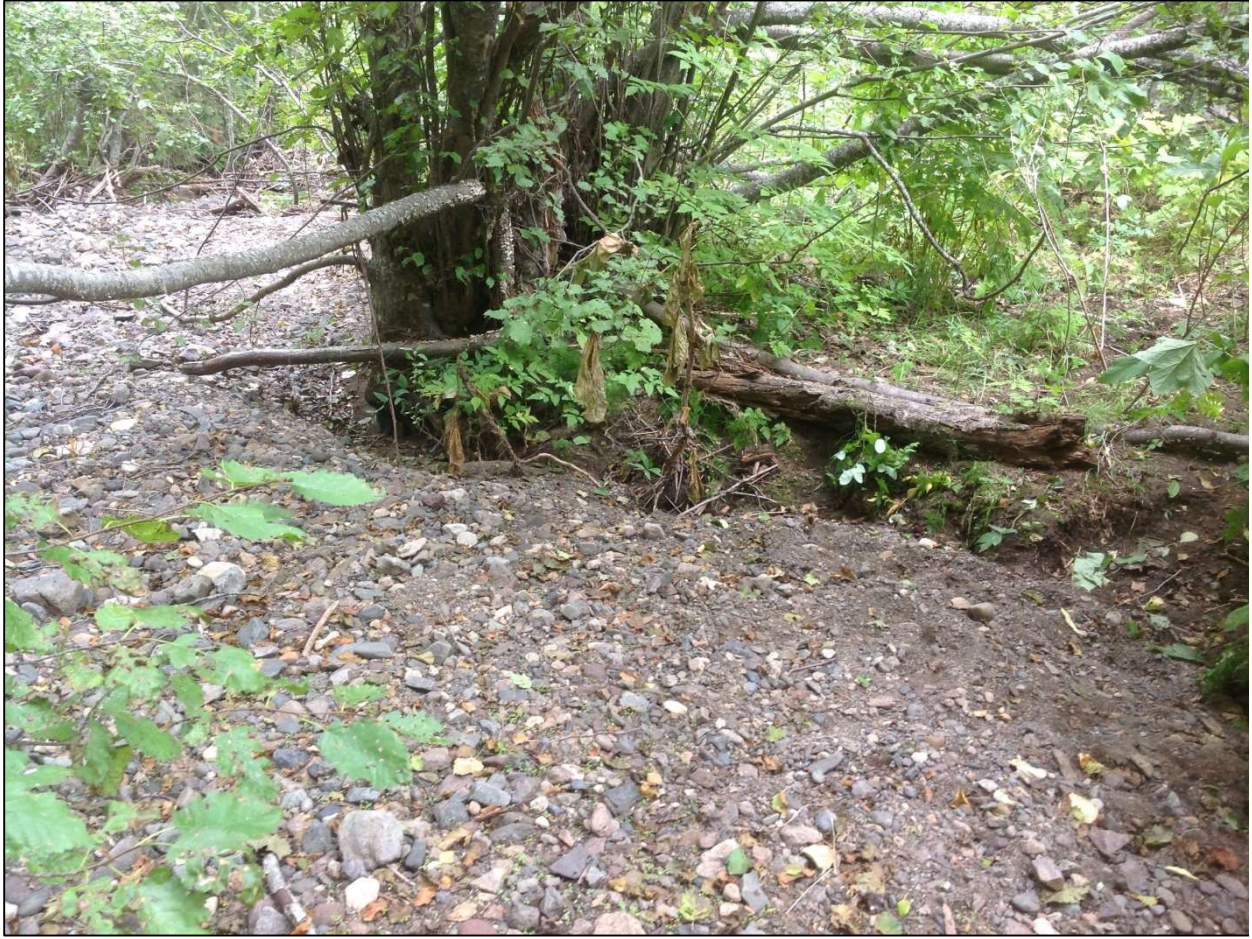
As the channel of Helps Creek becomes re-established in future high flow events, the aggraded gravel and cobble will likely be reworked (entrained and re-deposited). A new channel may become established anywhere within 10 to 20 m on either side of the filled-in channel. Large sediment pulses transporting residual bed material the disturbed upstream reaches of Helps Creek towards the Bypass Road crossing are unlikely, but possible.

**Plate 2-30: De-watered channel of Helps Creek due to sediment aggradation near the proposed crossing of the Bypass Road.**
