# Tenas Project – Pit Backfill Stability Assessment Report

Telkwa Coal Ltd.

SRK Consulting (Canada) Inc.  
2CT025.008  
April 2021

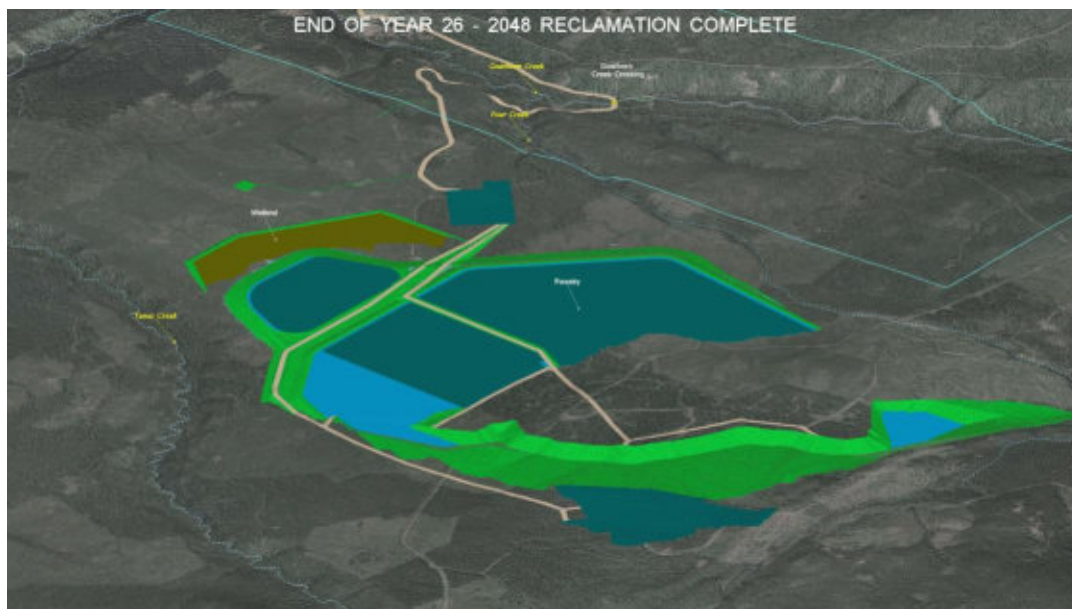
Figure 2-3: Proposed Year 2048 mine reclamation plan

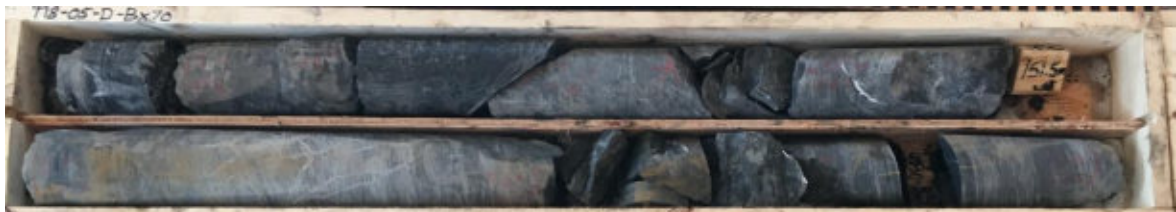
Fine grained, bedded, grey and dark grey, assessed fresh to highly weathered, generally estimated very weak to medium strong intact rock strength (R1 to R3). The mudstone is often interbedded with small coal seams and breaks on graphitic coated joints near major coal seams.

Figure 4-1: Example core of mudstone rock type

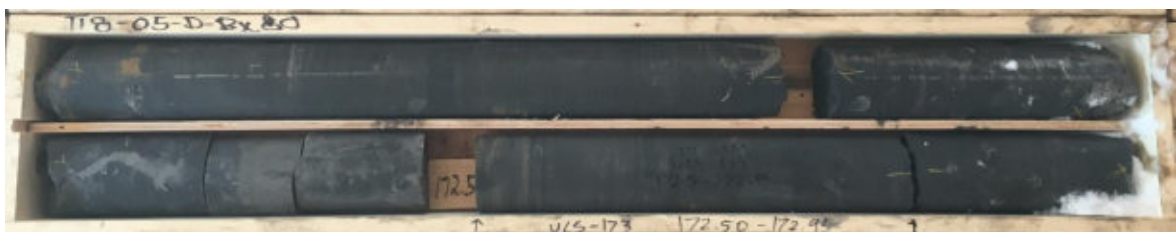
Fine grained, bedded and laminated texture, dark grey, assessed fresh to moderately weathered, generally estimated very weak to medium strong intact rock strength (R2 to R3). The siltstone can be interbedded with small coal seams and breaks on graphitic coated joints near major coal seams.

Figure 4-2: Example core of siltstone rock type

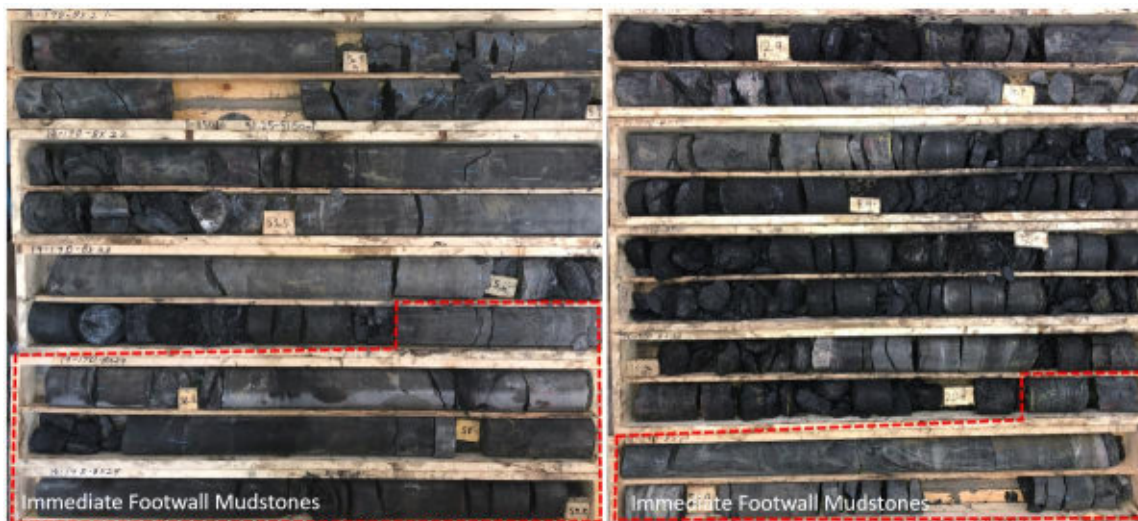
With consideration to possible weaker mudstone bedding planes located within the immediate footwall forming rocks (Figure 6-1), a lower shear strength material was applied to the backfill-footwall interface. Where the footwalls are steep, such as the Phase 3 West Footwall, weaker bedding structures are expected to detach from the exposed benches during excavation and were not included in the analyses. A weaker bedding layer was included in all other models, including the lower elevations of the Phase 3 sections. The weaker bedding layer is represented by a residual shear strength of 23 degrees which is consistent with the completed laboratory testing (SRK, 2019a and SRK, 2019b), and the empirical information noted by Klohn Leonoff (1985).

**Figure 6-1: Example of Mudstones immediately below the design footwall (19-17D, left and 19-09D, right)**
