# Tenas Project – Factual Data Report for 2018 Geotechnical Investigation

Telkwa Coal Ltd.

SRK Consulting (Canada) Inc.  
2CT025.002  
August 2018

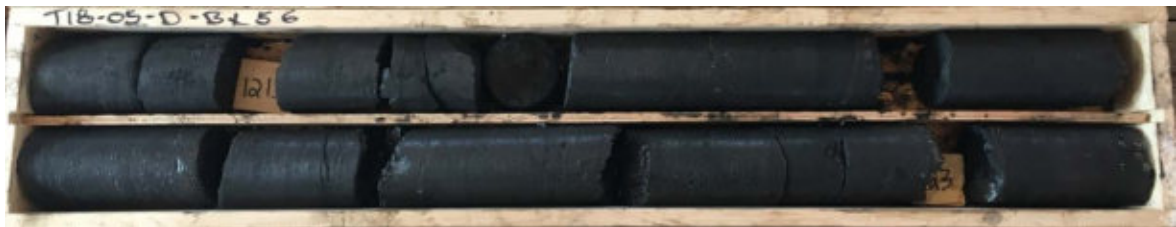
Figure 7-1: Example Core of Coal Rock Type

Fine grained, bedded and cleated texture, dark grey and black, assessed fresh to extremely weathered, generally estimated extremely weak to very weak intact rock strength (R0 to R1).

Rock types encountered in the geotechnical drilling program generally comprised Skeena Group mudstone, siltstone, sandstone and coal. The typical appearance of representative rock types are presented in Figure 7-1, through Figure 7-4.

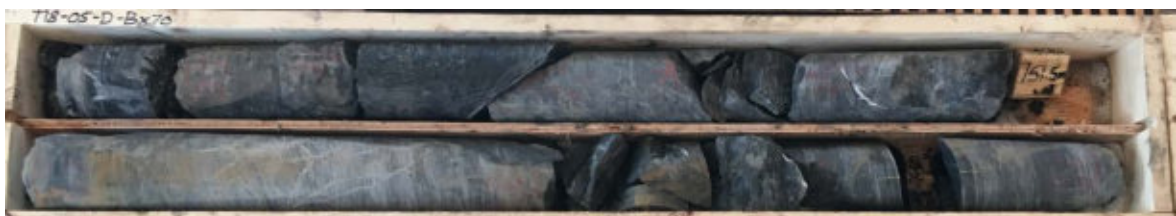
Figure 7-2: Example Core of Mudstone Rock Type

Fine grained, bedded, grey and dark grey, assessed fresh to highly weathered, generally estimated very weak to medium strong intact rock strength (R1 to R3). The mudstone is often interbedded with small coal seams and breaks on graphitic coated joints near major coal seams.

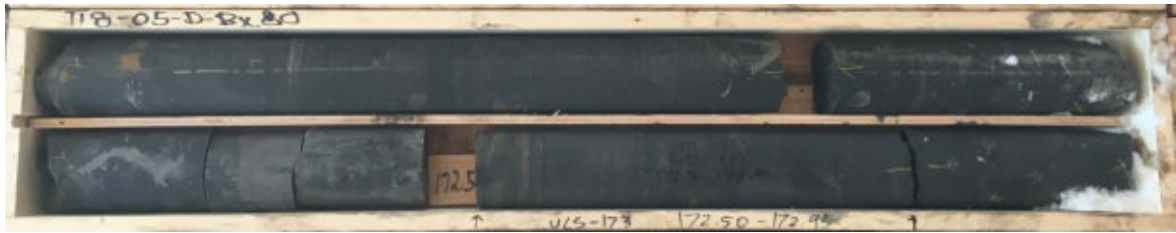
**Figure 7-3: Example Core of Siltstone Rock Type**

Fine grained, bedded and laminated texture, dark grey, assessed fresh to moderately weathered, generally estimated very weak to medium strong intact rock strength (R2 to R3). The siltstone can be interbedded with small coal seams and breaks on graphitic coated joints near major coal seams.
