# Tenas Project – Factual Data Report for 2019 Field Investigation

Telkwa Coal Ltd.

SRK Consulting (Canada) Inc.  
2CT025.006  
July 2019

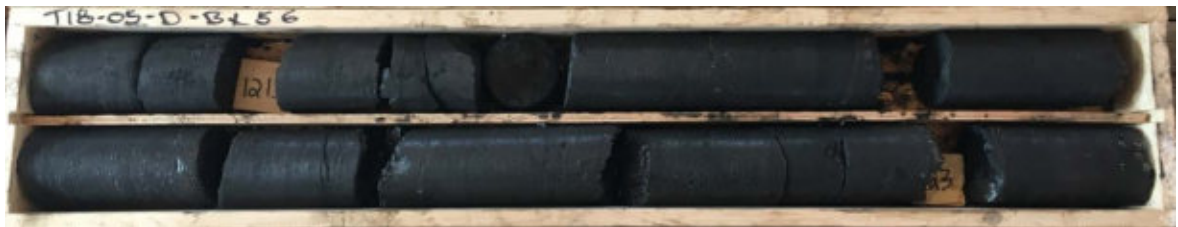
Figure 7-1: Example Core of Coal Rock Type

Fine grained, bedded and cleated texture, dark grey and black, assessed fresh to extremely weathered, generally estimated extremely weak to very weak intact rock strength (R0 to R1).

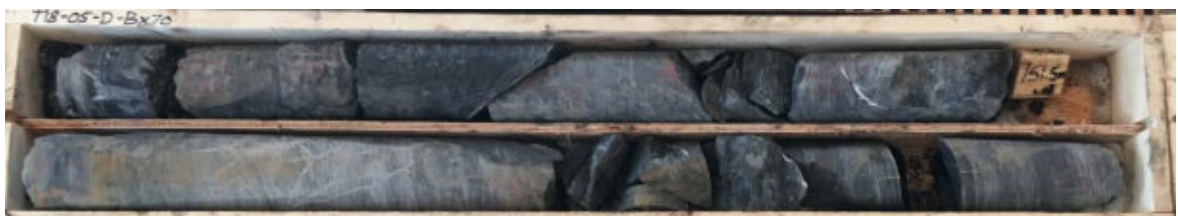
Figure 7-2: Example Core of Mudstone Rock Type

Fine grained, bedded, grey and dark grey, assessed fresh to highly weathered, generally estimated very weak to medium strong intact rock strength (R1 to R3). The mudstone is often interbedded with small coal seams and breaks on graphitic coated joints near major coal seams.

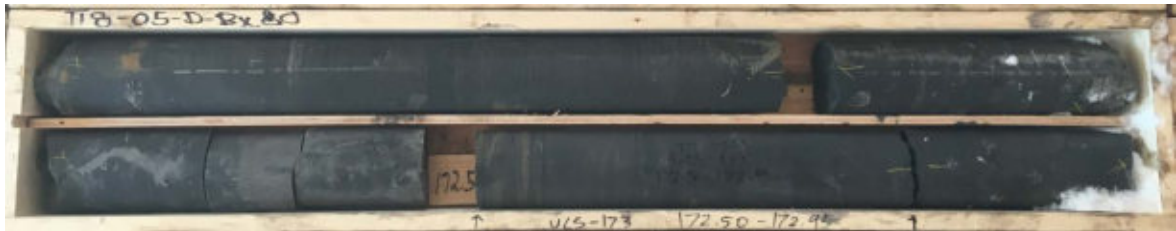
**Figure 7-3: Example Core of Siltstone Rock Type**

Fine grained, bedded and laminated texture, dark grey, assessed fresh to moderately weathered, generally estimated very weak to medium strong intact rock strength (R2 to R3). The siltstone can be interbedded with small coal seams and breaks on graphitic coated joints near major coal seams.

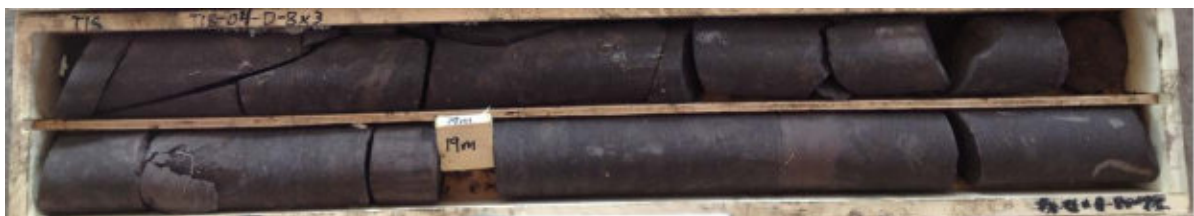
**Figure 7-5: Example core of Hazelton Volcanics rock type**

Fine to medium grained, massive and porphyritic texture, pink to dark red, assessed fresh to slightly weathered. The volcanics were only intercepted in one deeper cored exploration drillhole and are expected to be a significant distance from most of the final pit slopes.
