# **SRK, Tenas Project Management and Control Pond Stability Assessment**

# Tenas Project – Management and Control Ponds Stability Assessment

Tenas Project, British Columbia, Canada  
Telkwa Coal Ltd.

SRK Consulting (Canada) Inc.  
350 3rd Avenue North, Suite 600  
Saskatoon, SK S7K 6G7  
Canada

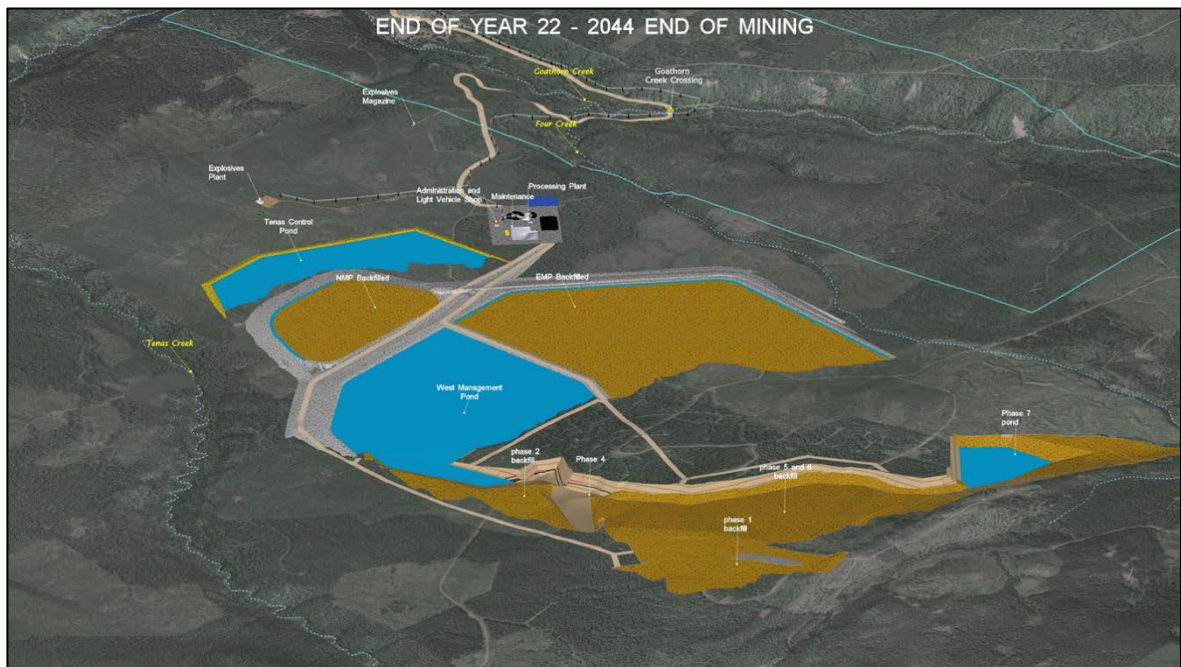
Figure 2-4: Mine Layout at the End of Life of Mine.

The excavation of the Tenas Pit is to be completed in seven phases, each with a subsequent backfill sequence. The non-acid generating (NAG) and PAG waste rock is to be segregated through strategic excavation of the sedimentary sequences. The NAG waste rock is to be used for construction purposes and to backfill the open pit while the PAG is to be placed in the three constructed MP comprising an East, West and North cell (Figure 2-4). The most recent revision of the completed MP (v.7 20210304) was provided by Telkwa for use in this assessment.
