**Geotechnical Investigation  
Tenas Haul Road  
Tenas Project Feasibility Study  
Telkwa, BC**

**Telkwa Coal Limited**

**Westrek Geotechnical Services Ltd.**

February 14, 2020  
File No. 017-318

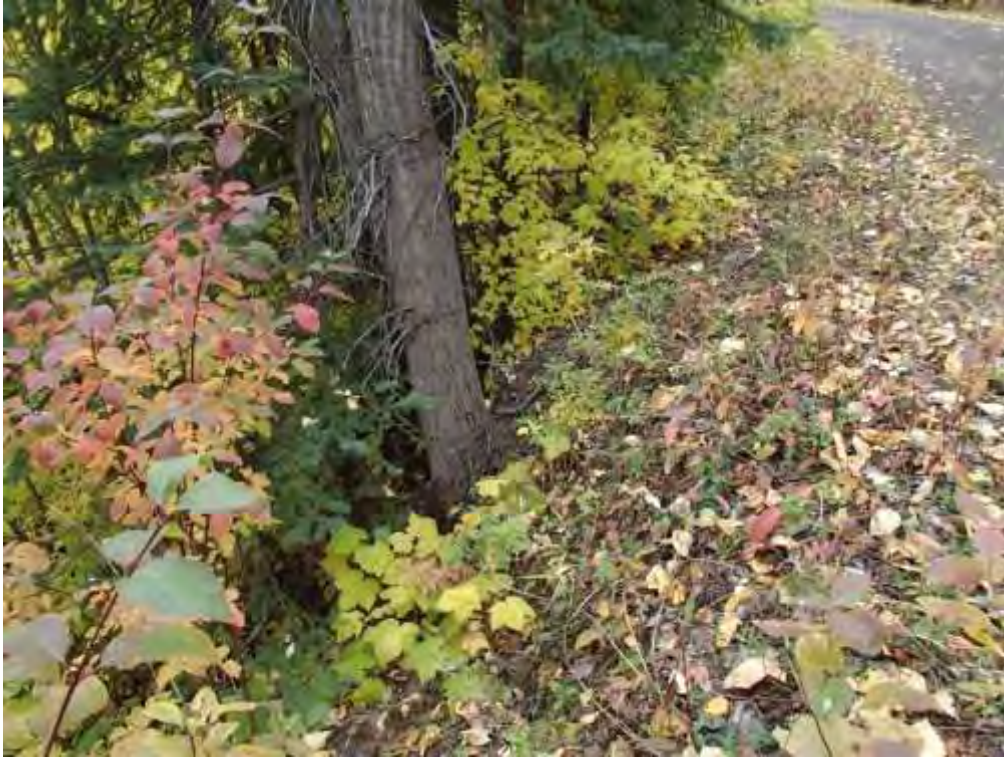
The fillslope is 100% (1:1) for 5 to 7 m and supported by tree trunks and roots (Photo 1). No tension cracks are visible in the road; however, this fillslope is over-steepened and marginally stable.

*Photo 1: Over-steepened fillslope supported by tree roots and trunks near Sta. 11+600.*

DWB's design cross-sections show sliver fills from Sta. 11+550 to 11+620 and from Sta. 11+760 to 11+815. The existing fillslope is over-steepened and adding sliver fill is not recommended. The narrow benches shown on the cross-sections are not continuous enough to adequately support the toe of the fillslope and some of the sliver fills will not be adequately supported. If additional fill is to be placed, the existing fillslope should be benched to create level benches about every 4 m elevation to support the fillslope. The fill should then be constructed in lifts beginning along the bottom bench. Alternatively, the road can be realigned 1 to 2 m into the cutslope to avoid filling, as discussed in Section 6.2.2.

DWB's cross-sections do not show any widening of the road into the cutslope, preferring to widen the road onto the fillslope. The segments from Sta. 11+550 to 11+620 and from Sta. 11+760 to 11+815 are recommended to be realigned 1 to 2 m into the cutslope to eliminate the proposed sliver fills. Additional trimming of the cutslope will also be needed along much of the road to deepen the ditch. Most of these cutslopes can be suitably trimmed to 1.25H:1V within the reach-height of a large excavator. Where the crest of the cutslope is beyond the excavator's reach, the cutslope could be steepened to 1.1H:1V.

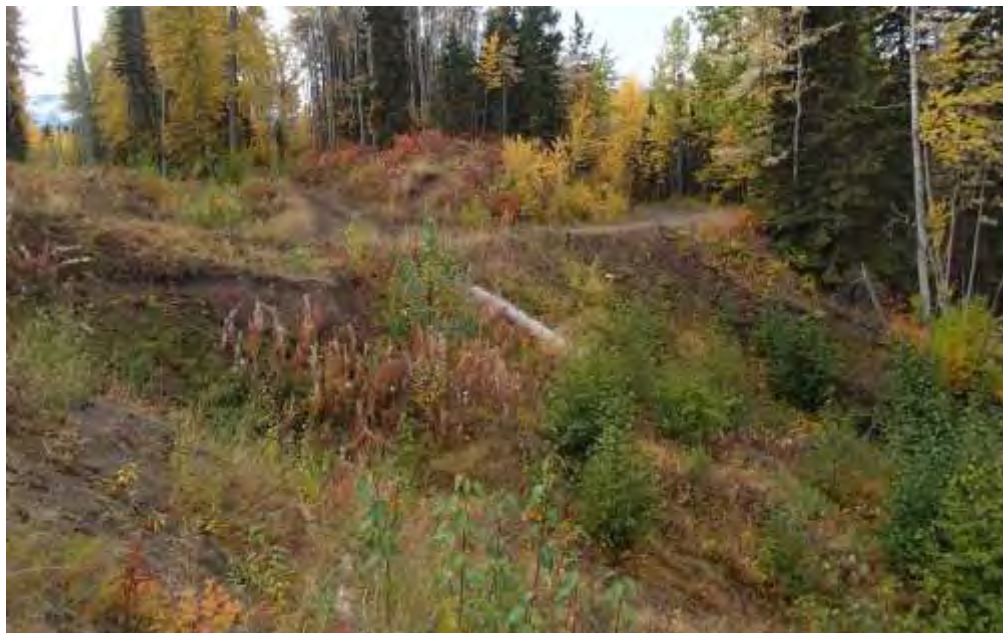
Surface water in this area drains from a large, low-lying area 100 to 200 m south along Caribou FSR01, beginning just north of the gravel pit. A trench or ditch was dug along Caribou FSR01 to partially drain this ponded area. The ditch drains into a culvert, across Goathorn Creek Road and directly into the failure headscarp. Water was reportedly ponded in the ditch prior to the failure.

*Photo 1: Overview of fillslope failure with the culvert in the middle of the photo and the other bowl to the left. Note the junction with Caribou FSR01. Goathorn Creek Road continues to the right.*

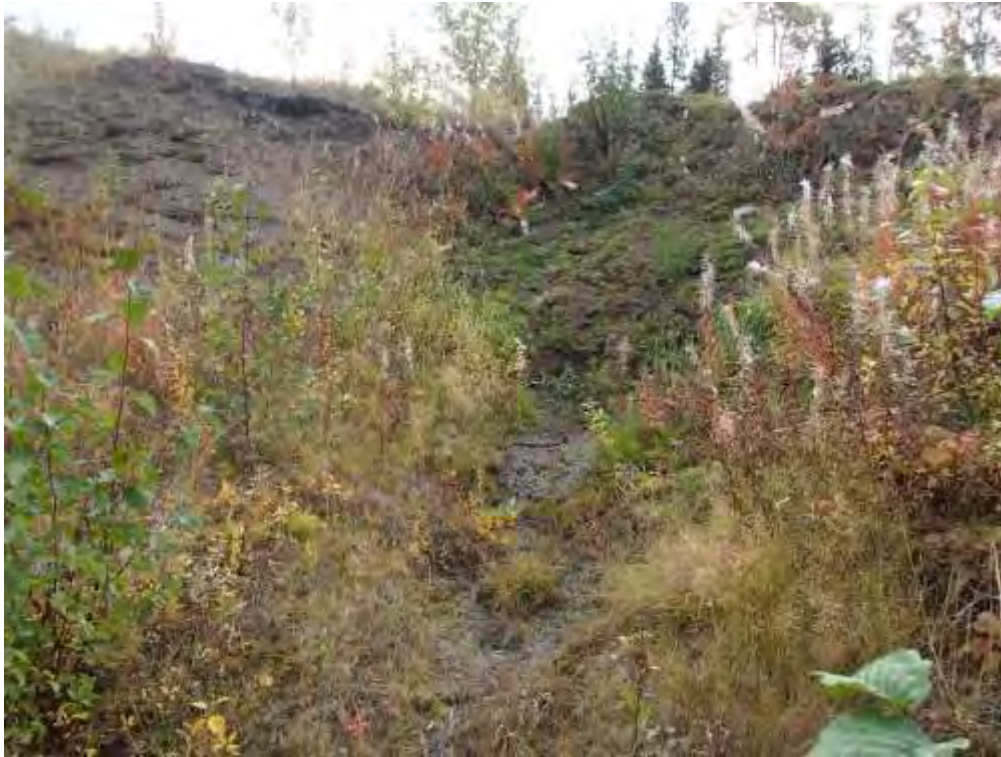
underlain by a 0.75 m thick seam of dense to very dense, silty sand and gravel that was wet and water bearing. The groundwater discharge is related to the road failure, as discussed in Section 7.

*Photo 2: View looking up the slide with seepage zone at the base of the fill.*

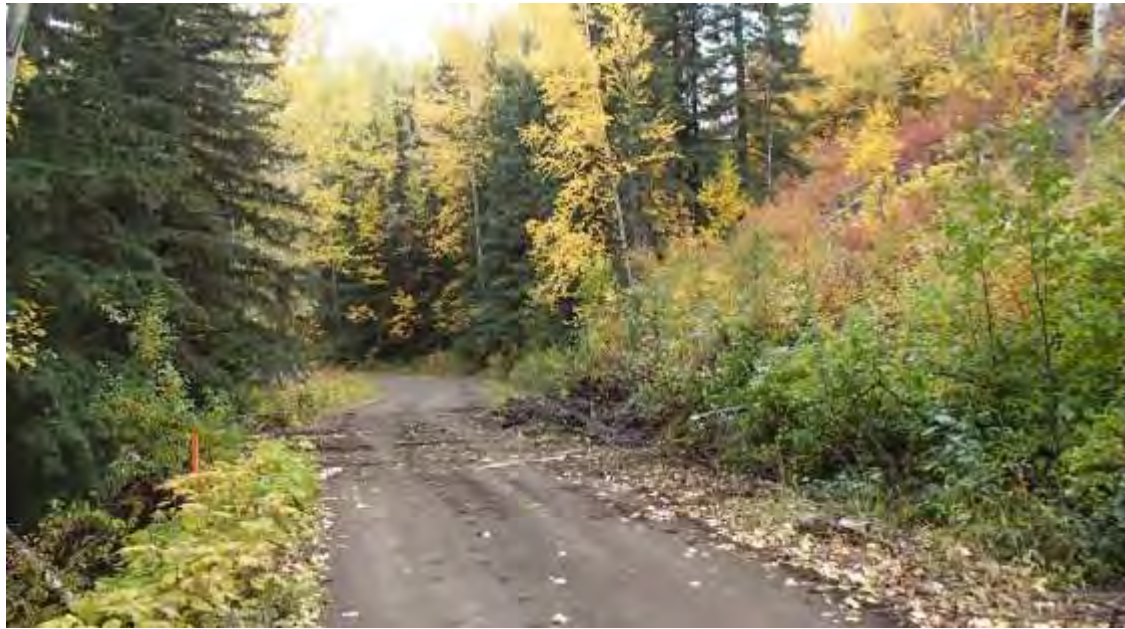
A 30 m wide cutslope failure occurred 1 to 2 years ago, between approximately Sta. 11+800 and 11+830. The landslide deposit blocked the road but was recently cleared (Photo 5).

*Photo 3: The road near Sta. 11+820 after slide debris had been cleared.*

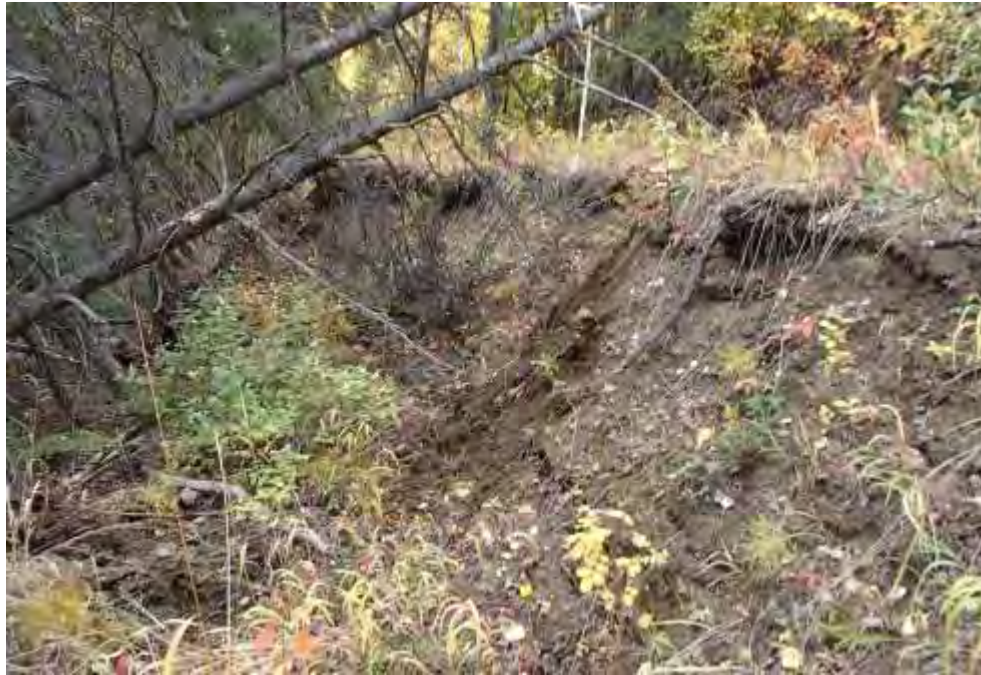
The failure headscarp is about 15 m upslope of the road; however, a much larger landslide is developing with the headscarp located 40 m upslope, along the former access road to BVC No. 1 Mine. Tension cracks in the shoulder of the abandoned road measure up to 1.2 m of vertical movement and 1 m of horizontal movement (Photo 6).

The landslide appears to still be active. The initial landslide probably ceased moving when the landslide mass reached Goathorn Creek Road, but began moving again when the landslide debris was cleared. The lack of toe support creates a high likelihood of a retrogressive landslide 70 m wide by 50 m long, capable of completely blocking the Tenas Haul Road.

*Photo 4: Vertical displacement in the former access road to BVC No 1 Mine.*

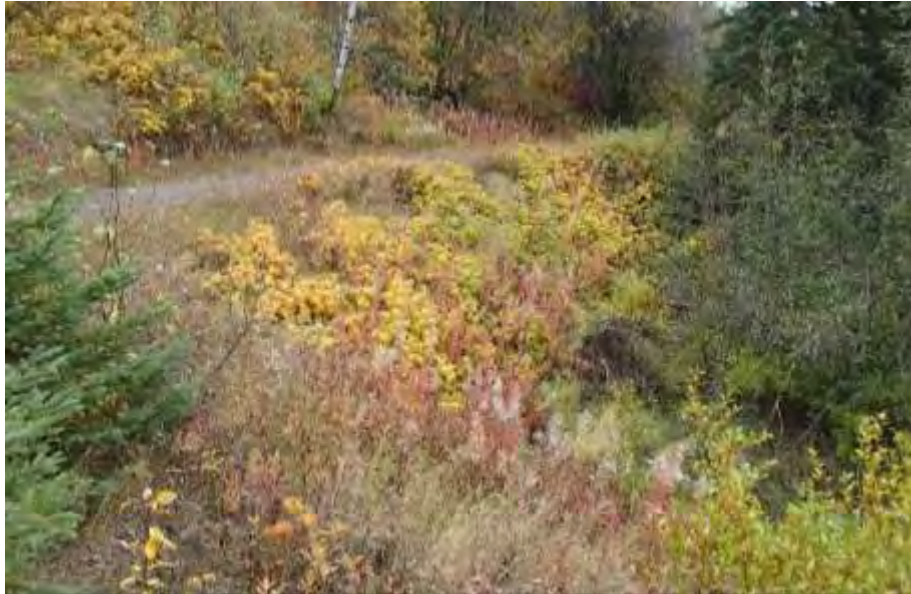
Approximately 40 m of the existing road fillslope is over-steepened due to toe erosion by a flood channel to Goathorn Creek. The fillslope is 4 to 5 m high, steeper than 100% and exposes loose, fine-grained sand. Most of the slope is vegetated with salmonberry and other shrubs but the toe of the slope shows signs of erosion (Photo 7).

*Photo 7: Over-steepened slope below road.*

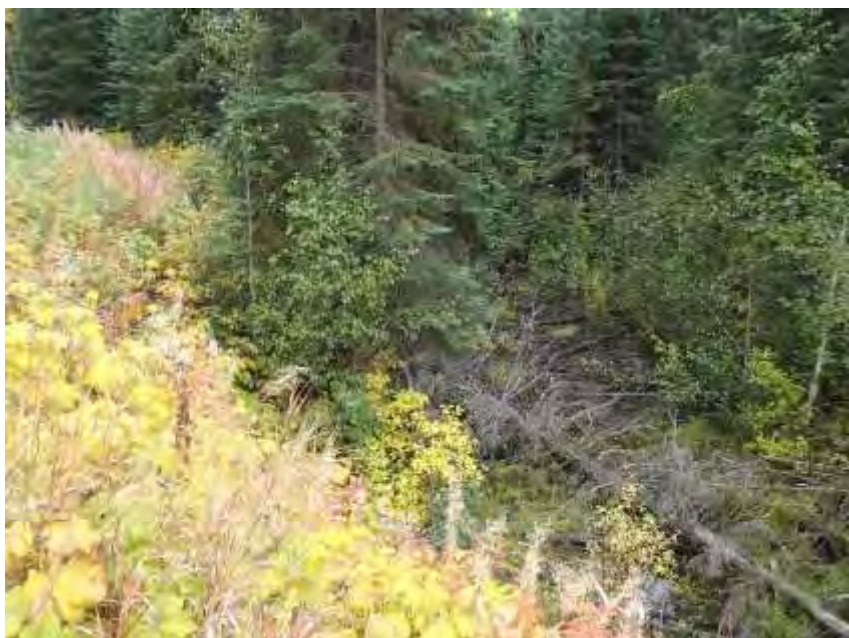
The adjacent back channel has a low gradient, contains deadfall, and is vegetated with sedges, indicating a low water velocity (Photo 8). The channel forms a meander that naturally erodes the toe of the slope below the road, but probably only during peak flow periods in Goathorn Creek.

*Photo 8: Flood channel below the road that has caused the erosion.*

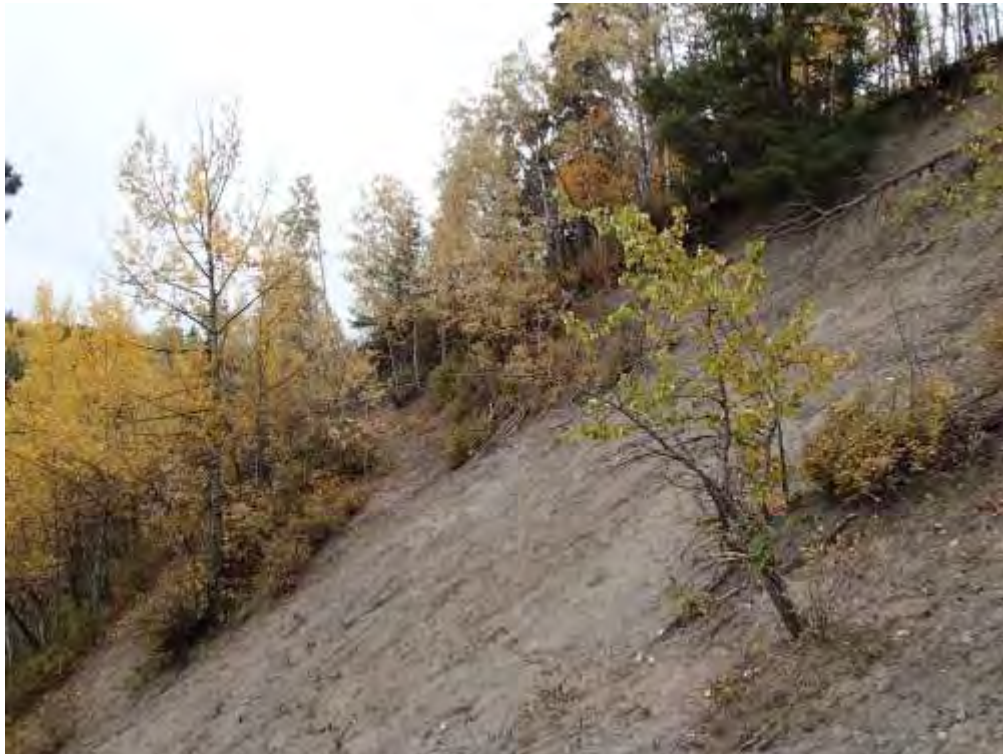
The headscarp is located approximately 125 m upslope of the creek and is more than 80 m wide. The headscarp is quite short, indicating that the past landslide was very shallow. The upper surface slopes at 75% and exposes clayey silt (Photo 9). The occasional patch of vegetation indicates that the slide is prone to frequent surface erosion and shallow slope movement.

*Photo 9: Clayey/silty soils in the landslide initiation zone.*

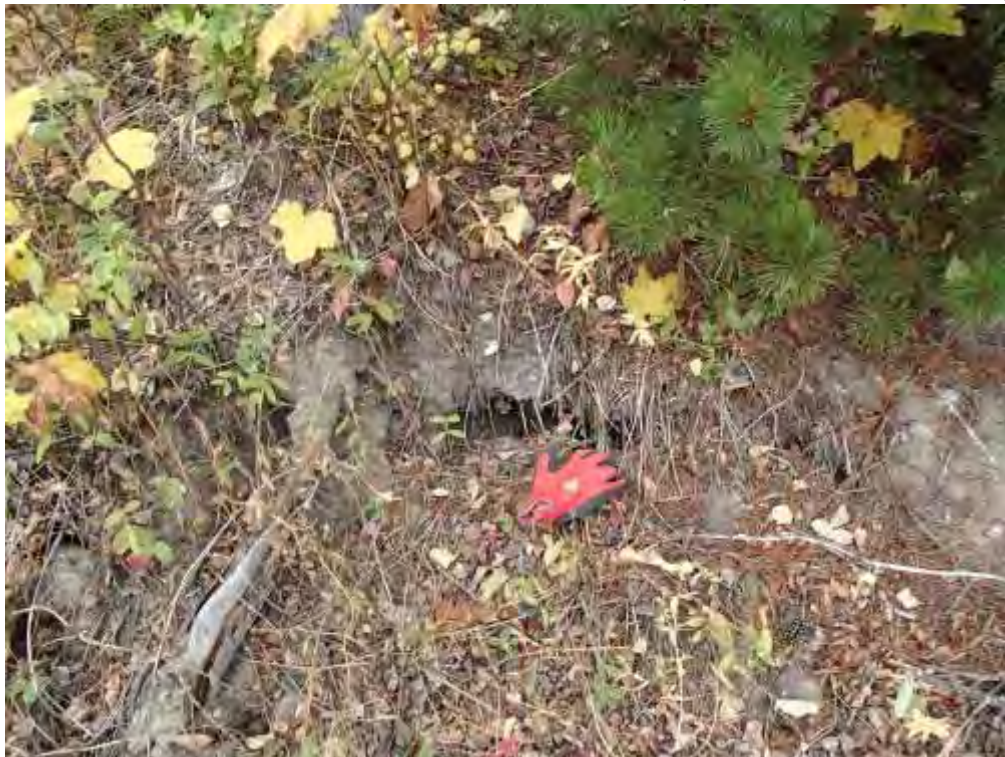
The headscarp follows the slope break with 75% terrain downslope within the landslide, flattening to 25% immediately upslope. More tension cracks are visible in the undisturbed ground 5 to 10 m upslope of the headscarp. These tension cracks are open 10 to 20 cm (Photo 11), indicating a potential for retrogressive failures.

*Photo 11: Tension cracks upslope of the landslide.*

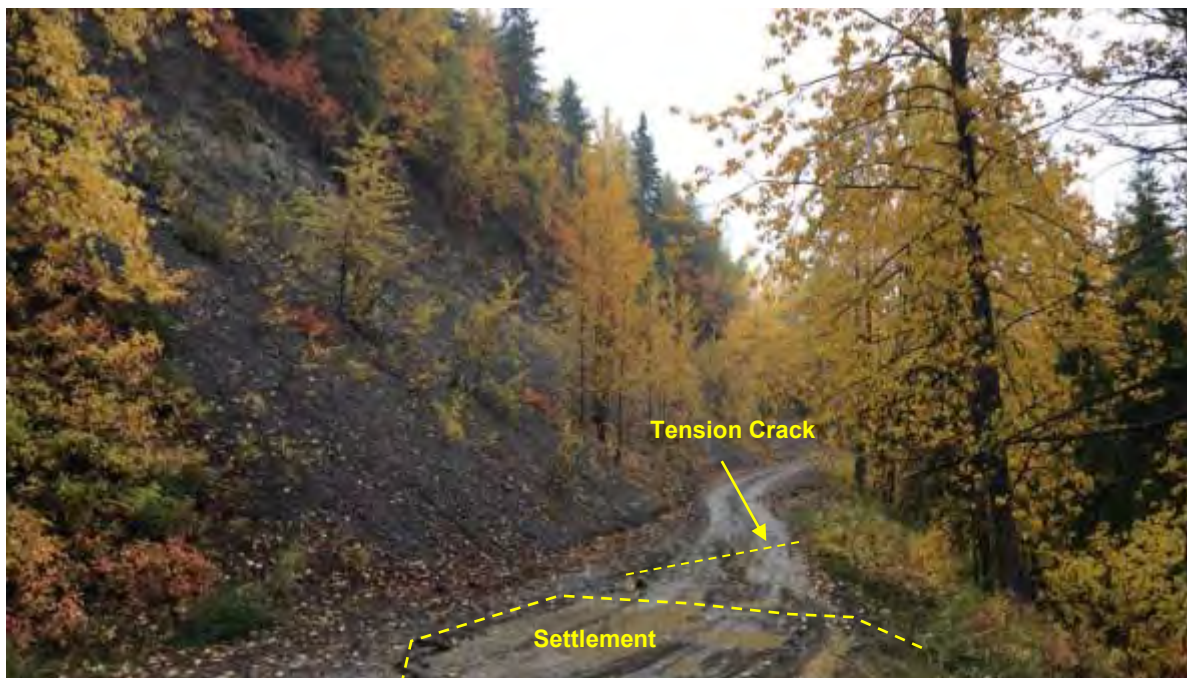
The road climbs gently towards the base of a bedrock bluff and talus slope. The terrain immediately upslope of the road is gently sloping and benchy, but steepens rapidly at the base of the steep colluvial slope near Sta. 13+920. The terrain downslope of the road forms a wide bench and then steps down onto the next bench about 14 m below. The road configuration seems stable, yet tension cracks cross the road between approximately Sta. 13+920 and 13+930. One set of tension cracks cross the road orthogonal to the alignment while the other crosses the road obliquely (Photo 12). Both tension cracks cross the entire road surface and are not limited to the outside shoulder. Ponded water also delineates an area of settlement across the entire road.

*Photo 12: Settlement and tension cracks near Sta. 13+920 to 13+930.*

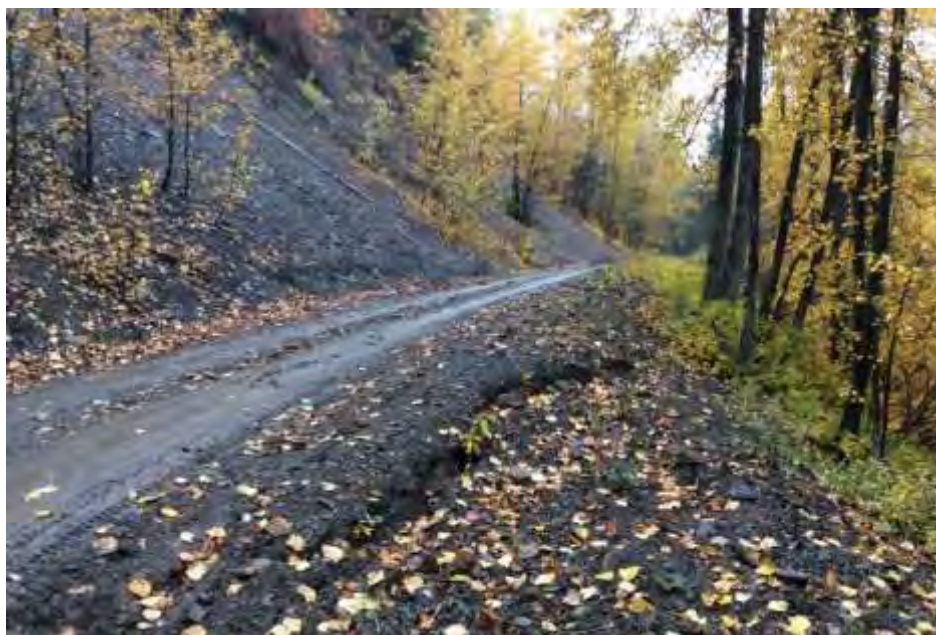
While most of this road segment seems solid, the outside shoulder is often tension cracked and has settled significantly (Photo 13). Some of the settlement also extends into the road subgrade. The terrain below the road slopes at 75% to 80% overall and is 12 to 22 m high, with the higher slopes located towards the north end of this segment. Several sets of tension cracks cross this steep fillslope, each measuring 0.3 to 1.5 m of vertical displacement and exposing silty/clayey colluvium and very weak, highly weathered siltstone and mudstone.

*Photo 13: Tension crack in shoulder.*

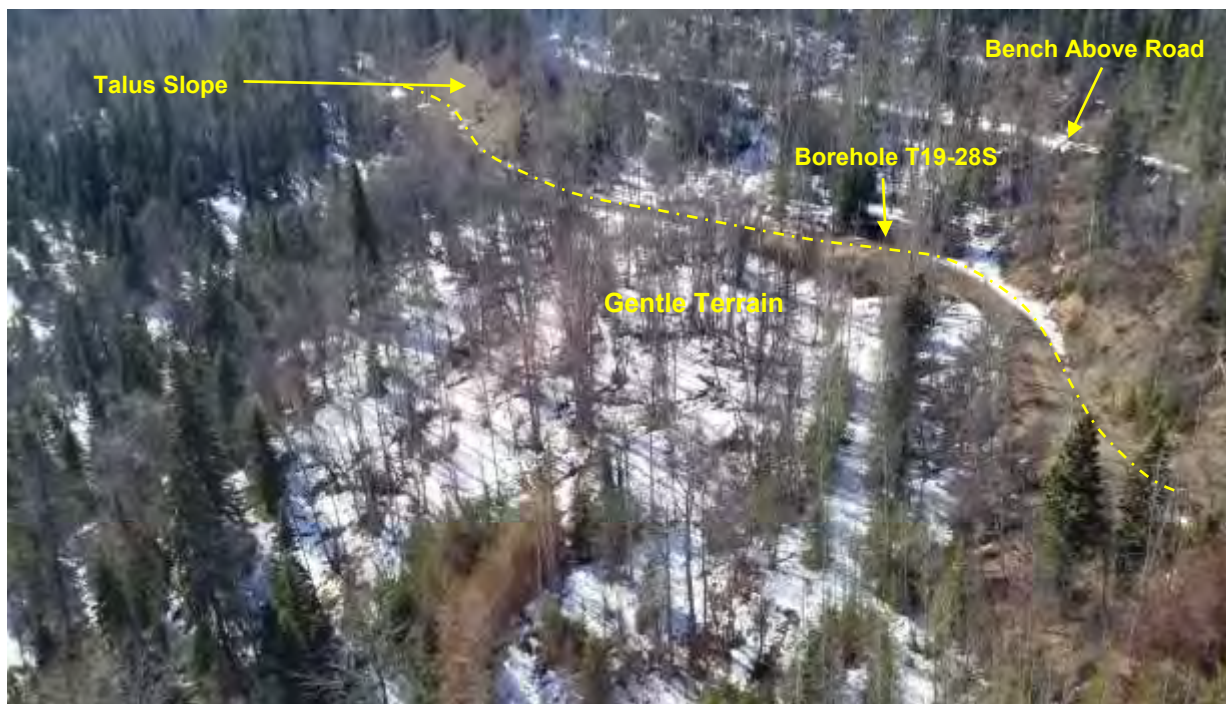
From approximately Sta. 14+180 to 14+220, the road curves to the northeast and begins to climb in grade. The cutslope to the west shortens and the fillslope to the east increases. The cutslope exposes sand, likely part of a glaciofluvial blanket. Tension cracks were noted on both sides of the road, as well as visible subsidence on the surface, indicating settlement of the road fill.

Photo 14: Aerial view of Sta. 14+030 to 14+220.

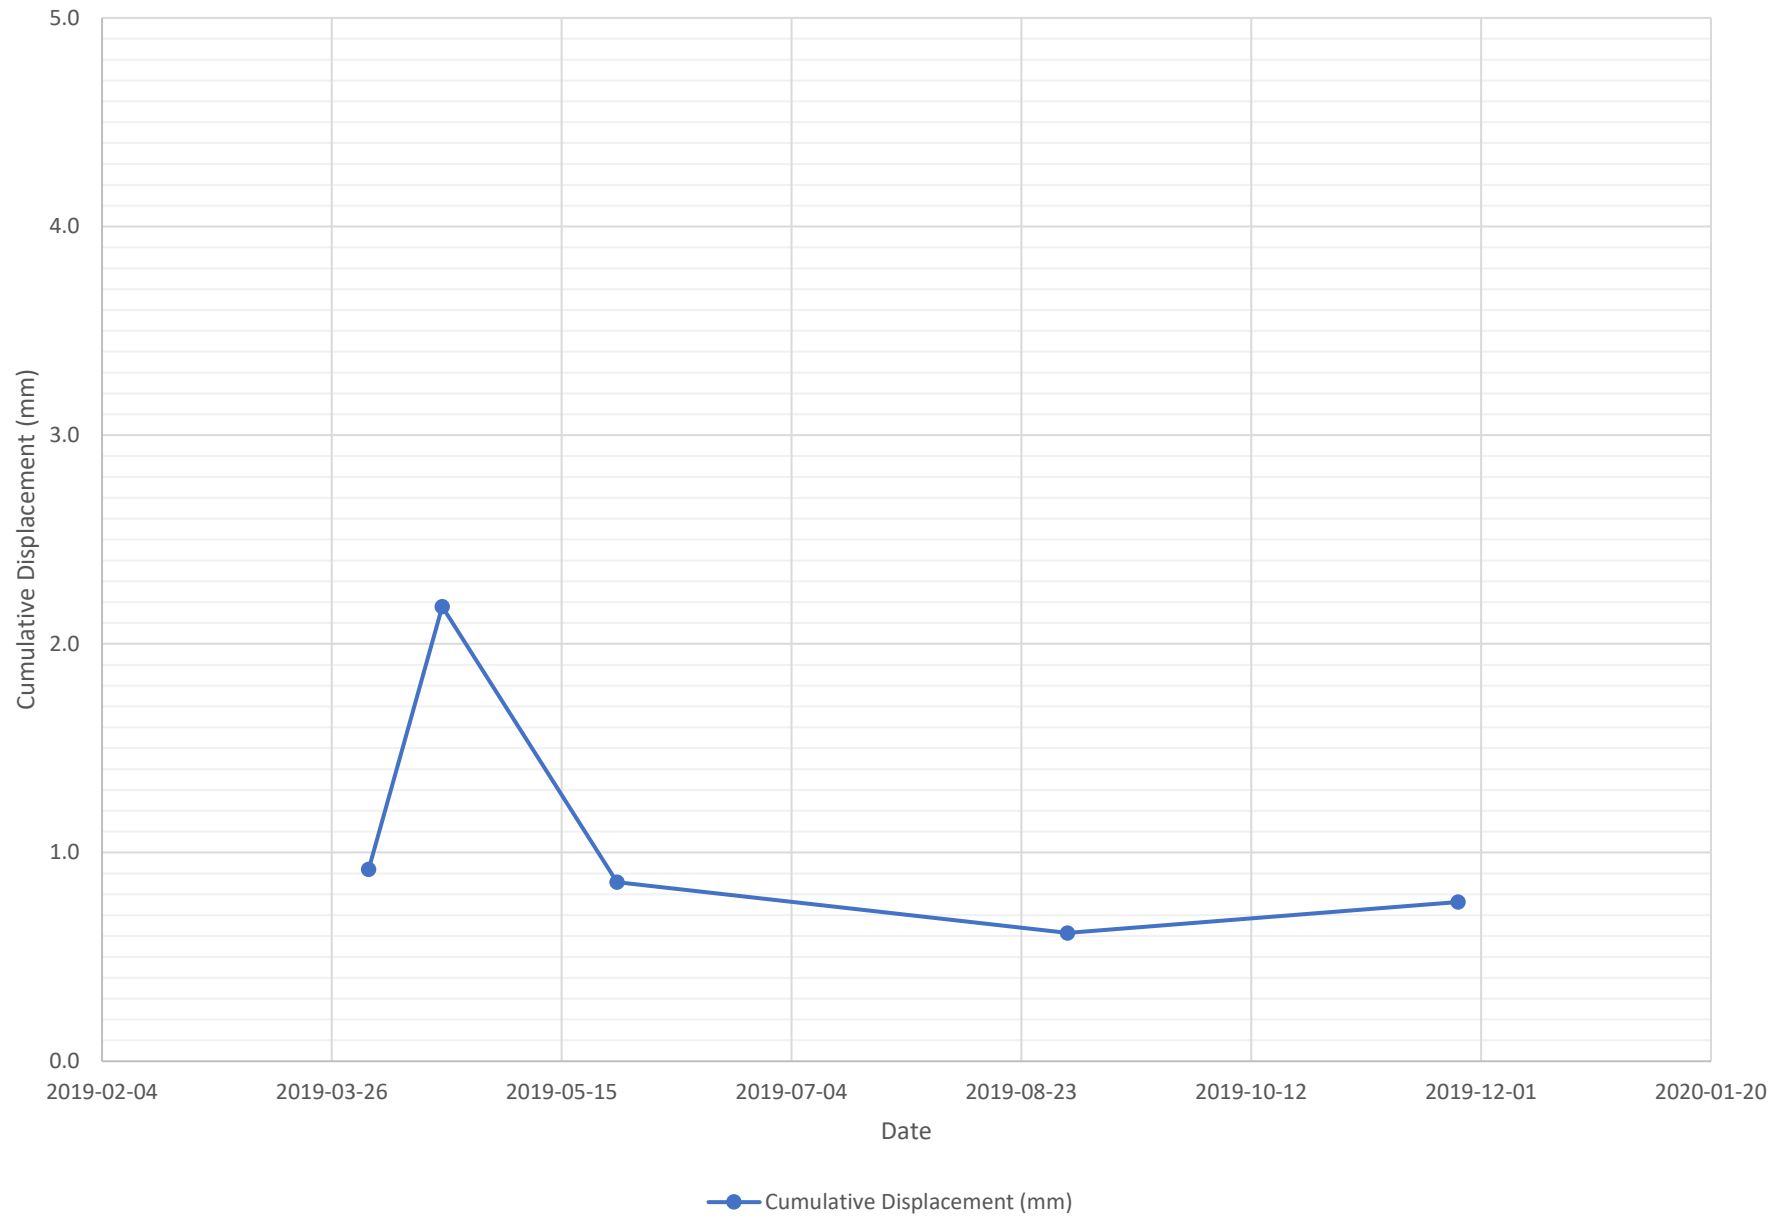
T19-31S Cumulative Movement from 3.0 m to 24.5 m below top of pipe
