## 7.2 REGULATORY AND POLICY FRAMEWORK

## 7.3 EXISTING INFORMATION

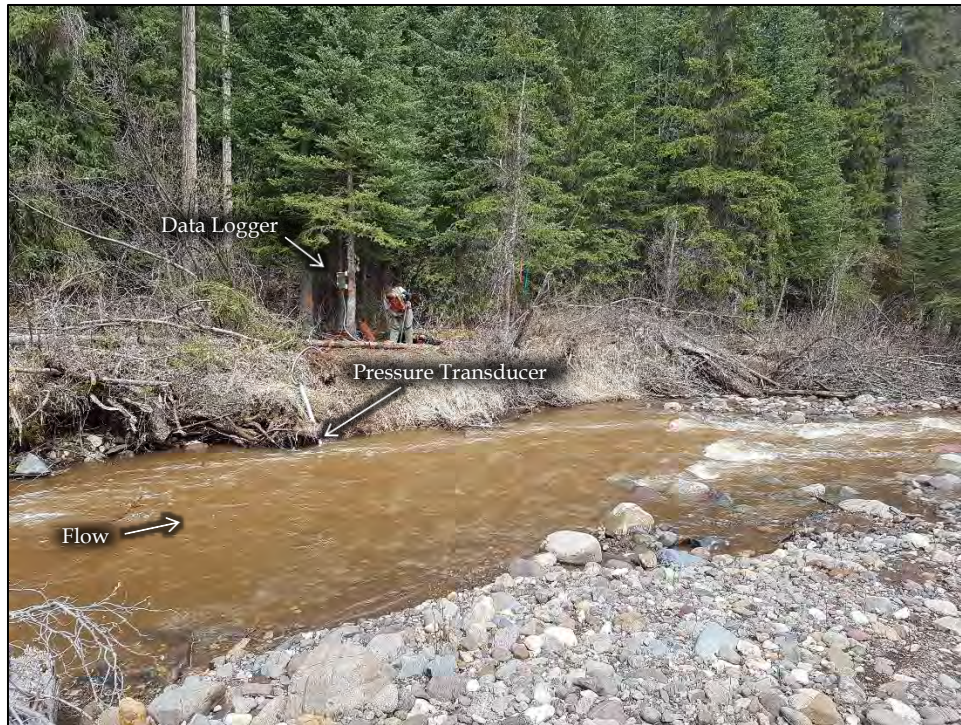
*Photo 7.4-1. Hydrometric monitoring station Tenas-Hydro. May 18, 2017.*

In late October of 2017, a peak flow event eroded the bank and washed away hydrometric monitoring station Tenas-Hydro. Changes to the channel caused by the peak flow event rendered the monitoring location unsuitable for continuous monitoring, due to the unstable banks, poor water elevation control, and lack of a suitable place to anchor the instrumentation. In May 2018, a new monitoring station (Tenas-Hydro B) was established approximately 200 m upstream at a location that best met the “Desirable Criteria for a Basic Station” (RISC 2018; Photo 7.4-2). The station was re-established by inserting the pressure transducer and cabling into a flexible aluminum conduit, and fixing the conduit to angle iron that was pounded into the streambed and secured to the bank using rebar. The data logger was housed in a steel, waterproof enclosure and secured to a mature tree well above the high water mark. In April of 2019 the station Tenas-Hydro B was re-established at the same location, after being removed for the 2018-2019 winter period to protect the instrumentation from ice damage.

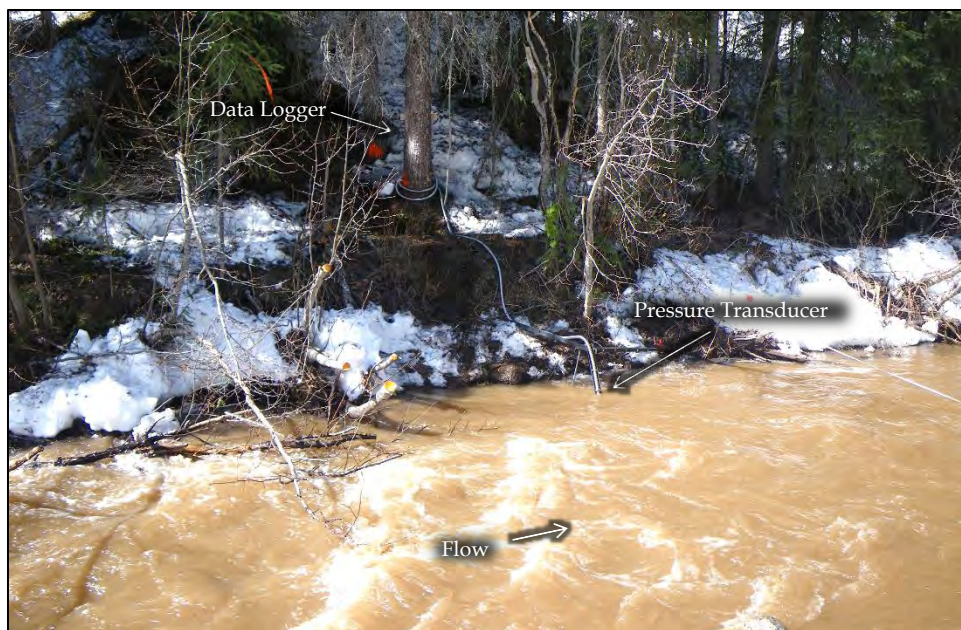
Photo 7.4-2. Hydrometric monitoring station Tenas-Hydro B. May 2, 2018.

The new monitoring station Tenas-Hydro B was sited close enough to the original monitoring location to allow for comparison between the years of data collection. Although a new rating curve was required for the station, measured discharge, along with calculated runoff and indices are not affected by the move. This is accounted for by the negligible change in drainage area and that there are no tributaries between the 2017 and 2018/2019 locations.

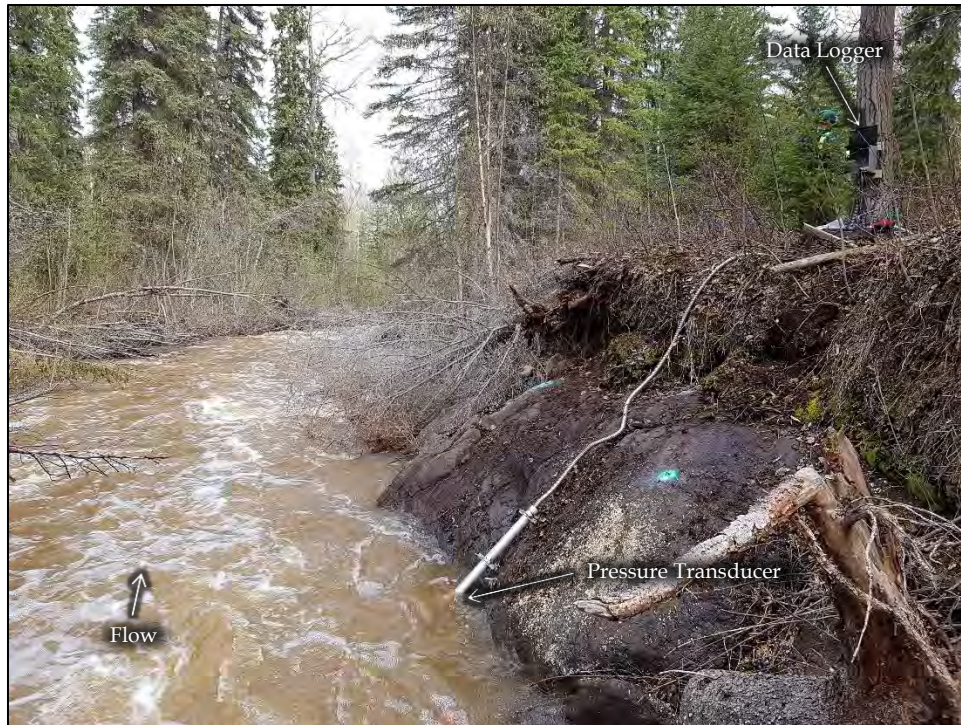
Photo 7.4-3. Hydrometric monitoring station Goathorn-Hydro. May 17, 2017.

Hydrometric monitoring station Goathorn-Hydro was established on Goathorn Creek downstream of the proposed pit in early May 2017 (Figure 7.4-1; Photo 7.4-3). The station was co-located with water quality site WQS06, and is in close proximity to a WSC hydrometric station (08EE008), which at the date that Goathorn-Hydro station was established had data available from 1960 to the end of 2014. The pressure transducer and cabling were inserted into a flexible aluminum conduit with one end of the conduit secured in an aluminum pipe. The aluminum pipe was then placed into the water and secured to bedrock along the bank using threaded anchor rods. The rods were drilled into the bedrock and anchored in place with quick setting epoxy. The data logger was housed in a steel, waterproof enclosure and secured to a mature tree well above the high water mark. The station was re-established in May 2018 at the same location, after being removed for the 2017-2018 winter period to protect the instrumentation from ice damage, and again in April of 2019 after being removed for the 2018-2019 winter period.

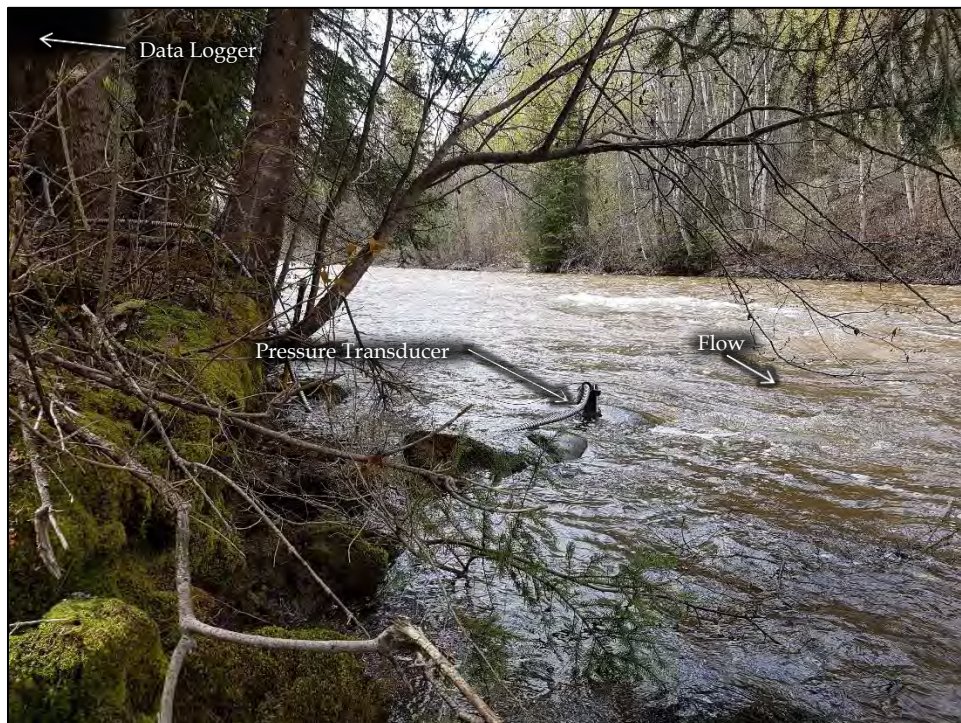
Photo 7.4-4. Hydrometric Monitoring Station Telkwa-Hydro. May 16, 2017.

Hydrometric monitoring station Telkwa-Hydro was established on the Telkwa River upstream of the confluence with Goathorn Creek in early May 2017 (Figure 7.4-1; Photo 7.4-4). The station was co-located with water quality site WQS08. The pressure transducer and cabling were inserted into a flexible aluminum conduit with one end of the conduit secured in an aluminum pipe. The aluminum pipe was then placed into the water and secured to a large boulder along the bank using threaded anchor rods. The rods were drilled into the boulder and anchored in place with quick setting epoxy. The data logger was housed in a steel, waterproof enclosure and secured to a mature tree well above the high water mark. The station was re-established in May 2018 at the same location, after being removed for the 2017-2018 winter period to protect the instrumentation from ice damage, and again in April of 2019 after being removed for the 2018-2019 winter period.

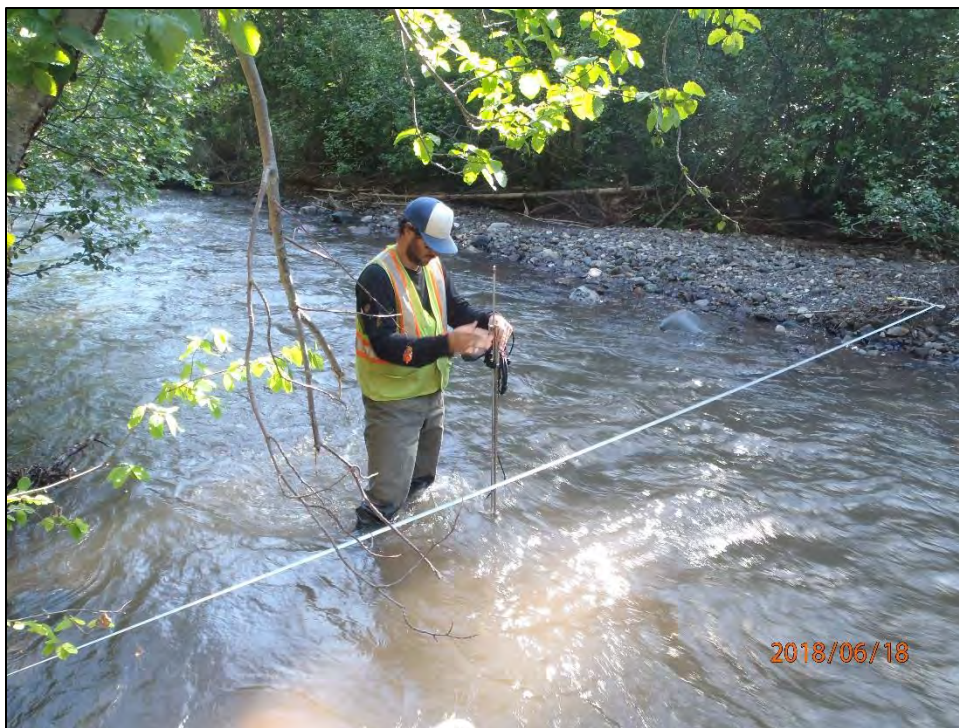
*Photo 7.4-5. Velocity-area discharge measurement on Tenas Creek. June 18, 2018.*

Measurements of water current velocity, depth of flow, and distance across the channel were obtained (Photo 7.4-5) to determine the total stream discharge during each station visit. Typically, a minimum of 20 current velocity measurements were taken across the width of a channel, with the aim of having each vertical or observation interval account for less than 10% of the total discharge (RISC 2018). This method assumes that the velocity measured at each vertical represents the mean velocity in a segment. During the velocity measurements, if the observed water depth was less than 0.75 m, the water velocities were measured at 60% of the water depth, measured from the water surface. The measurement at 60% of the water depth is generally accepted as representing the mean velocity of the vertical water column (Herschy 2009). If water depth was greater than 0.75 m, the water velocities were measured at 20% and 80% of the water depth, with the average of the two readings taken to represent the mean velocity for the vertical water column. In all cases, where feasible, the methodologies employed adhered to the *British Columbia Manual of Standard Operating Procedures for Hydrometric Surveys* (RISC 2018) and Water Survey of Canada (WSC) operating procedures (Terzi 1981).

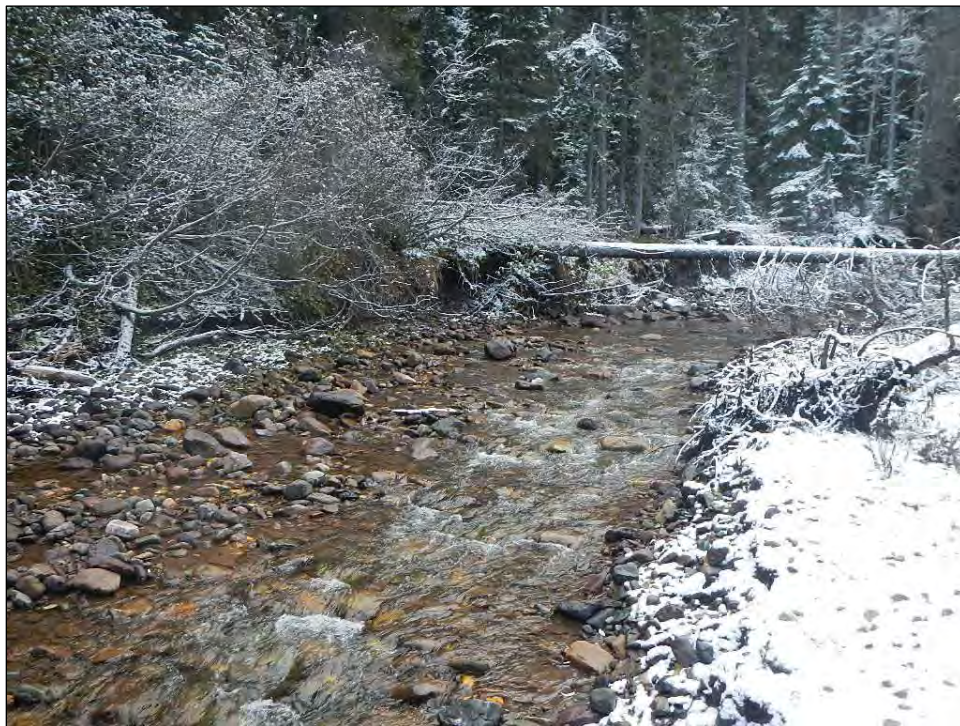
*Photo 11.5-1. Tenas Creek fish habitat site WQS01 located upstream of proposed mine site (upstream view). October 12, 2017.*

Channel width ranged from 3.4 m to 4.5 m with a mean of 4.1 m, making Tenas Creek S3<sup>8</sup>-sized at WQS01. Cobbles and gravels represented the dominant and subdominant substrate types. Boulder and trace amounts of large woody debris (LWD) provided the majority of cover for fish at upstream sites.

WQS01 was ranked as *important*<sup>9</sup> for resident Dolly Varden and Rainbow Trout. Spawning and rearing habitat were *good*, based on the presence of appropriate-sized gravel and abundant rearing habitat. Overwintering and migratory habitat were fair: a few slack water pools were observed, and no barriers prevented passage to similar habitat upstream.

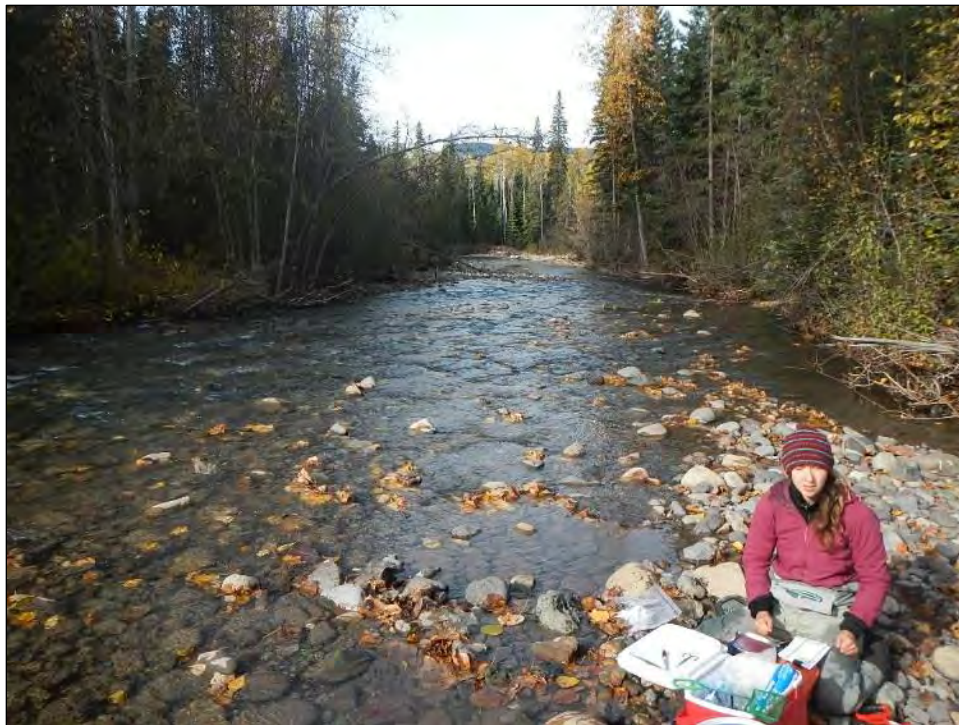
Photo 11.5-3. Goathorn Creek fish habitat site WQS05 located downstream of the confluence of Tenas Creek, Four Creek, and Goathorn Creek (downstream view). October 11, 2017.

Fish habitat within Goathorn Creek was surveyed downstream of the proposed mine project at WQS05 (Photo 11.5-3), located just below the confluence of Tenas, Four, and Goathorn creeks.

Goathorn Creek at WQS05 is an S2-sized stream, with channel widths ranging from 14 m to 20 m (mean 16.8 m). Gravel and cobbles represented the dominant and subdominant substrate types. Habitat cover was dominated by LWD with boulders and undercut banks noted as sub-dominant.

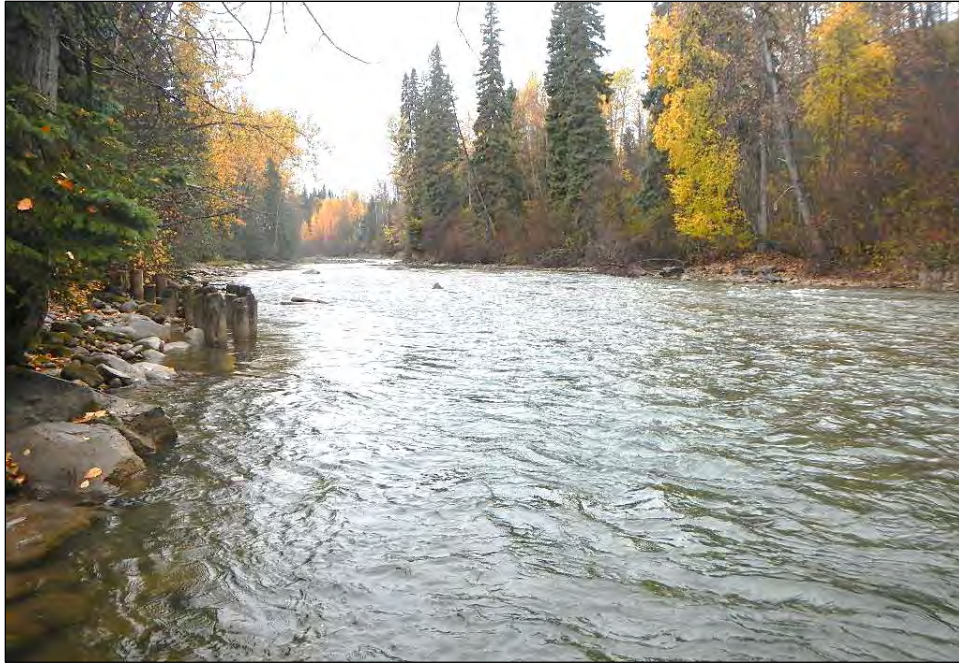
Photo 11.5-4. Telkwa River fish habitat site WQS08 located upstream of the Goathorn and Telkwa rivers' confluence (upstream view). October 15, 2017.

Gravel and cobbles represented the dominant and subdominant substrate types at Site WQS08. LWD dominated habitat cover for small fish with both boulders and undercut banks ranking as subdominant. Channel width ranged from 35 m to 38 m with a mean of 36 m for an S1-sized watercourse. Site WQS08 provides *good* rearing habitat with abundant cobble and boulder cover for invertebrate production (Photo 11.5-4). This site has *good* migration habitat that can be used to access upstream spawning and rearing habitat. Spawning and overwintering habitat are both *fair*. Some small areas with appropriate gravels and flow are present. Few pools or slack water areas were observed. Overall, this is an *important* site for fisheries value.

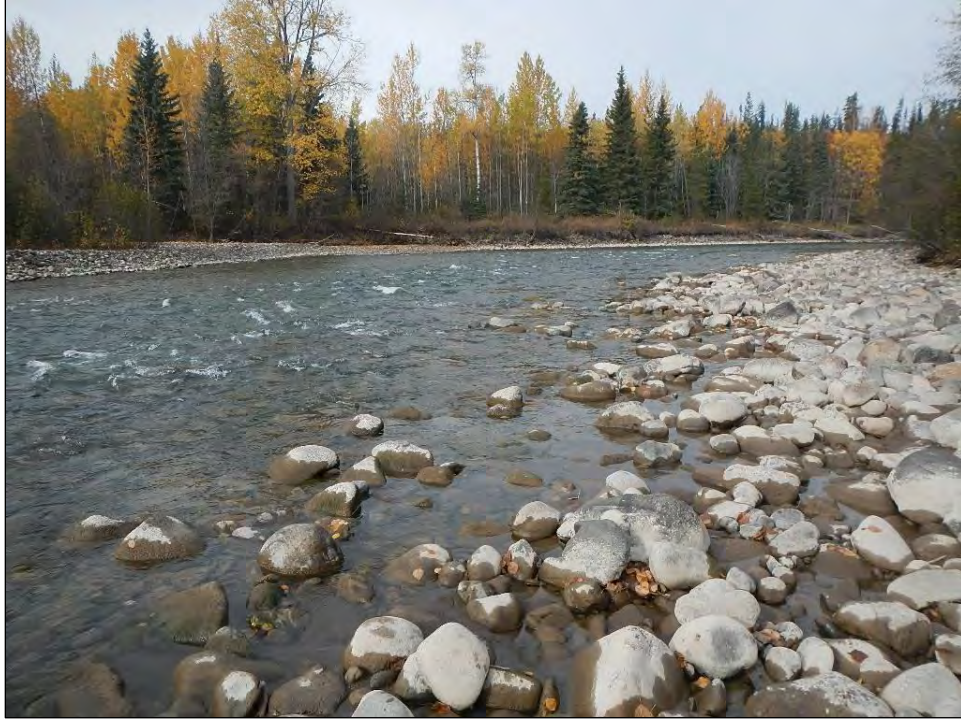
*Photo 11.5-5. Telkwa River fish habitat site WQS09 located downstream of the Goathorn and Telkwa rivers' confluence (downstream view). October 13, 2017.*

Downstream from WQS08 and the Goathorn Creek / Telkwa River confluence is WQS09 (Photo 11.5-5). WQS09 includes high quality (i.e., *good*) spawning areas for salmon and *good* rearing habitat with abundant boulder cover for small fish. Overwintering habitat is *good*: the site has sufficient flow but few slack water areas. Migration potential is considered *good* with connectivity to major spawning habitat upstream. The Telkwa River is S1-sized at WQS09. Channel width ranged from 42 m to 45 m with a mean channel width of 44 m. Cobbles and boulders represented the dominant and subdominant substrate types. Overall, there was a moderate amount of cover, with boulders dominating. This site is listed as *critical* with a fisheries sensitive zone<sup>10</sup> (FSZ) and a back channel providing rearing habitat for salmon fry.

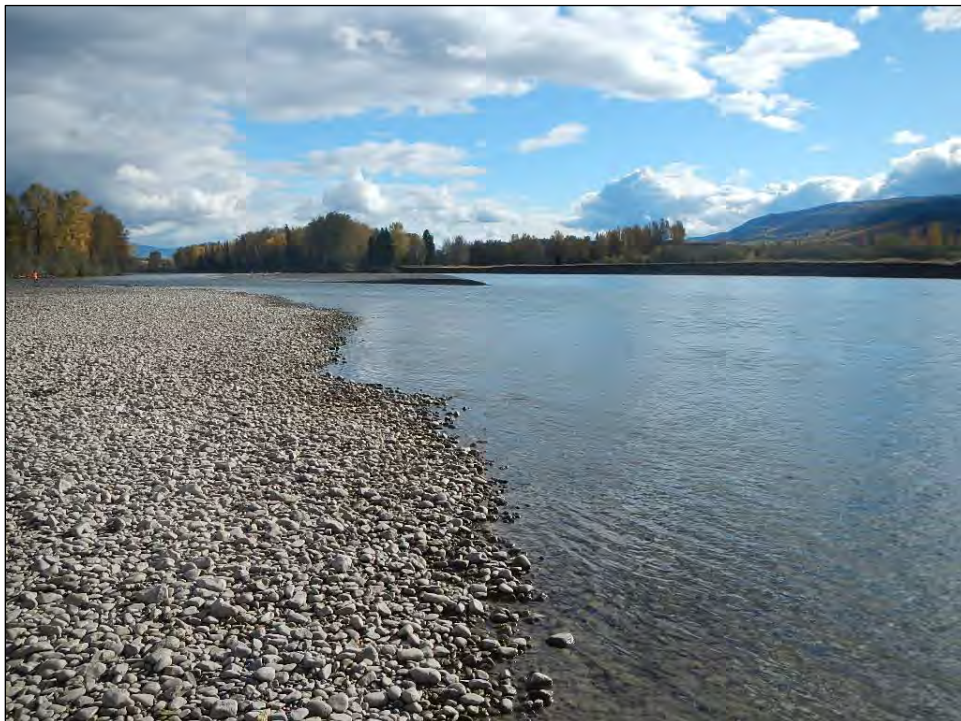
*Photo 11.5-6. Bulkley River fish habitat site WQS11B located upstream of the Telkwa River and Bulkley River confluence (downstream view). October 12, 2017.*

The main substrates at Site WQS11B were gravel (dominant) and cobbles (sub-dominant). Site WQS11B provides *good* spawning habitat with patches of suitable gravels (dead pink salmon were noted along banks at time of survey; Photo 11.5-6). This is a *good* migration site with major spawning habitat located upstream. Rearing habitat is *fair*, as very little cover is available for fry. Overwintering habitat is also *fair*, given the short supply of slack water pools at WQS11B. Overall, this site was ranked as *important*, given its spawning values.

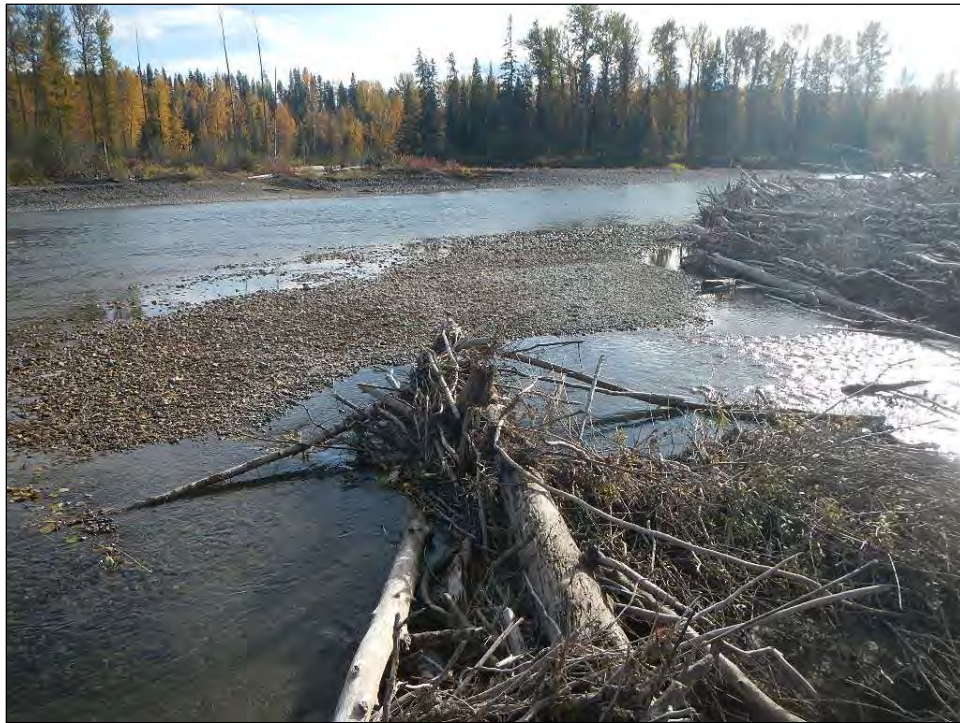
Photo 11.5-7. Bulkley River fish habitat site WQS12B located downstream of the Telkwa River and Bulkley River confluence (downstream view). October 14, 2017.

Downstream of WQS11B and the confluence of the Bulkley and Telkwa rivers is site WQS12B (Photo 11.5-7), which features an FSZ. Similar to WQS11B, the main substrate is gravel (dominant) and cobbles (sub-dominant). Site WQS12B was ranked as *critical*, as it has abundant available *good* pink salmon spawning habitat. Although there is limited cover for small fish, extensive back-channel sloughs do provide important rearing habitat for these fish, resulting in a ranking of *good*. Overwintering and migratory habitat were also ranked as *good*. The mainstem is deep enough to provide refugia<sup>11</sup> in the wintertime, and the site is well-connected to additional salmon spawning habitat upstream.

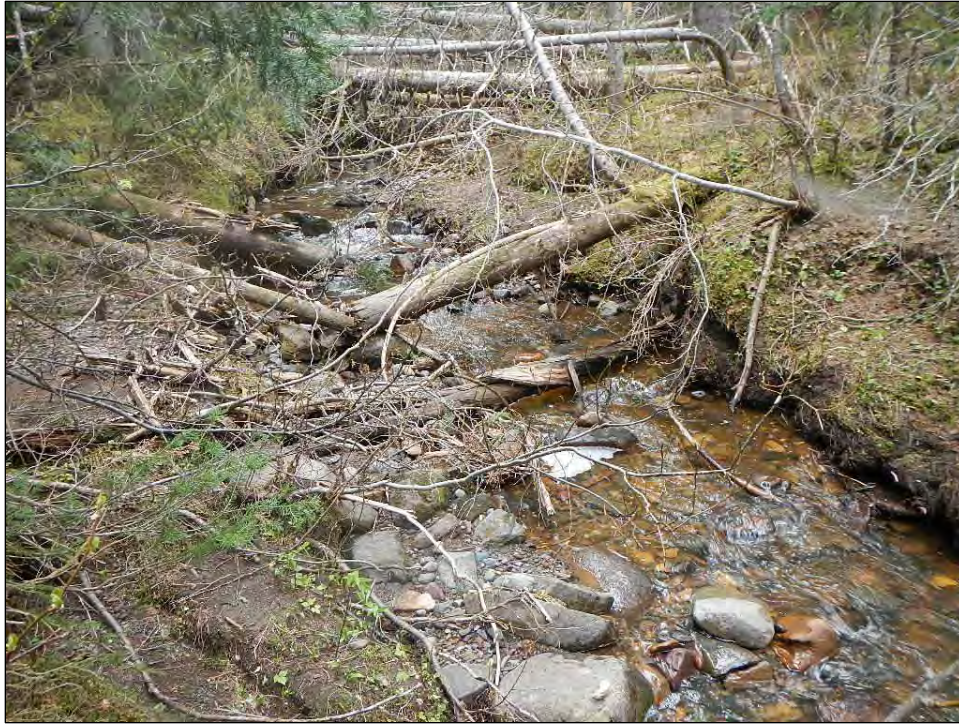
Photo 11.5-8. Four Creek at site WQS03, looking upstream. June 12, 2018.

The main substrates at Site WQS03 were gravel (dominant) and cobbles (sub-dominant). Site WQS03 provides *poor* spawning habitat, as there were very few suitable gravel areas. This is a *good* rearing area because it had a lot of cover including large woody debris. *Fair* overwintering habitat exists here due to a few good pools. Overall, this site was ranked as *important* for fisheries values, mainly due to the presence of good rearing habitat for resident Dolly Varden.

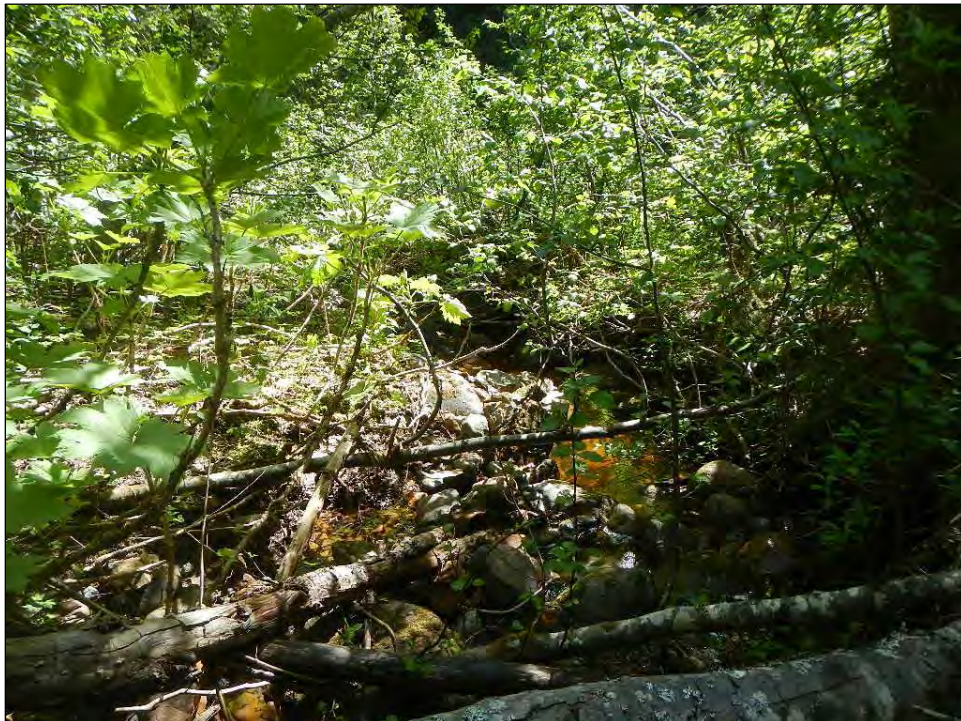
*Photo 11.5-10. Four Creek tributary looking downstream towards gradient barrier (>30%). June 18, 2018.*

One tributary to Four Creek was assessed in June 2018 because the map depicted it as draining the north end of the proposed mine site. The stream had a mean bankfull width of 2.1 m, and a mean wetted width of 1.4 m. Pools had a mean residual depth of 0.2 m. The gradient averaged 15%; however, the first 30 m of the stream closest to the confluence with Four Creek had a gradient in excess of 21% (Photo 11.5-10). Cover was abundant and dominated by boulders, followed by large and small woody debris and overhanging vegetation. The bed material was dominated by cobbles and gravel. Habitat quality was considered *fair* for rearing due to the presence of small pools, *poor* for spawning due to the lack of spawning gravel, and *poor* for overwintering due to the shallow depth. A 0.8 m barrier at the confluence likely prevents fish access, and no fish were captured during electrofishing. The stream was considered *non-fish-bearing*, and was classified as S6.

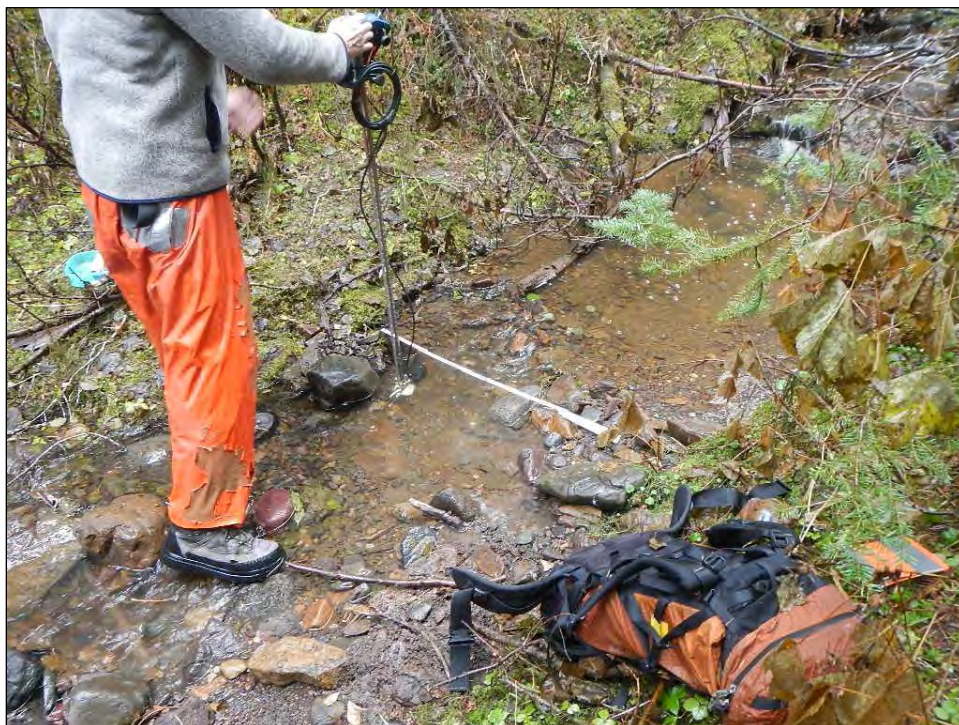
*Photo 11.5-11. Tributary of Four Creek near WQS03, showing flow measurements on a narrow, shallow channel. October 9, 2018.*

Two tributaries of Four Creek upstream of WQS03 were assessed in October and December 2018 as part of the search for potential water withdrawal sites (Photo 11.5-11). Both sites featured very low flow (total estimated discharge of both sites was 6.68 L/s on October 9, and 2.46 L/s on December 11). No permanent barriers to fish migration were identified, and it is assumed that both sites are fish-bearing due to their proximity to WQS03.

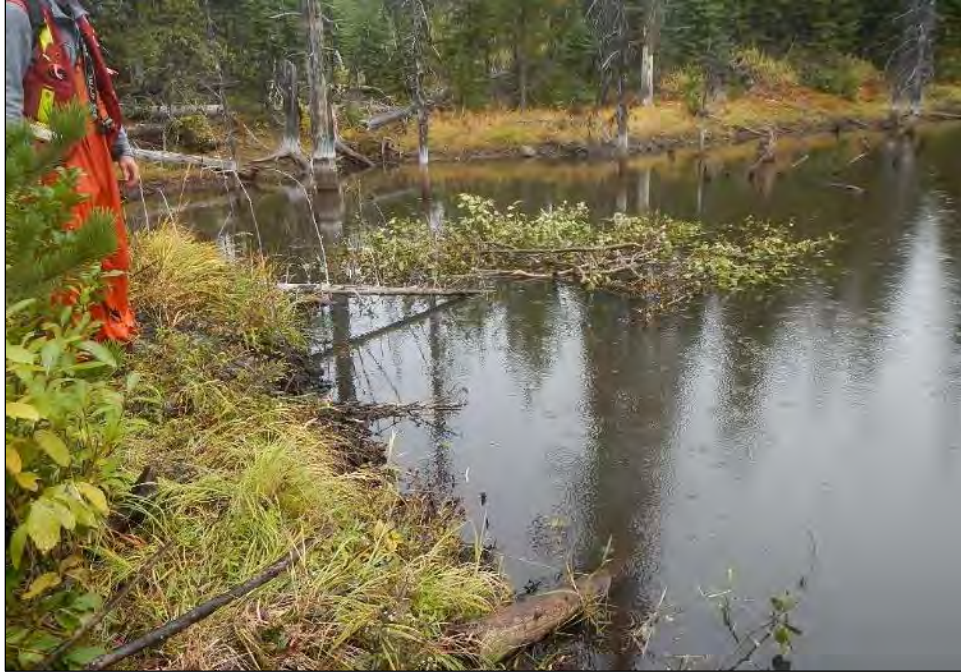
*Photo 11.5-12. Beaver pond at upstream end of East Fork Tenas Creek tributary. October 9, 2018.*

One tributary of the east fork of Tenas Creek was assessed in October 2018 as part of the search for potential water withdrawal sites. This stream features a large beaver pond at the upstream end (Photo 11.5-12); however, downstream of this point, the stream flows down a steep canyon and was mostly dewatered on October 9, 2018 (Photo 11.5-13). No fish access is possible due to gradient and obstruction barriers in the canyon.

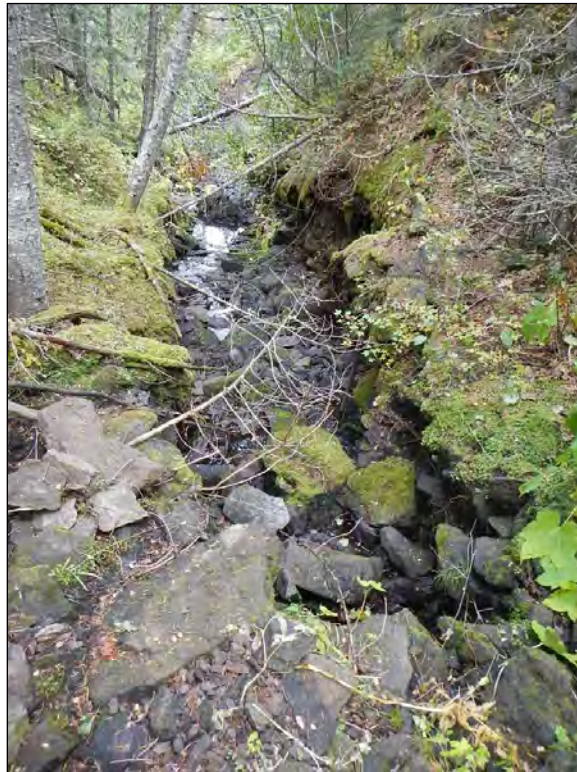
*Photo 11.5-13. East Fork Tenas Creek tributary, looking downstream through the steep, dewatered canyon section. October 9, 2018.*
