### **Stream Assessment Report, Feasibility Road Design Phase 2, Telkwa Metallurgical Coal Project, prepared by DWB Consulting Services Ltd., 2018**

# Stream Assessment Report

## Feasibility Road Design Phase 2 Telkwa Metallurgical Coal Project

Date: 19.11.2018 | DWB file: 18364-204 | Revisions: 2

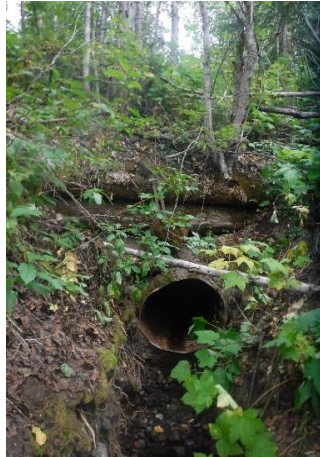
**Photo 28.** Outlet of 900 mm culvert at proposed road crossing.

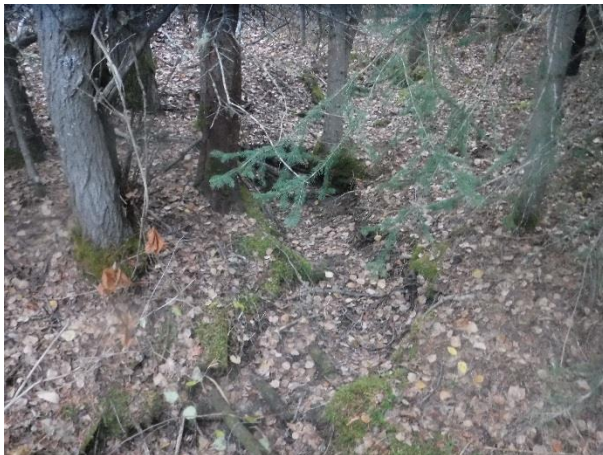
**Photo 43:** Some scour in a small patch where the tree root provided an obstacle to flow.

As this watercourse is not considered fish-bearing, an appropriately sized closed bottom structure can be installed at this location.

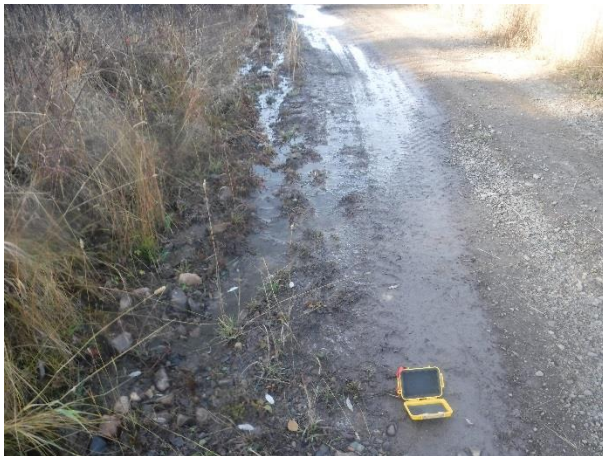
**Photo 51:** Overland flow onto powerline road (~50 m downslope from crossing).

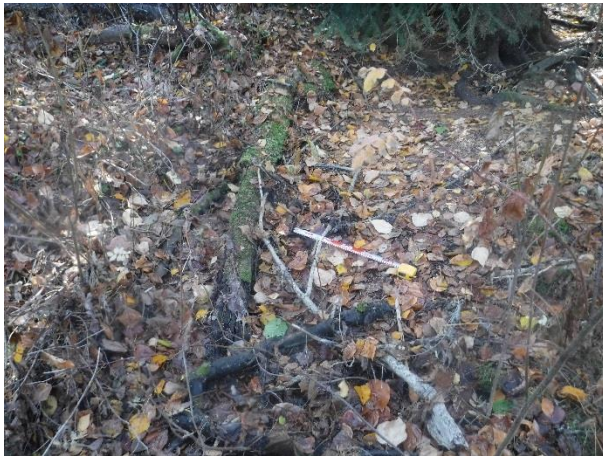
**Photo 53:** Upslope from road. Discontinues section of channel.

As this watercourse is not considered fish-bearing, an appropriately sized closed bottom structure can be installed at this location.

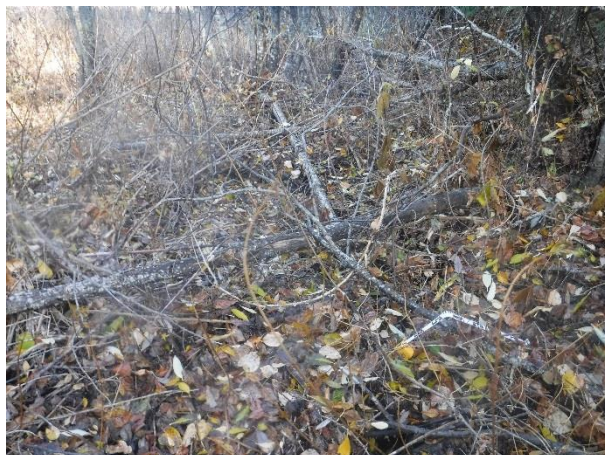
**Photo 56:** Downslope from road. Small isolated pocket of scour. Channel inconsistent.

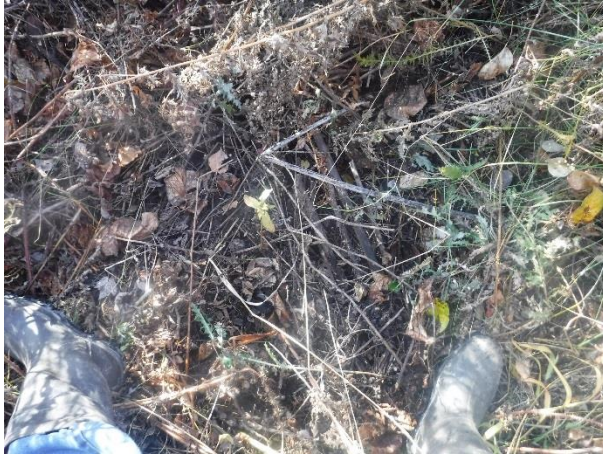
**Photo 57:** Lack of channel/scour located approximately 50 m downslope of crossing.

As this watercourse is not considered fish-bearing, an appropriately sized closed bottom structure can be installed at this location.

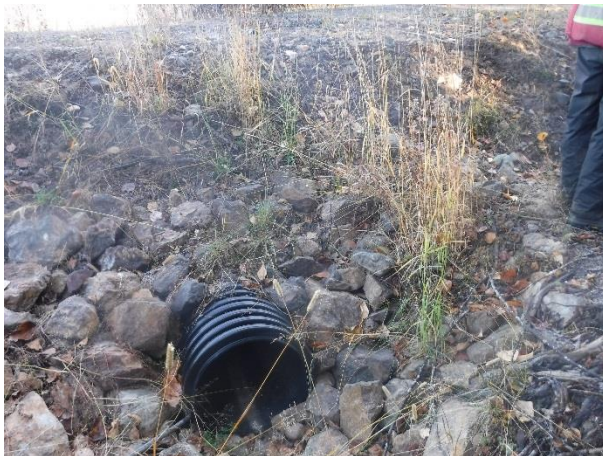
**Photo 59:** Newer, functional 500 mm culvert at crossing with a 1 m fill.

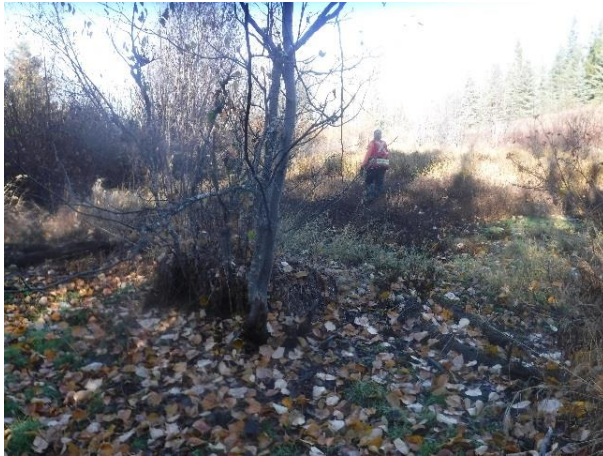
**Photo 64:** Damp area below the road crossing with some sedges. No evidence of flow.

As this watercourse is not considered fish-bearing, an appropriately sized closed bottom structure can be installed at this location.
