# Tenas Project

## Terrain and Soil Baseline Report

**December 2021**

VERSION 3.6.1

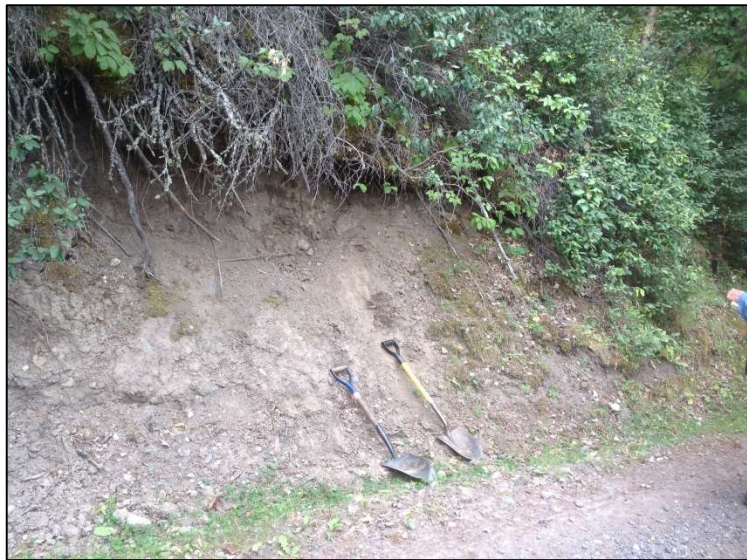
**Plate 2-7: Glaciolacustrine silt exposed along the driveway on the McDonald's property near the proposed rail infrastructure at field site IW216.**

Glaciolacustrine sediments are susceptible to soil creep and small slides on slopes steeper than 35% when imperfectly drained, e.g. on the 12 m high escarpment west of the Bypass Road, but can form steep cutbanks when dry year-round. The deposits are susceptible to surface erosion and typically have a low permeability, and may be acting as a water barrier.

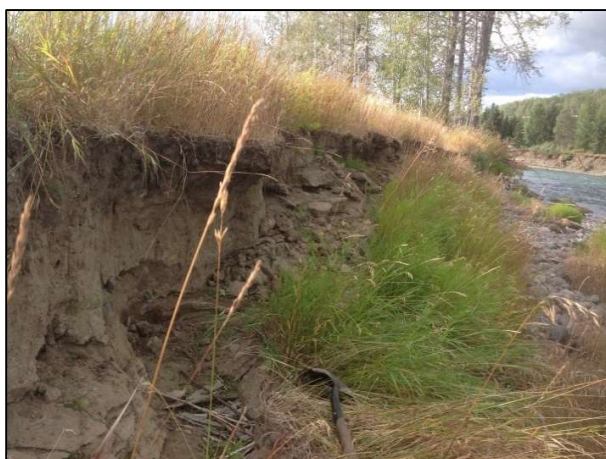
Plate 2-13: Bulkley River, field site IR160; overbank deposit of fine sand.

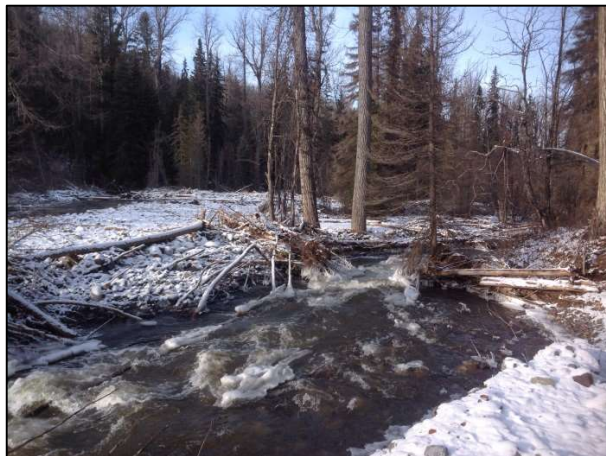
Plate 2-19: Goathorn Creek, field site IW054.

Along unconfined floodplain sections, the active channel zone and the adjacent forested floodplain were typically mapped as a complex polygon to account for the rapid lateral shifting of the main channel in recent and future years (Plate 2-19, field site IW054). The active channel bed material ranges in size from gravel to boulders (50 cm diameter) and sand (**ksgFAp**, field site IW045, IW277, IW279). Clasts are rounded to subrounded and include maroon and green-grey volcanic rocks and light-coloured granitic rocks. The adjacent forested floodplain consists of similar material and is typically overlain by a 1 m thick deposit of sand, silt or, locally, silty clay(**zsFAv**). These overbank and backchannel deposits contain small chunks of

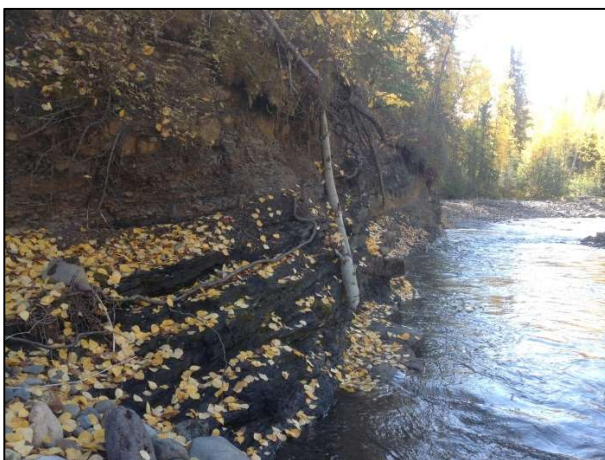
Plate 2-20: Goathorn Creek, field site IW241.

coal. In many places the fluvial deposits are underlain by bedrock at 1 to 5 m depth (Westrek Geotechnical Services Ltd. 2019<sup>27</sup>), or bedrock is exposed in the stream banks (**FAp[Ru]**) (Plate 2-20).

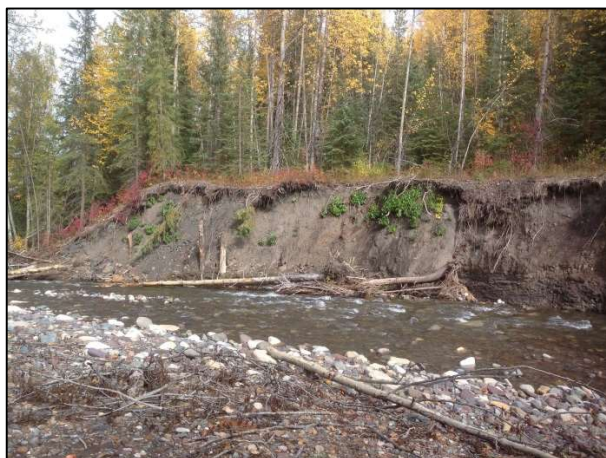
**Plate 2-25:** Fill material as an extension of a fluvial terrace; field site IW247.

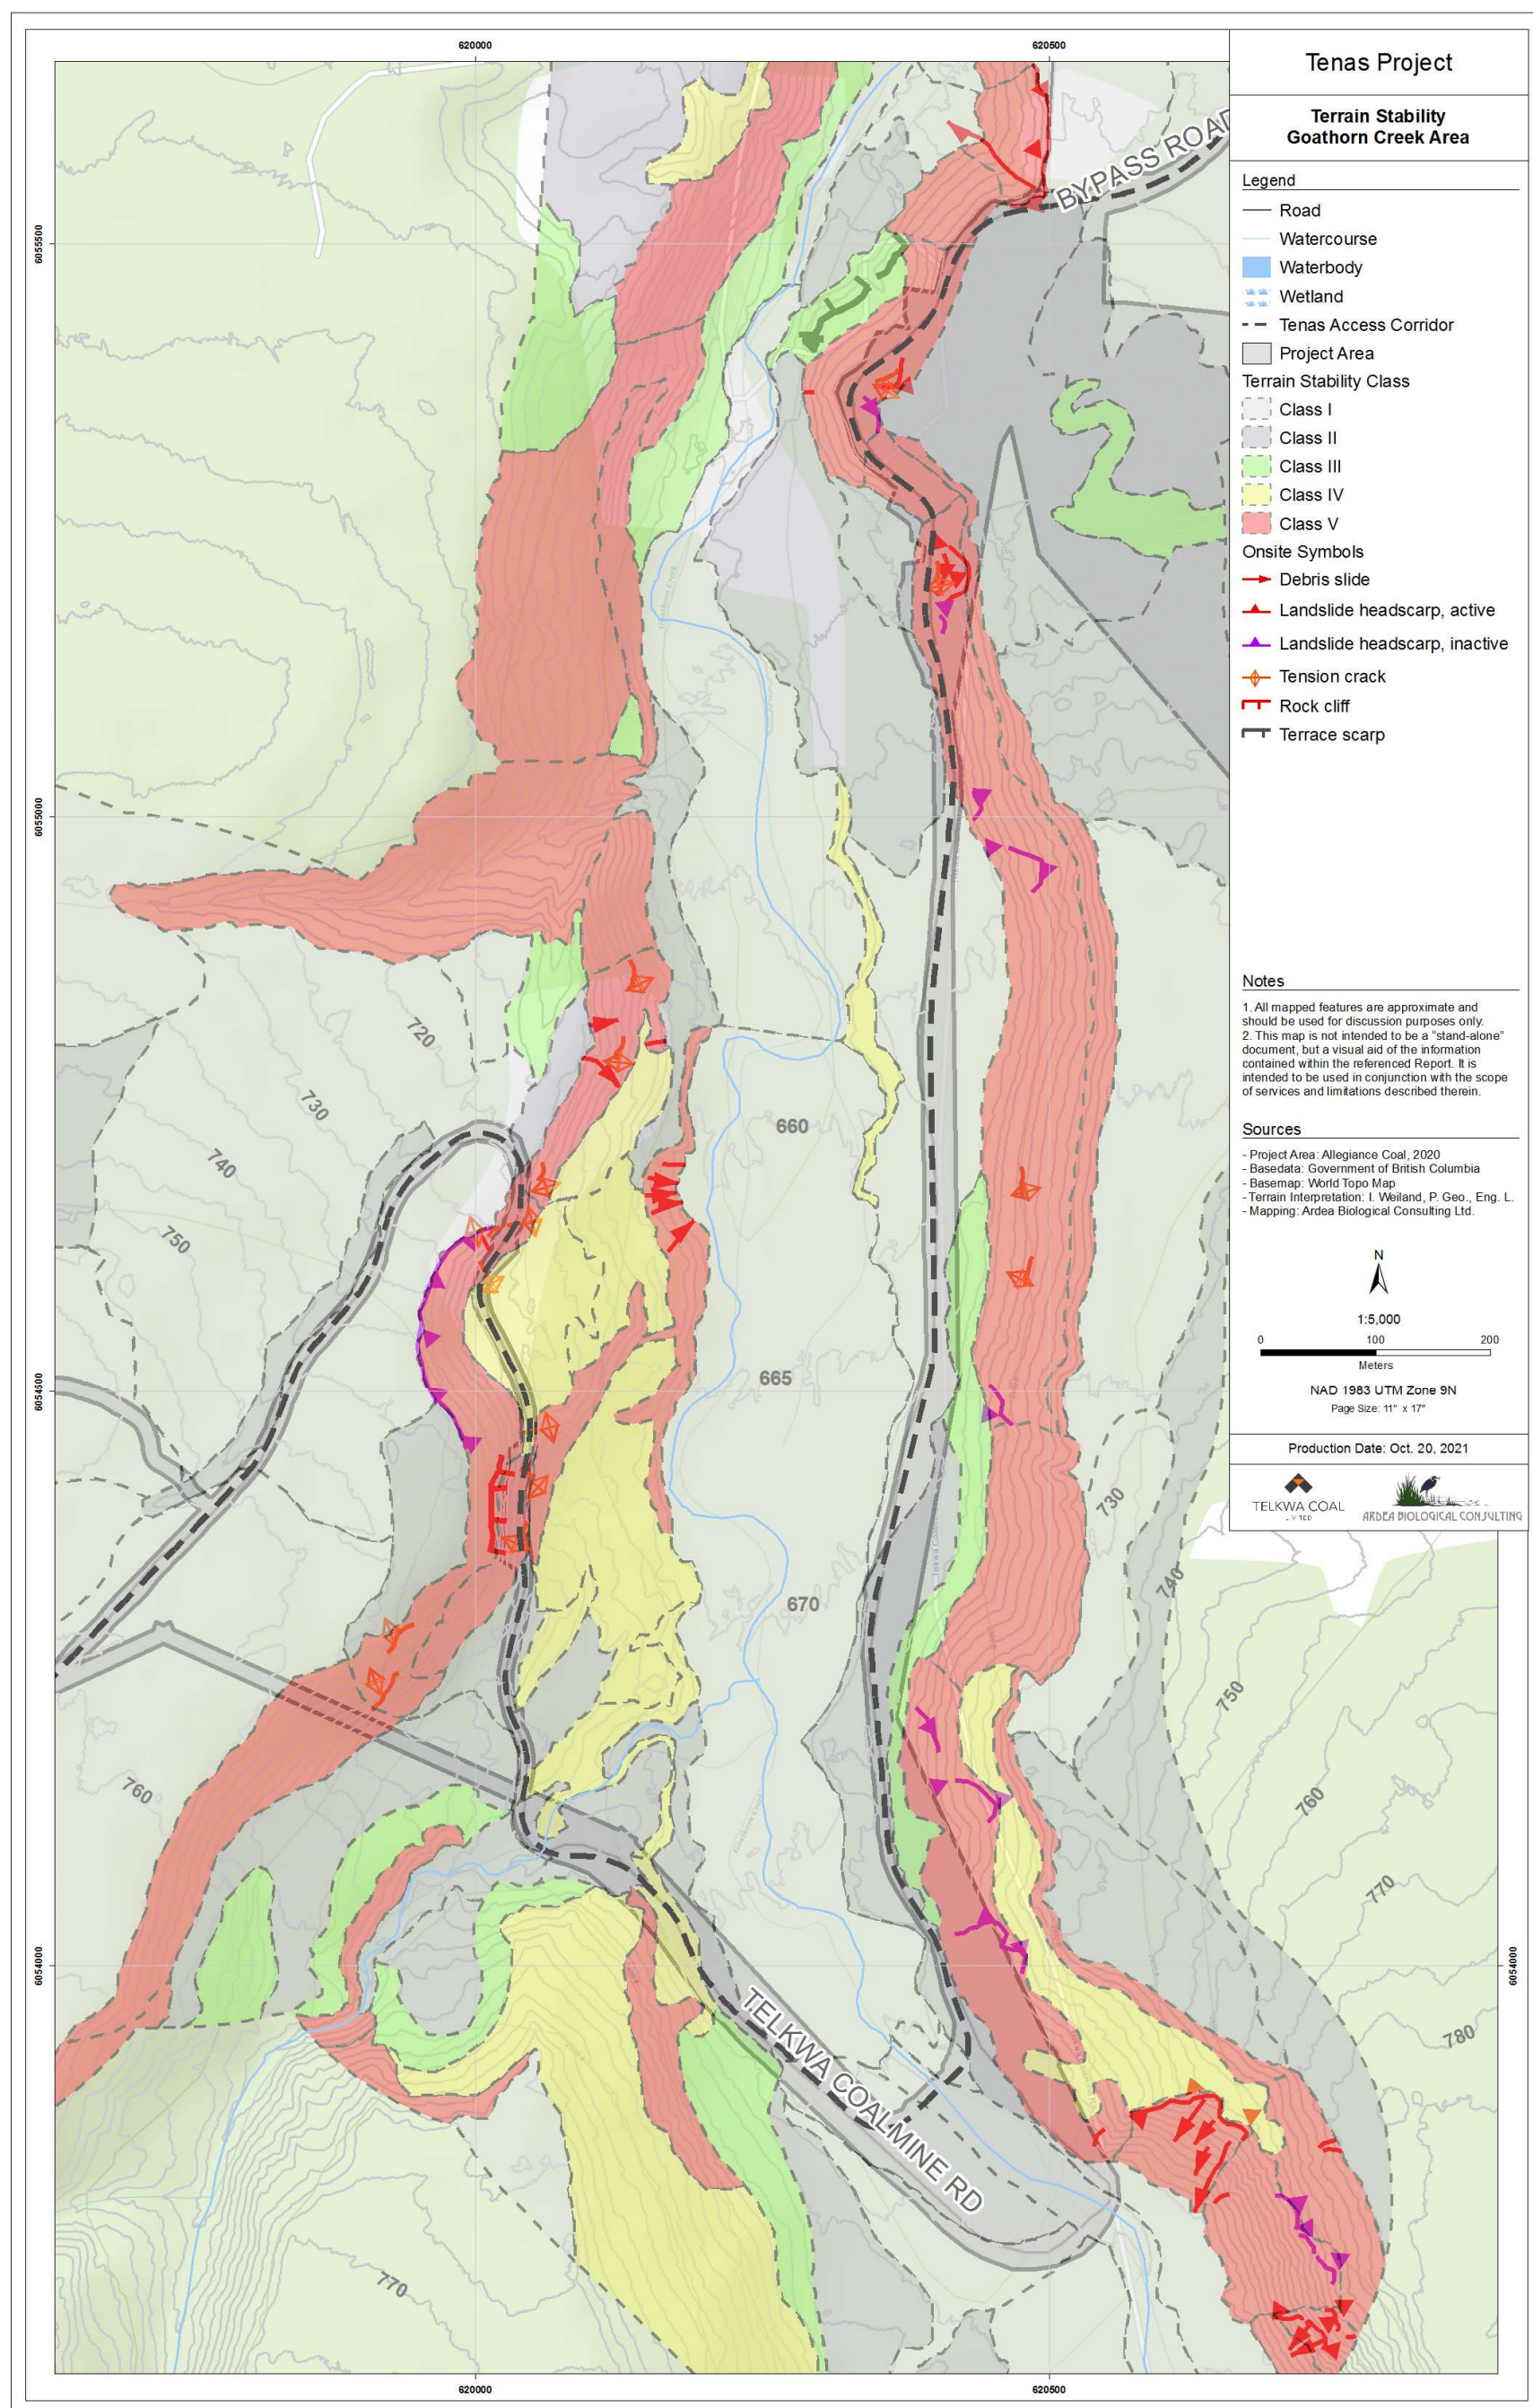
TSC V and IV was assigned to unstable and potentially unstable terrain. This terrain makes up 7.0% of the T-LSA and occurs predominantly along the steep valley walls of Tenas Creek, Goathorn Creek and some sections of Four Creek (Figure 2-6). TSC V terrain units typically have moderately steep to steep slope gradients and show evidence of active or recent slope movement<sup>34</sup>. TSC IV terrain typically has similar slope angles or is located adjacent to TSC V terrain, and commonly shows signs of historic mass movement. Landslides or soil creep are expected to occur during excavation or following cut-and-fill road construction. TSC IV and V terrain units may include small sites of stable terrain. A geotechnical investigation is required to determine the site-level landslide hazard associated with proposed development and to design mitigative measures that reduce or eliminate the landslide hazard.

Figure 2-7: TSC IV and V and landslide sites in the Goathorn Creek valley along the Coalmine Road and Caribou FSR.
