## 1.22.3.5.2 Groundwater Conditions

1.22.3.5.3 *Stability Results*

## 1.23 Gravel Quarry

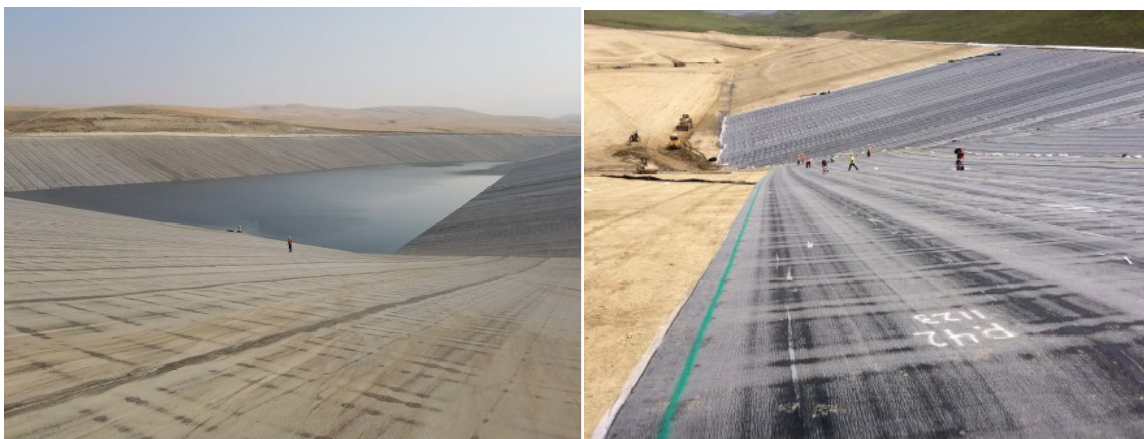
**Figure 1.22-19: Typical installation of a bituminous liner in a large sedimentation pond**

Installation is completed using a mechanical beam attached to an excavator or similar vehicle, an installation crew of three (3) to four (4) people and is welded by flame with 20 cm overlap between individual rolls of liner. The excavator holds the roll up from the ground and slowly places the liner while transferring the slope from the bottom up if possible. Anchor trenches are used at the top of the slopes for all applications and mechanically fastened on the lower portion of the slope. The anchor trenches for this project are designed to be 3 m deep and 1 m wide at the bottom and 1 to 1 slopes, which will be filled in and compacted with overburden to hold the liner in place until water fills the pond. **Figure 1.22-19** illustrates a typical installation bituminous geomembrane liner in a large sedimentation pond like the Tenas Control Pond.

Subgrade preparation should consist of compacted soil, or sand or gravel with no sharp edges. There is no geotextile required below Coletanche as there is a geotextile impregnated inside of the liner during the manufacturing process.
