Telkwa Coal

Environmental Assessment

Water Management  
End of Year 5

# Tenas Project Dam Breach Assessment Report

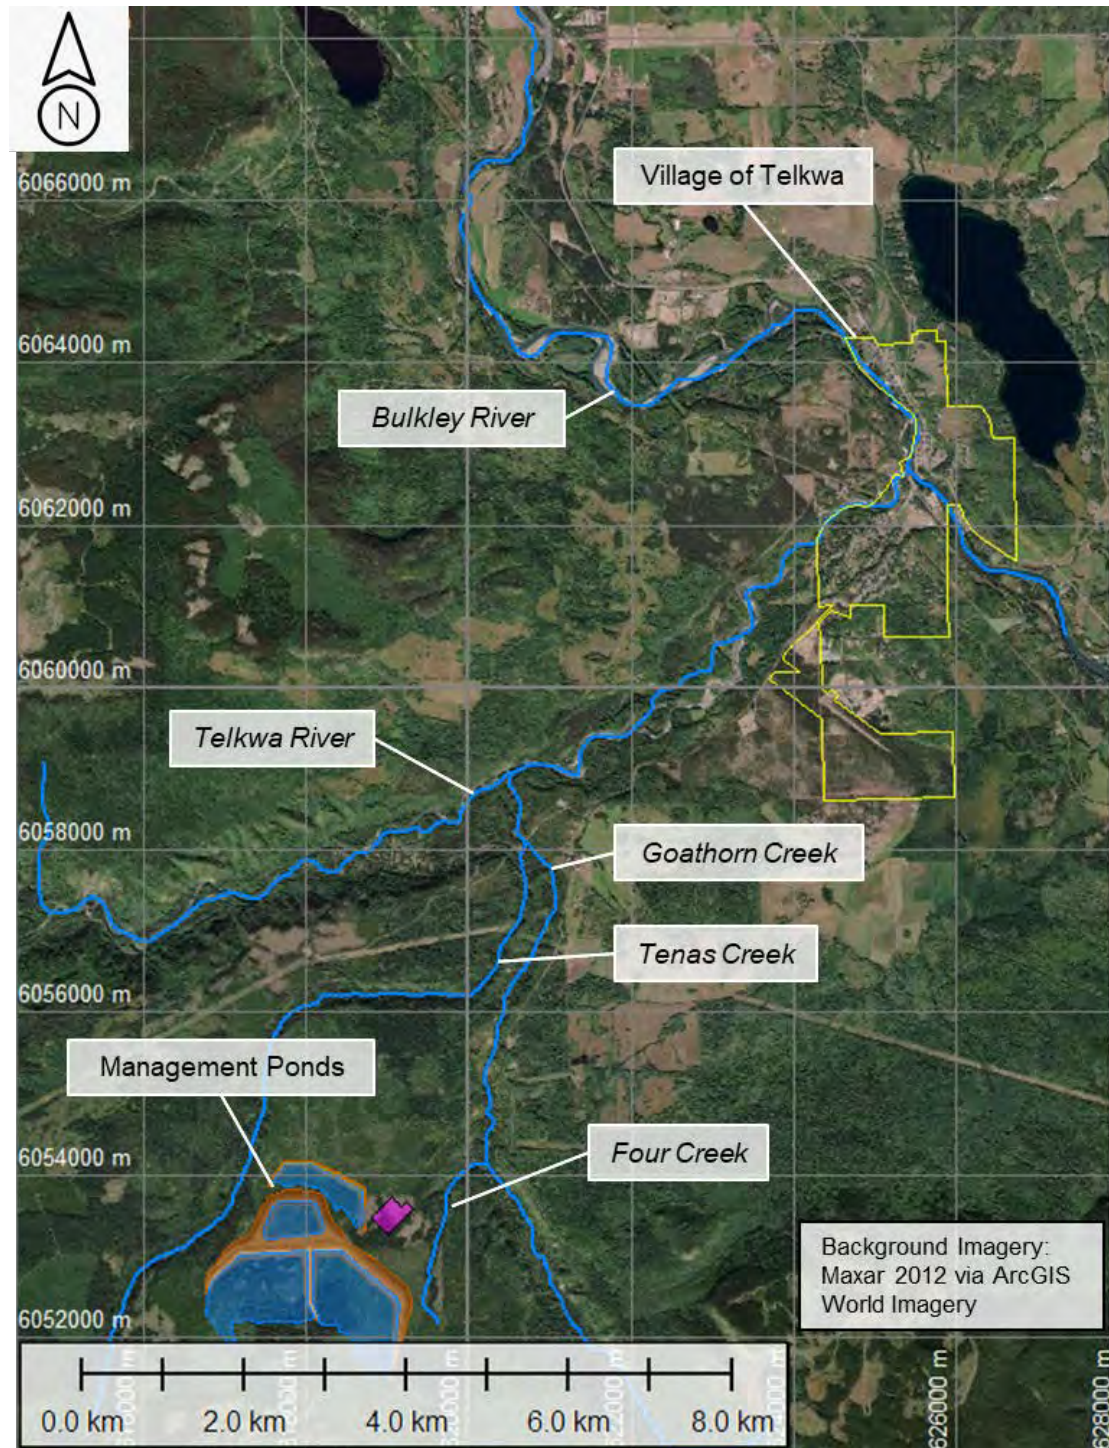
**Figure 1-1: Dam Breach Analysis Site Plan**

The dam breach assessment extents encapsulate areas directly downgradient of the potential breach locations, areas along streams leading to the key receptors, and areas containing the key receptors. Figure 1-1 provides an aerial view of the project area, showing the site water management facilities, as well as the locations of the streams along which water released from the dams may travel. There are three creeks of interest, as well as the Telkwa River and Bulkley River. The nearby Village of Telkwa is located at the confluence of the Telkwa and Bulkley Rivers, approximately 11 km northeast of the Project's mine site.
