## **Appendix F – Geological Cross Sections**

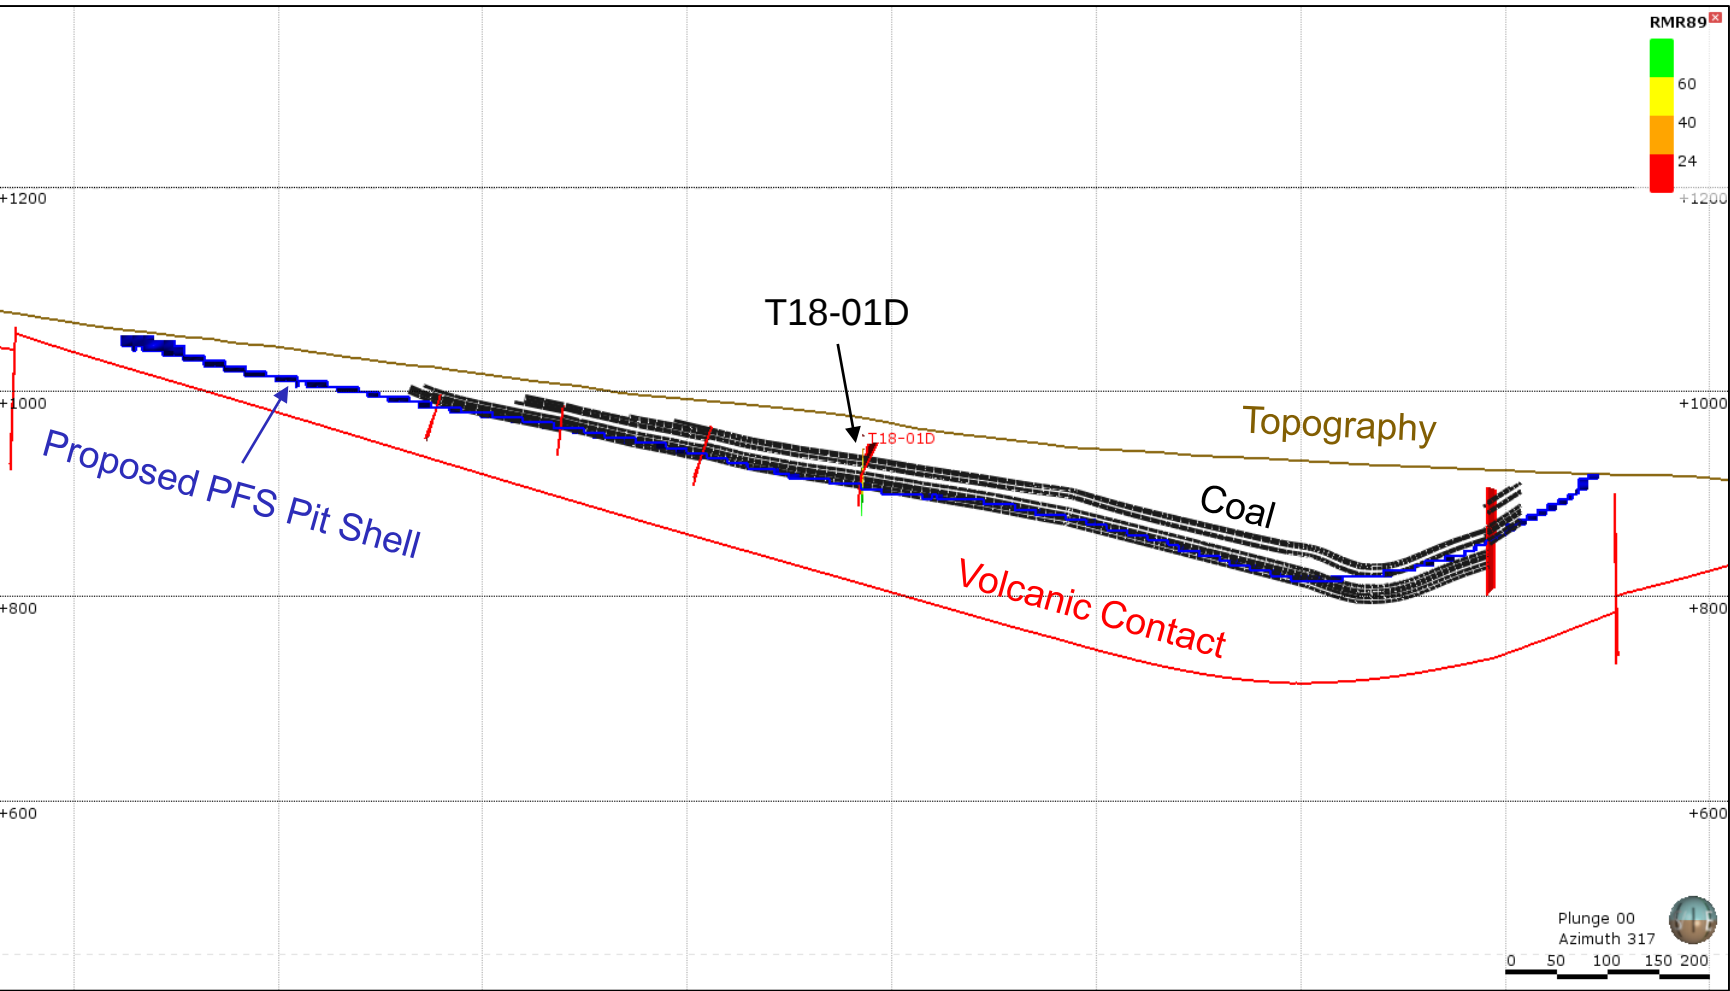
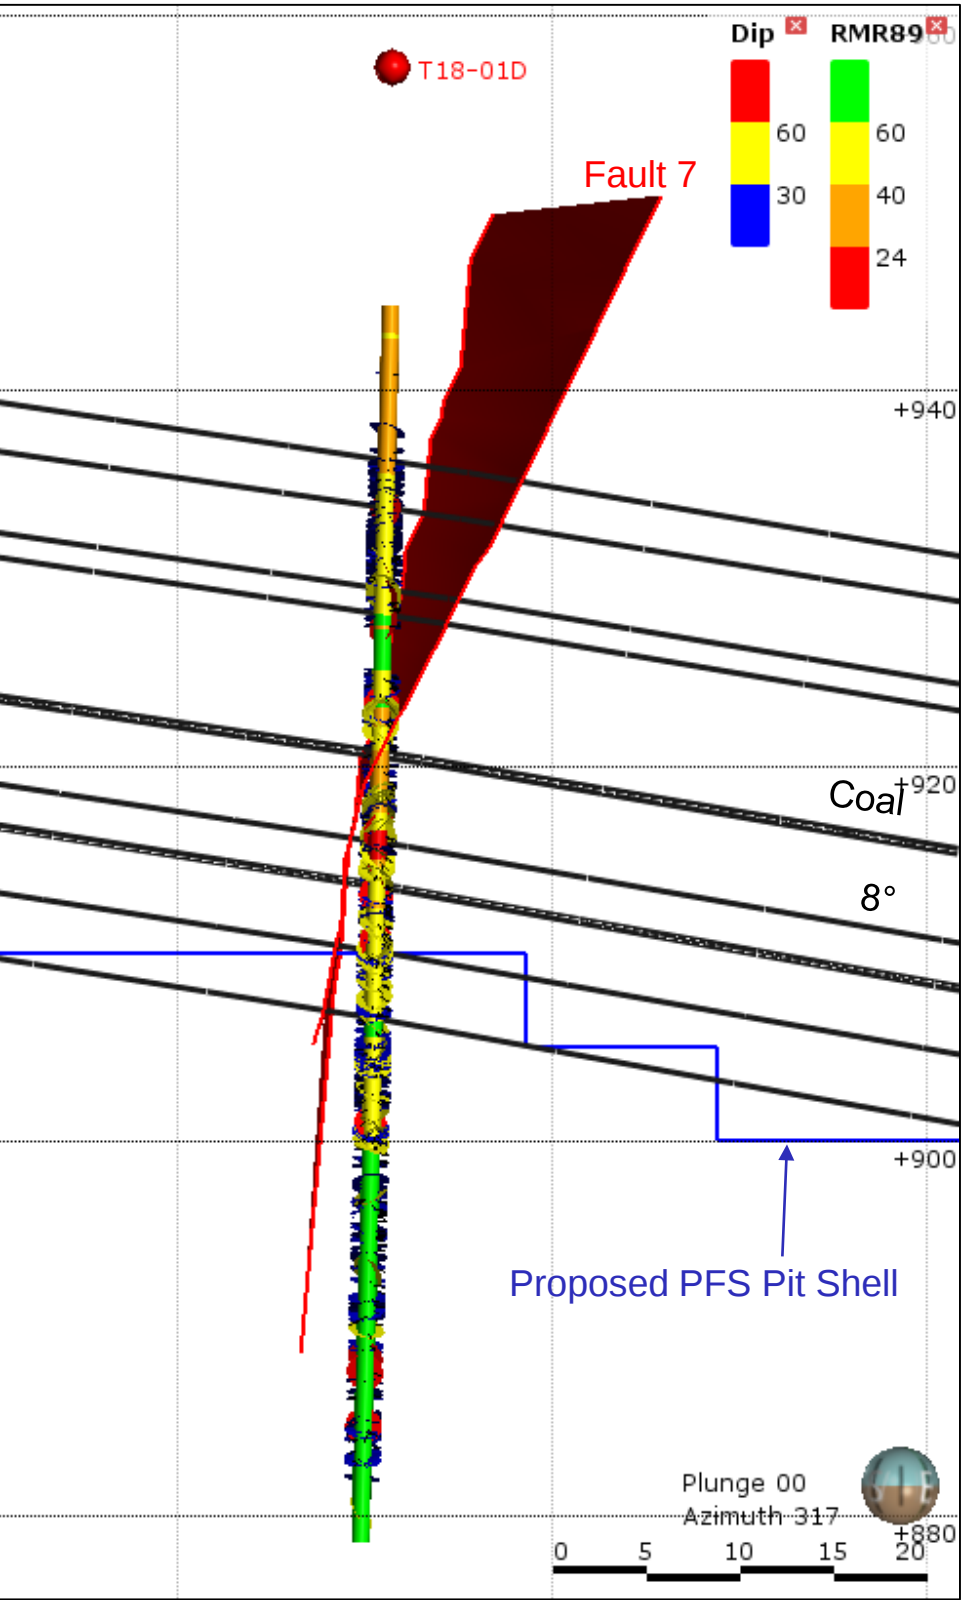
- Notes;
- Geologic model, topography, proposed pit and fault model provided by Telkwa.
  - Drillhole colour indicates RMR<sub>89</sub> value.
  - Disks around drillhole indicate dip and dip direction of features recorded in ATV survey.

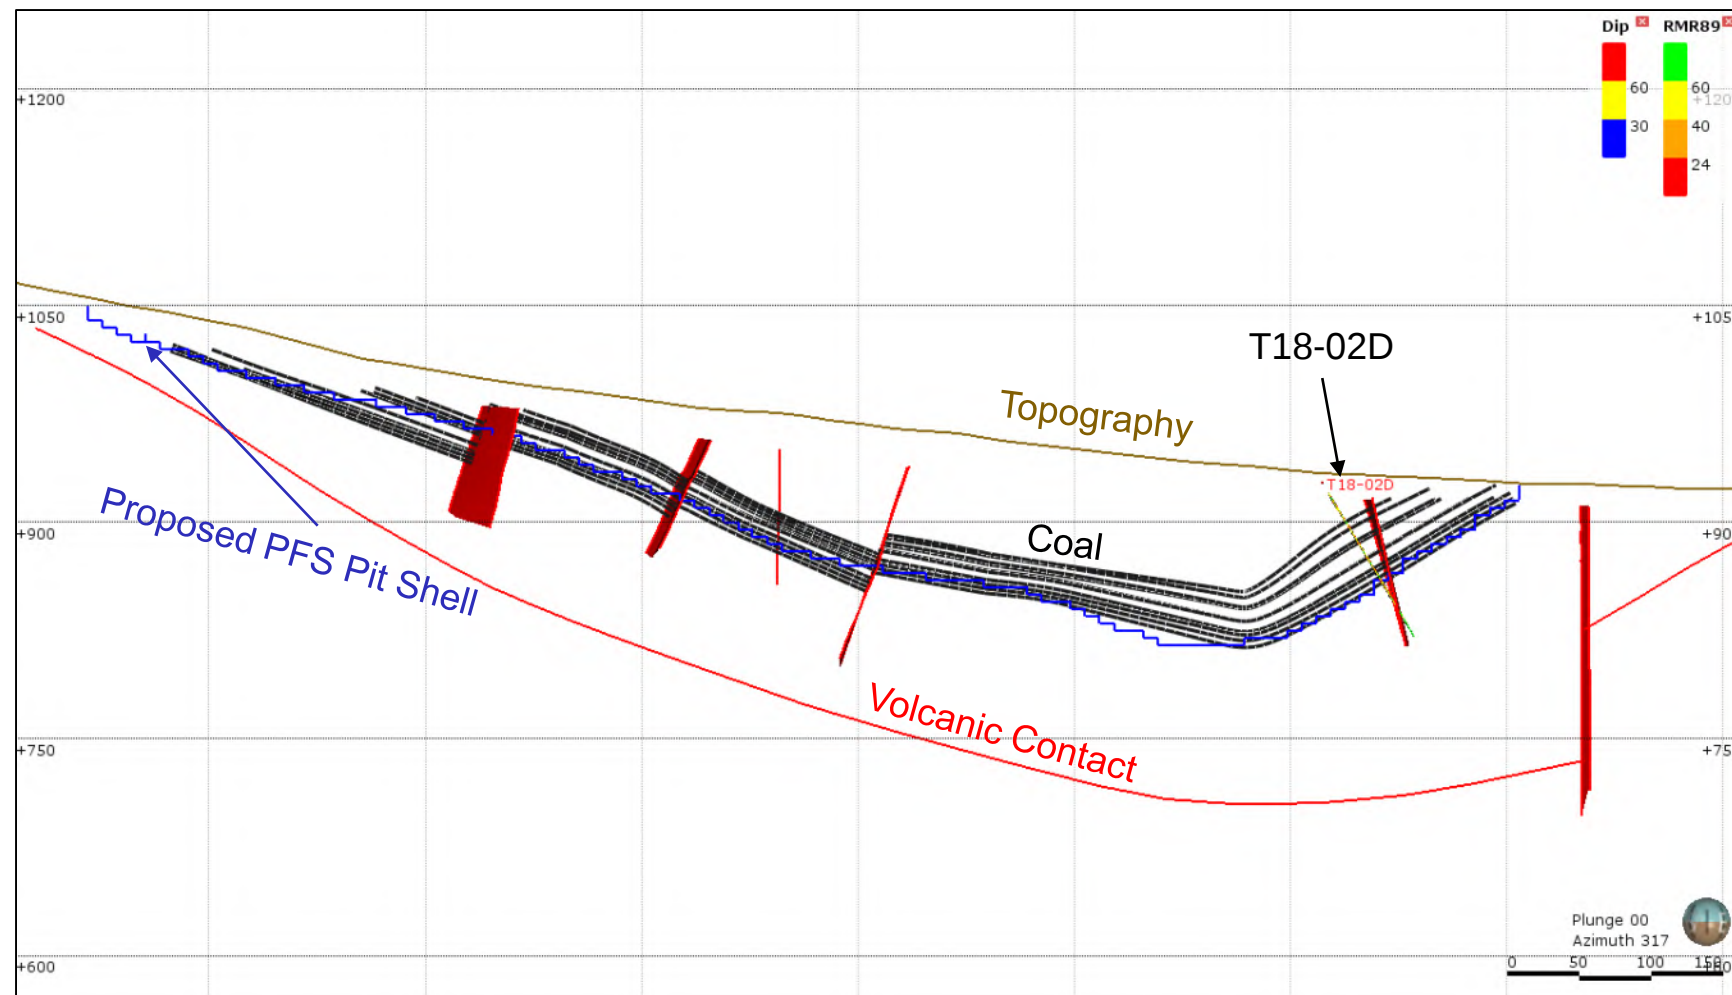
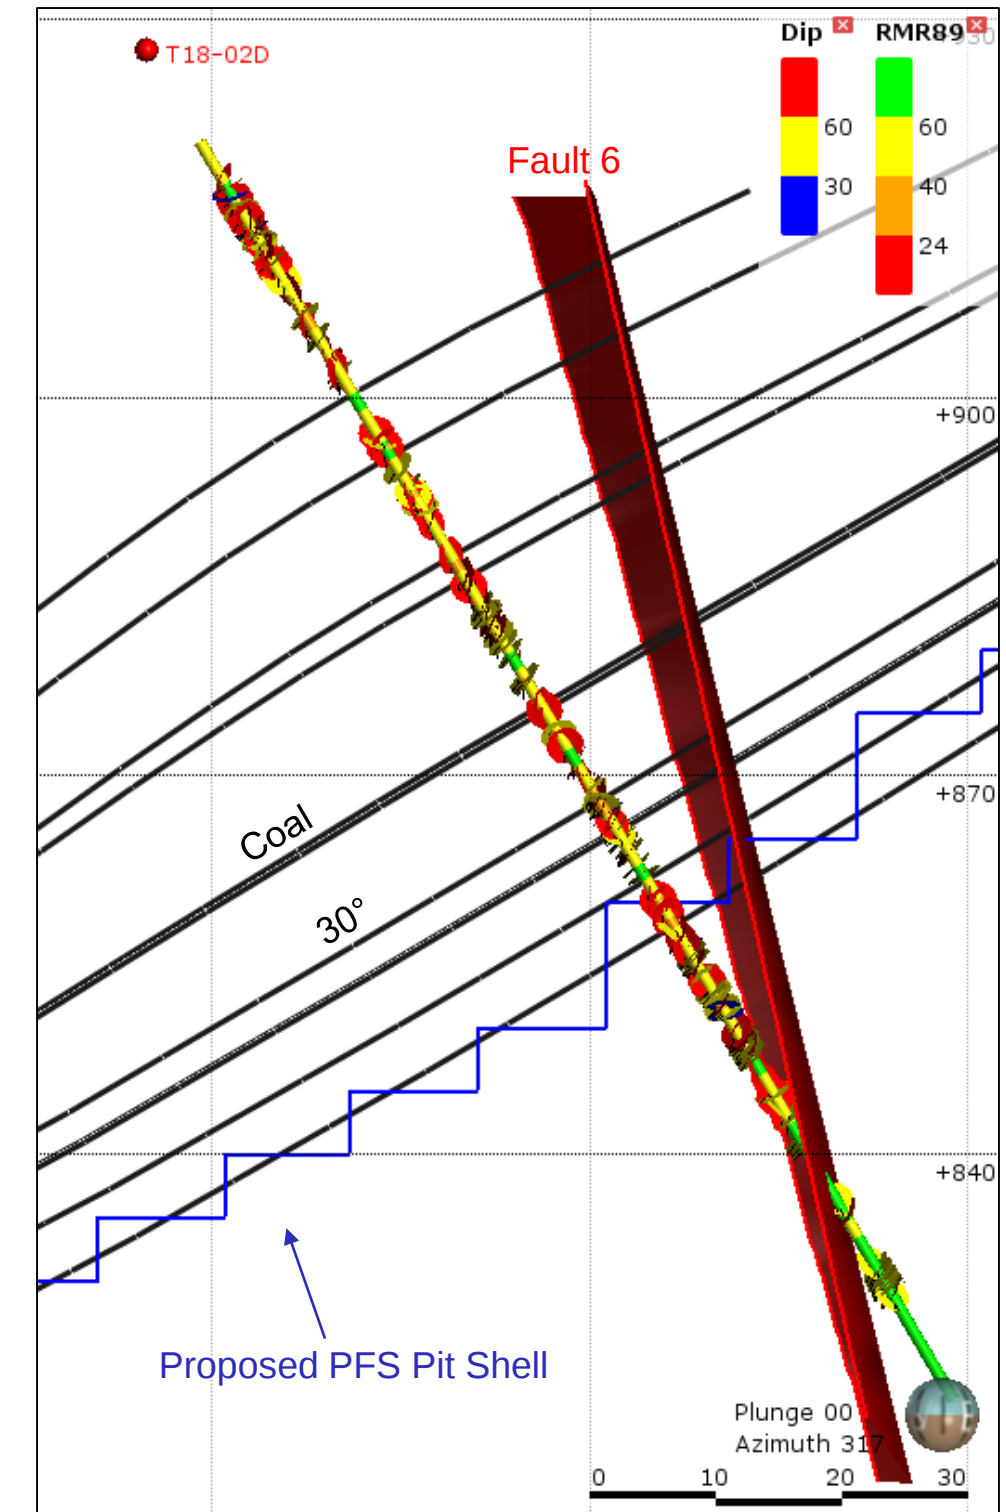
- Notes;
- Geologic model, topography, proposed pit and fault model provided by Telkwa.
  - Drillhole colour indicates RMR<sub>89</sub> value.
  - Disks around drillhole indicate dip and dip direction of features recorded in ATV survey.

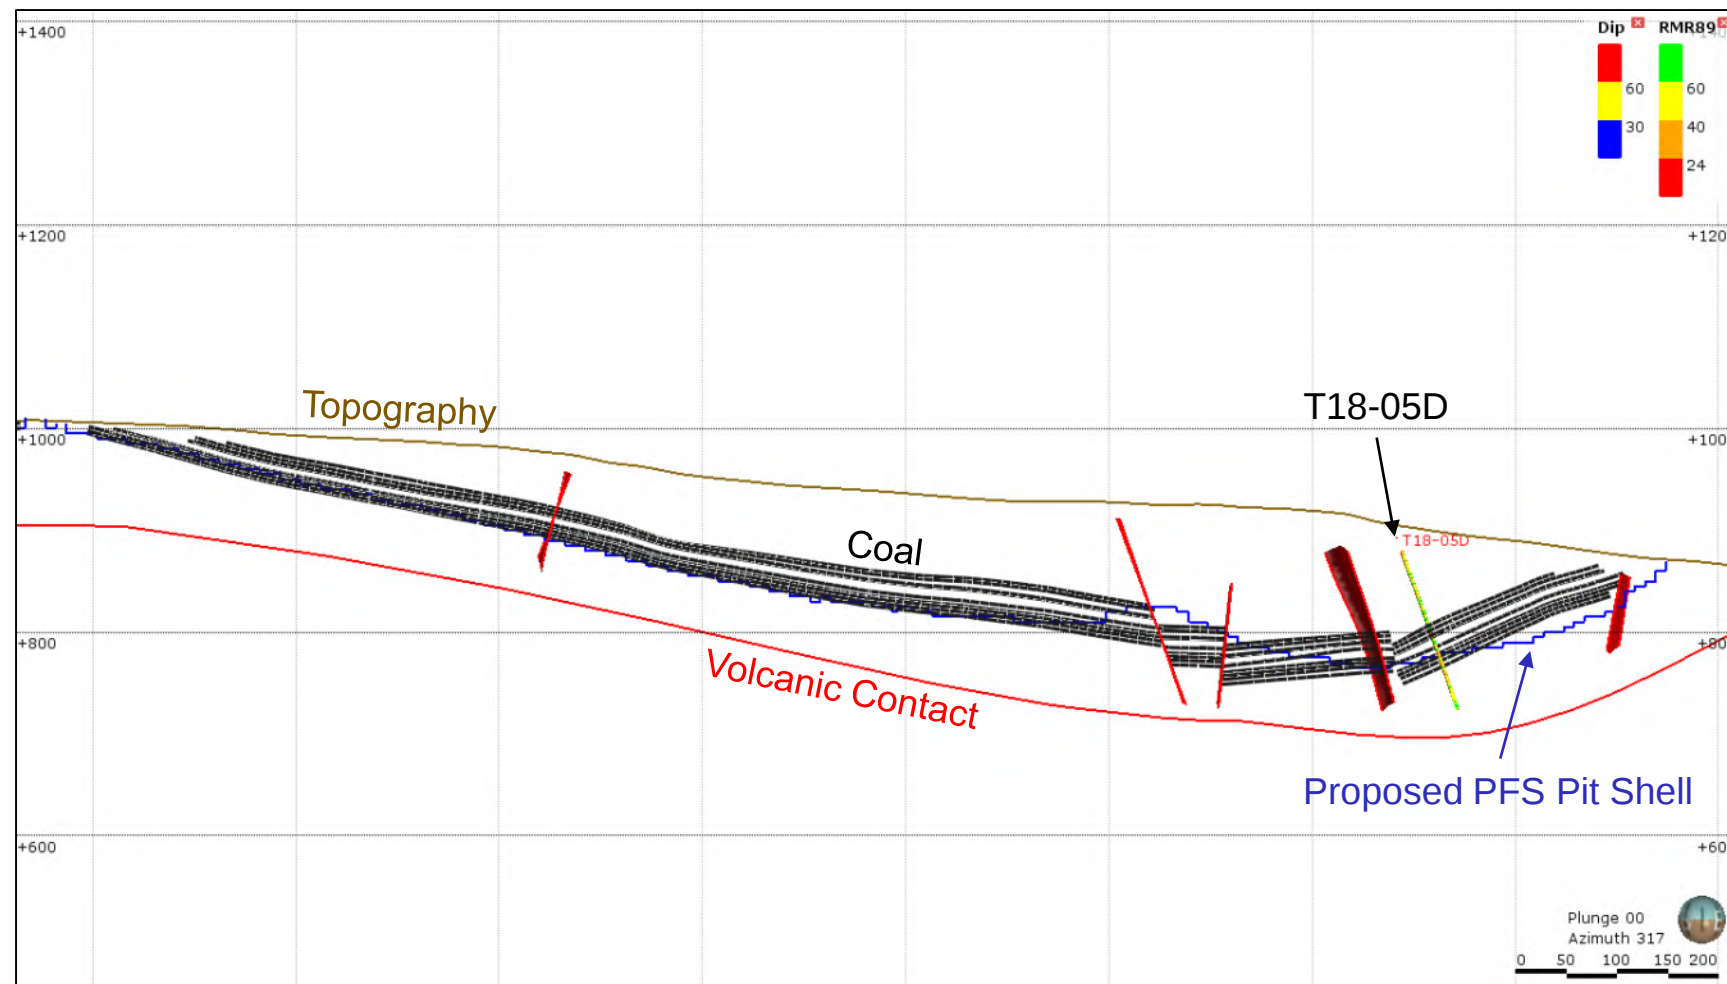
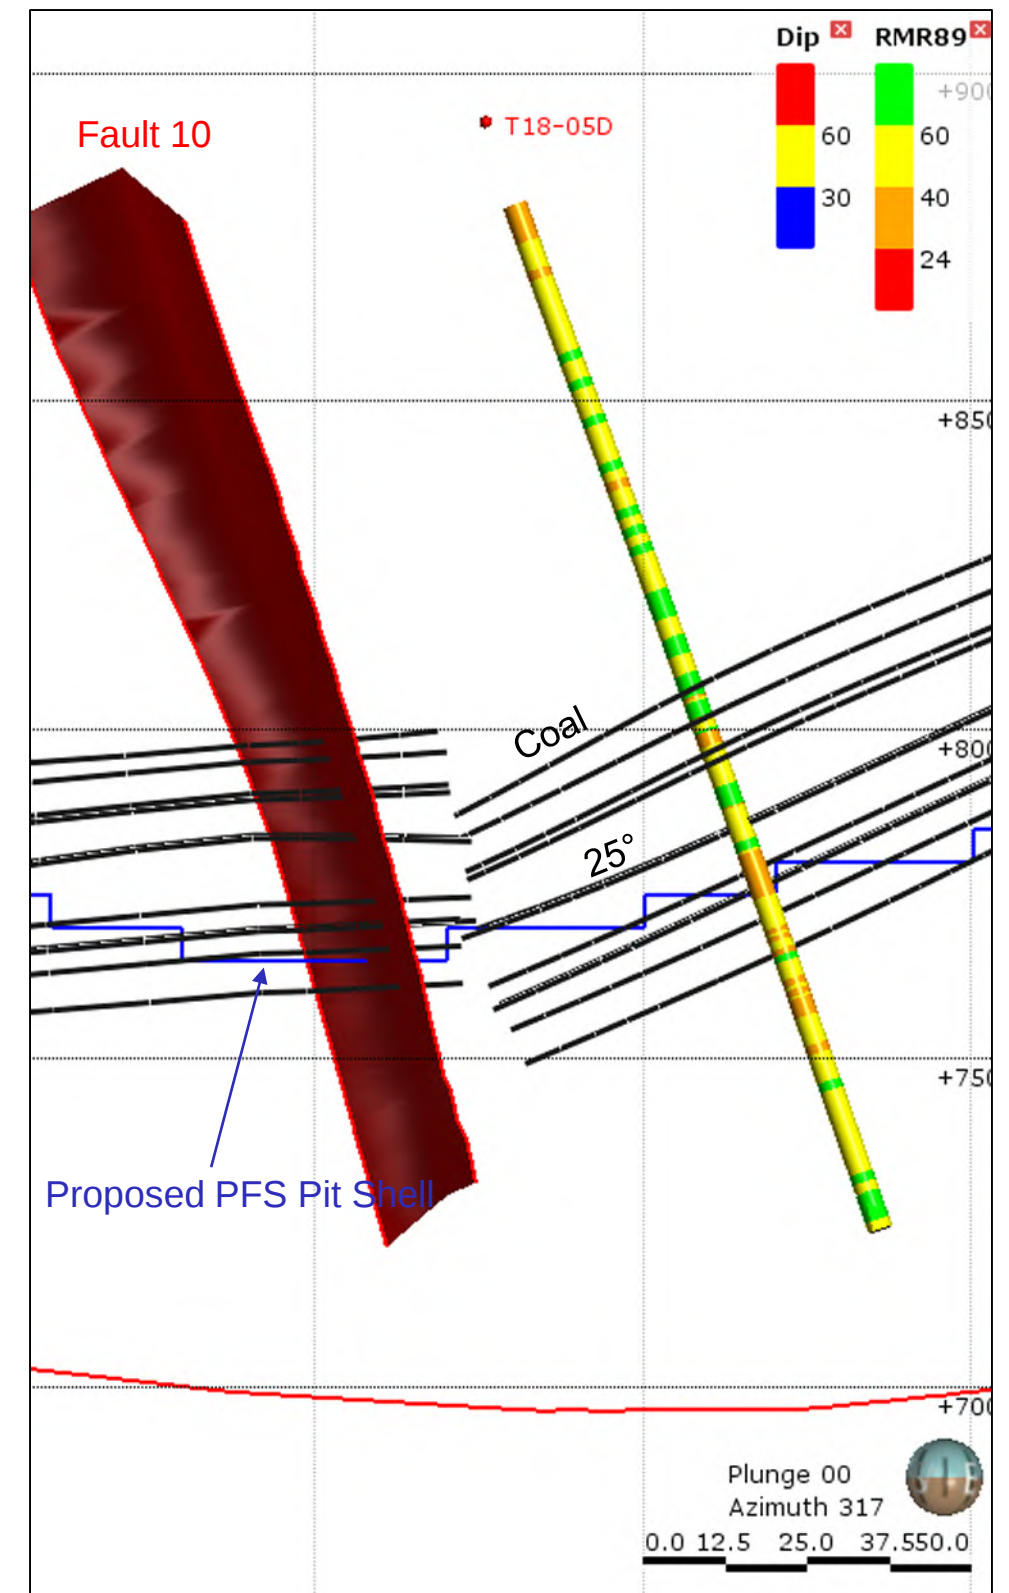
Notes;

- Geologic model, topography, proposed pit and fault model provided by Telkwa.
- Drillhole colour indicates RMR<sub>89</sub> value.
- ATV survey not completed for T18-05D due to drillhole instability.

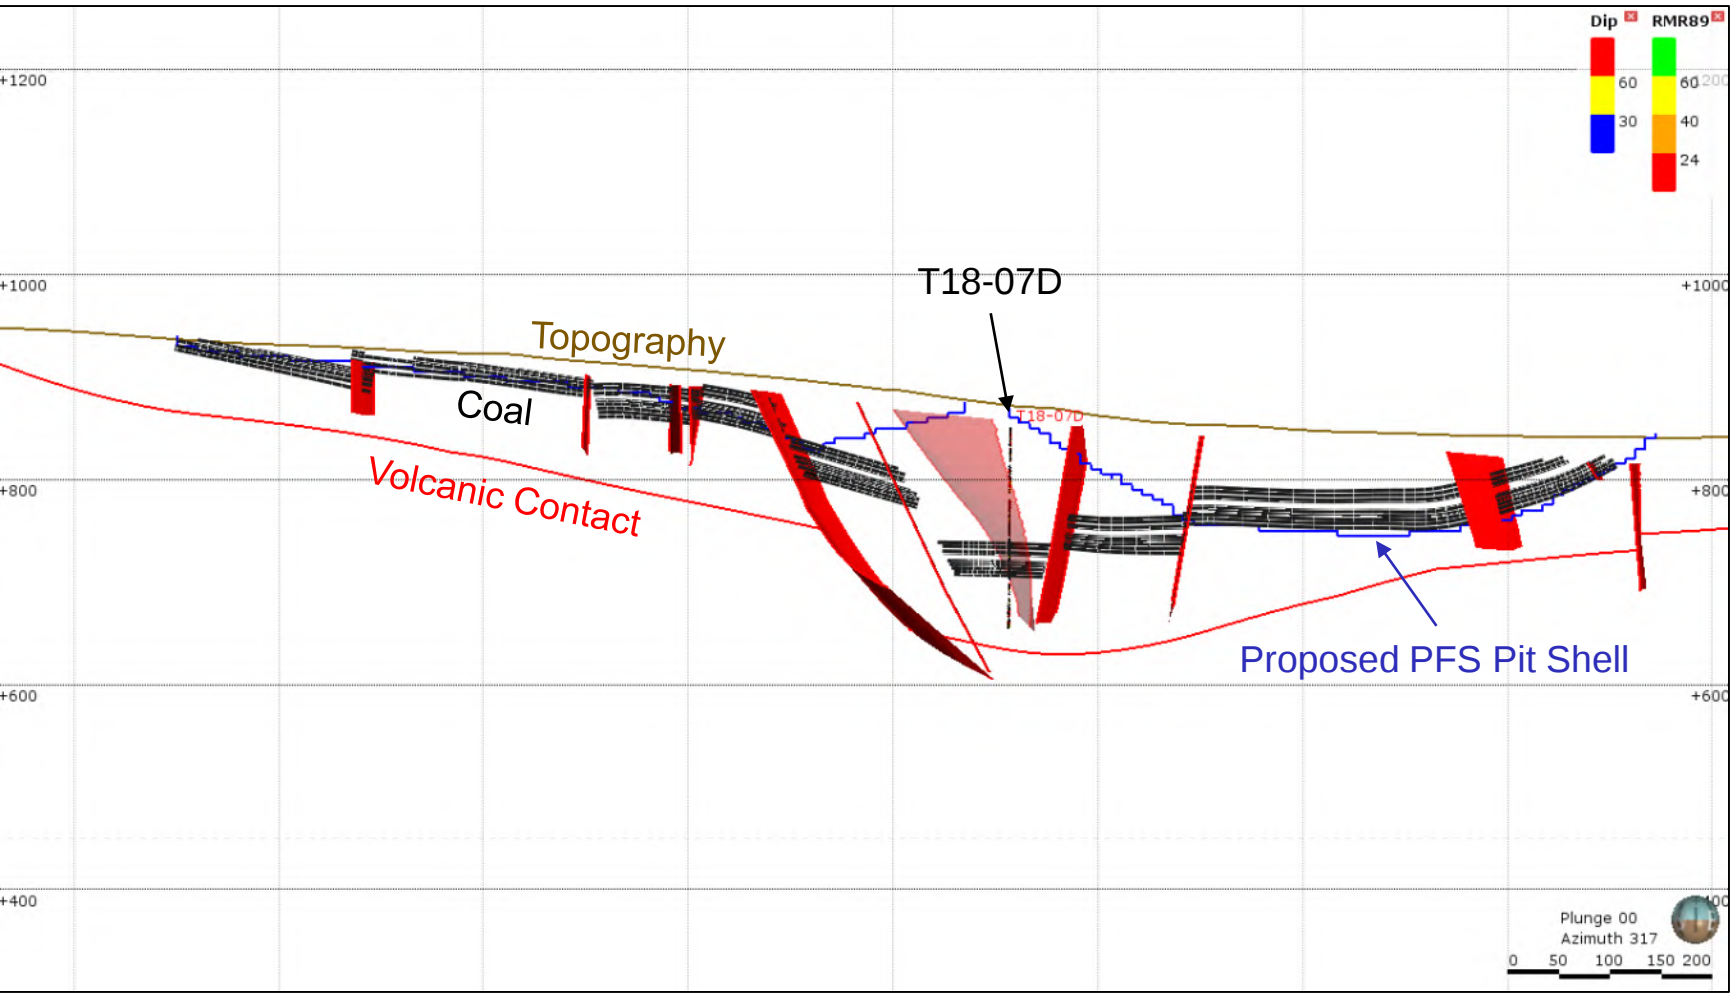
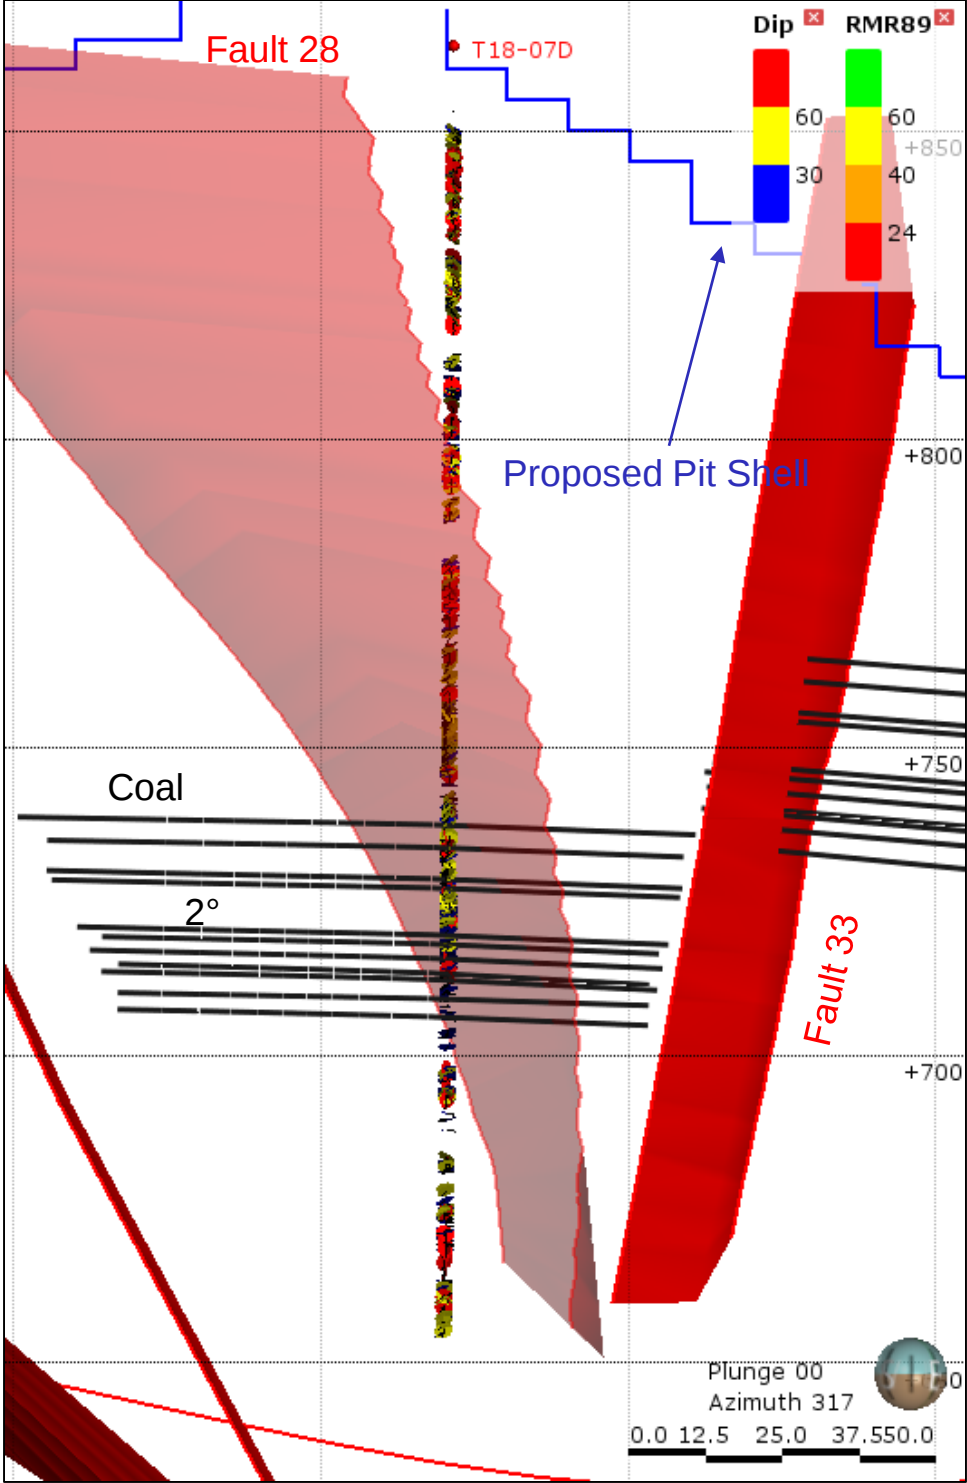
- Notes;
- Geologic model, topography, proposed pit and fault model provided by Telkwa.
  - Drillhole T18-07D not logged for RMR<sub>89</sub>.
  - Disks around drillhole indicate dip and dip direction of features recorded in ATV survey.
