# Tenas Project

## Terrain and Soil Baseline Report

**December 2021**

VERSION 3.6.1

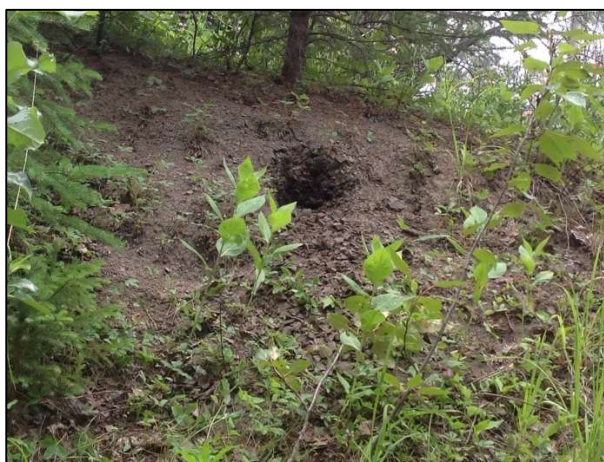
**Plate 2-2:** Soil pit in rubbly weathered mudstone, Caribou FSR, fieldsite IR131.

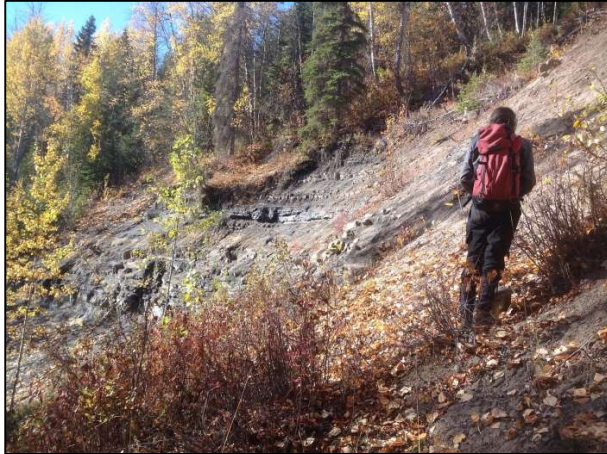
**Plate 2-3:** Bedrock outcrop, valley wall of Goathorn Creek, field site IW280.

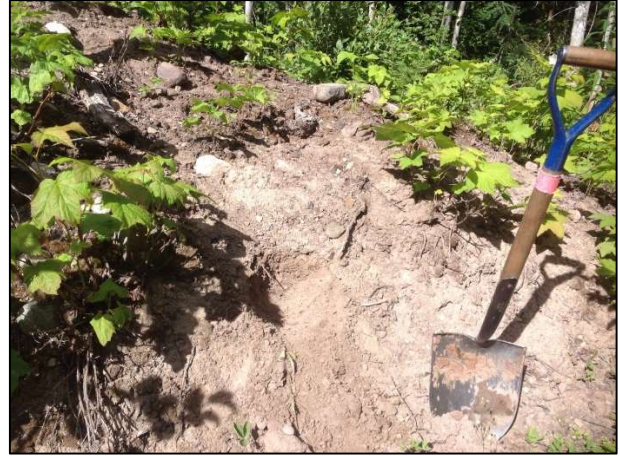
**Plate 2-6:** Soil pit in ablation till ridge (M3), field site IR106.

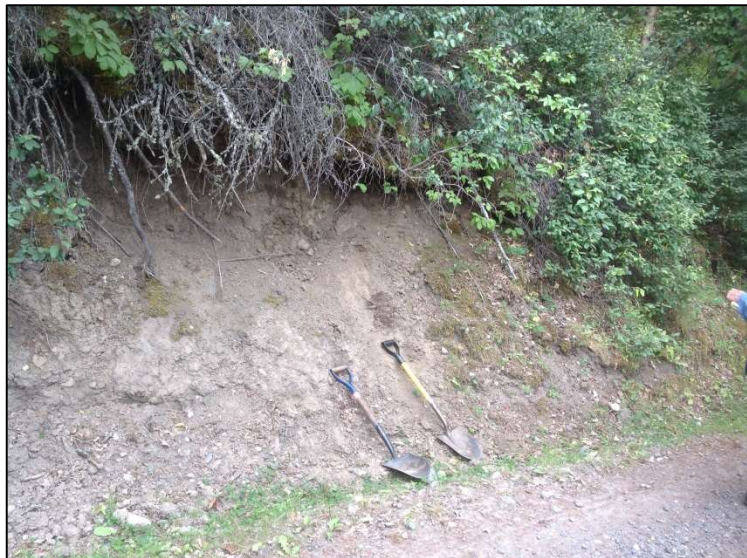
**Plate 2-7: Glaciolacustrine silt exposed along the driveway on the McDonald's property near the proposed rail infrastructure at field site IW216.**

In the Rail Infrastructure area, glaciolacustrine silty clay was found as surficial material (**zcLGp**) on level terrain near Lawson Road (e.g. field site IW001) at 525 m elevation. The same deposit is exposed along the driveway to the McDonald's property in the 12 m high escarpment between Lawson Road and the Bulkley River floodplain at field site IW216 (Plate 2-7) where it underlies 8 to 10 m of glaciofluvial sand and gravel. West of the driveway, the glaciolacustrine deposit extends to the top of the 12 m high escarpment (field sites IR237, IR239) and has a clayey-sandy-silty texture (**szLGak**). East of the driveway, the escarpment consists of 12+ m thick, medium to coarse sand and gravel. The glaciolacustrine material was also encountered as a clayey silt deposit underlying the 3 to 4 m thick gravel and sand deposits of the Bulkley River floodplain (Westrek Geotechnical Services Ltd. 2019a<sup>19</sup>).

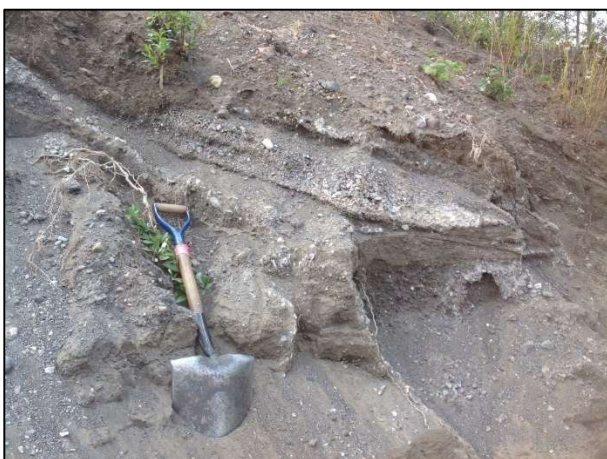
**Plate 2-8. Glaciofluvial ice-contact deposits of sand and gravel, field site IW202.**

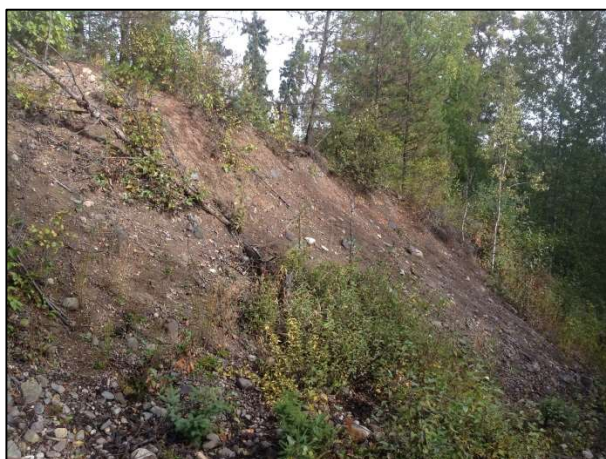
**Plate 2-9. Road cut in sandy gravel above the Telkwa River, field site IW133.**

Near the mouth of Goathorn Creek, a glaciofluvial fan covers about 60 ha, at 570 m to 600 m elevation. The fan consists of cobbles, gravel and sand, with small boulders near the fan apex. Thickness of the deposit varies from 3 m to 25 m (field sites IW316, AD188, IW133, IR202). This well to rapidly drained, near-level deposit underlies the Cottonwood subdivision and a Pacific Natural Gas (PNG) substation. The present-day Goathorn Creek and Telkwa River have eroded a 10 to 25 m high escarpment along the western and northern edge of this deposit (Plate 2-9). Localized slope stability concerns exist along these steep escarpments where the gravel is underlain by fine-textured, possibly glaciolacustrine sediments (field site IR203), or where Goathorn Creek undercuts the steep escarpment (field site IW316). Surface erosion is typically not a concern due to the coarse textures and high permeability of the deposit.

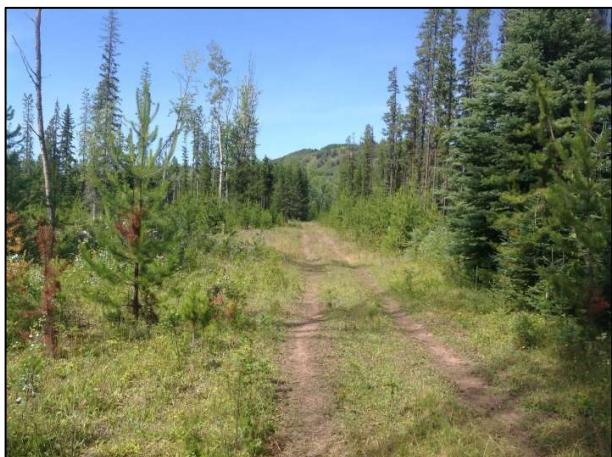
Plate 2-10: Bulkley River floodplain, field site IW013.

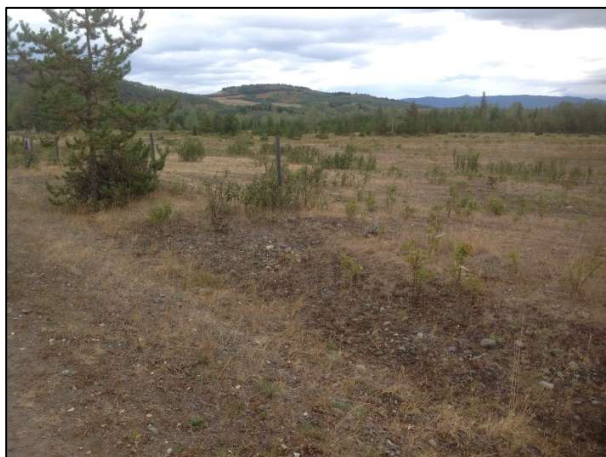
Plate 2-11: Bulkley River floodplain, field site IR154.

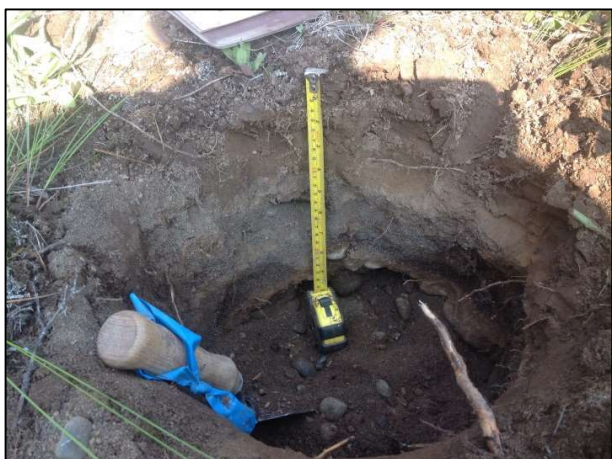
Plate 2-12: Medium to coarse sand over gravel; field site IR236.

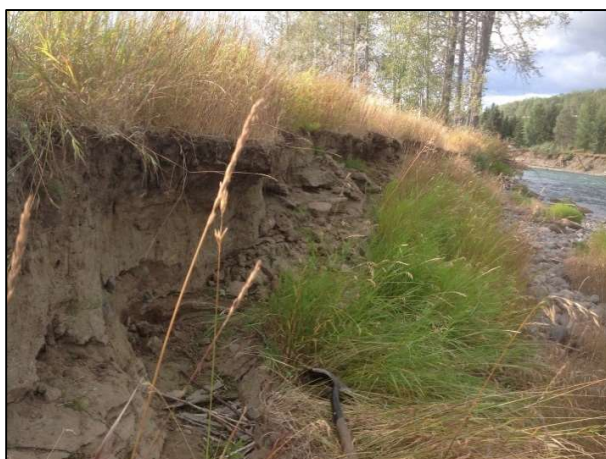
Plate 2-13: Bulkley River, field site IR160; overbank deposit of fine sand.

The west side of the rail infrastructure T-LSA sub-area is considered active floodplain with seasonal flooding along former channels. A well to rapidly drained, sandy gravelly level surface (**sgFp**) 1.5 to 2 m above bankfull river level is dissected by a series of 0.5 to 1.5 m deep former back channels which are filled with 0.5 to 2 m thick fine sand, silt and clay (**smFAvb**) overlying gravel and sand (Plate 2-12). These channel remnants flood most years in the spring, fed by a high groundwater table corresponding to the river level. In addition to the seasonal flooding, this part of the rail area is part of the 200-year floodplain (BC MOE 1984). The active channel environment of the 125 m wide, main channel (**FAp-I**) consists of sand and gravel with subrounded cobbles up to 25 cm diameter (field sites IW010, IR160;). The active channel bank is formed by a narrow, discontinuous low-bench floodplain with a surface elevation corresponding to bankfull flow, showing a 1 m thick fine sand deposit overlying the cobbly channel deposits at 510 to 513 m elevation (Plate 2-13).

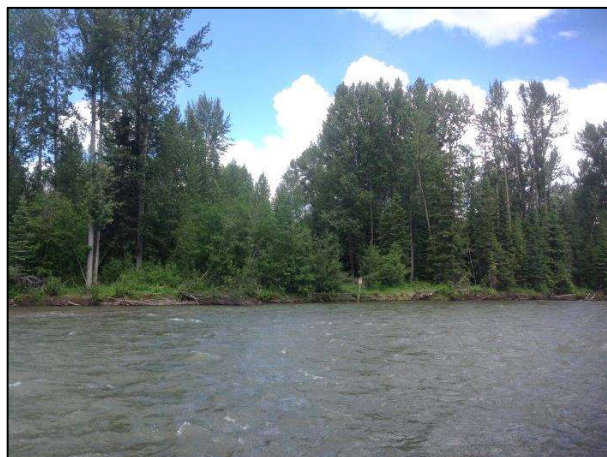
Plate 2-15: Telkwa River, natural gas pipeline crossing; field site IW308b.

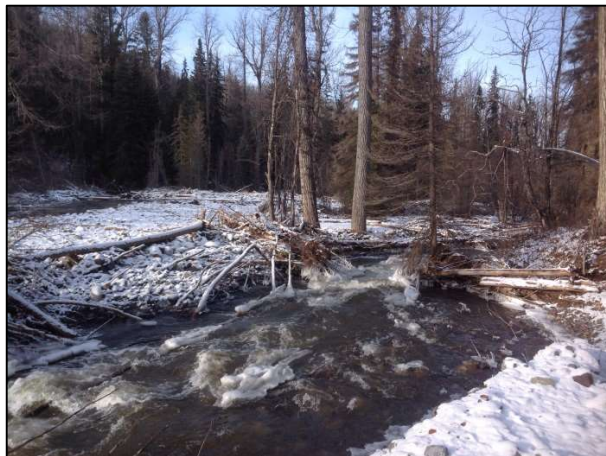
Plate 2-19: Goathorn Creek, field site IW054.

Along unconfined floodplain sections, the active channel zone and the adjacent forested floodplain were typically mapped as a complex polygon to account for the rapid lateral shifting of the main channel in recent and future years (Plate 2-19, field site IW054). The active channel bed material ranges in size from gravel to boulders (50 cm diameter) and sand (**ksgFAp**, field site IW045, IW277, IW279). Clasts are rounded to subrounded and include maroon and green-grey volcanic rocks and light-coloured granitic rocks. The adjacent forested floodplain consists of similar material and is typically overlain by a 1 m thick deposit of sand, silt or, locally, silty clay(**zsFAv**). These overbank and backchannel deposits contain small chunks of

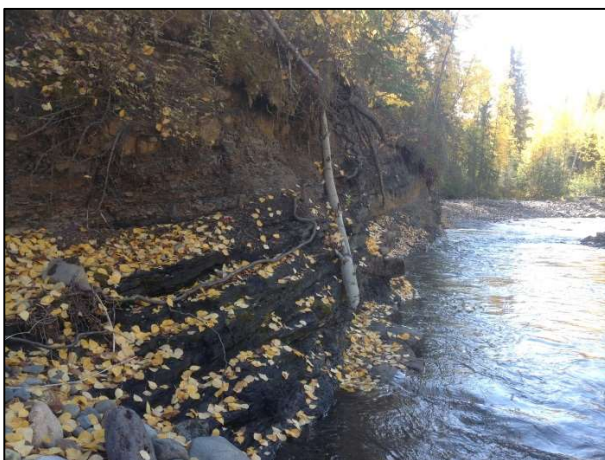
Plate 2-20: Goathorn Creek, field site IW241.

coal. In many places the fluvial deposits are underlain by bedrock at 1 to 5 m depth (Westrek Geotechnical Services Ltd. 2019<sup>27</sup>), or bedrock is exposed in the stream banks (**FAp[Ru]**) (Plate 2-20).

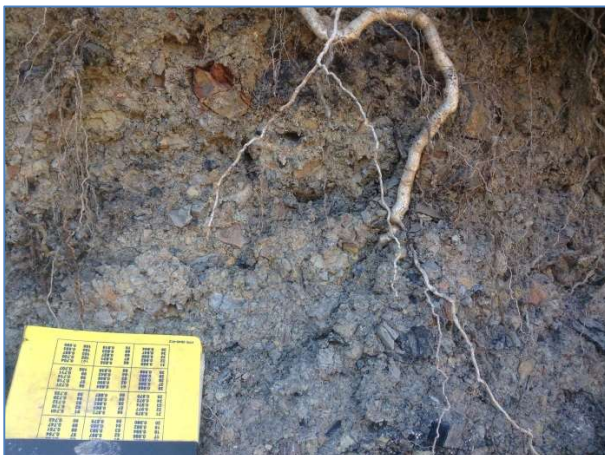
**Plate 2-22:** Past mine waste material exposed in an eroding streambank along Goathorn Creek; field site IW270.

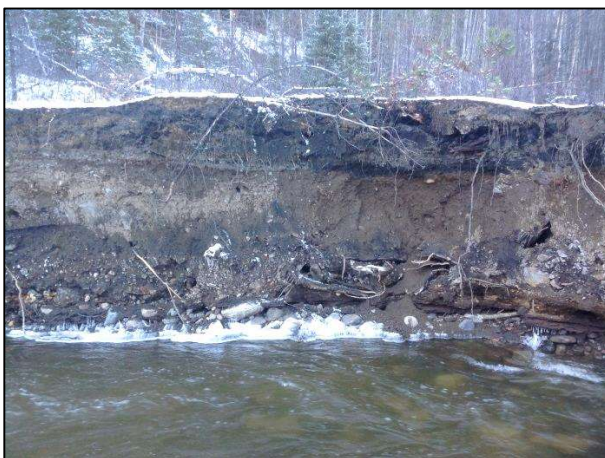
**Plate 2-24:** Mine waste material at the BV Horsemen's Camp, former BV Collieries operation; field site IW060a.

(Westrek Geotechnical Services Ltd. 2019b<sup>28</sup>). Where the material is undercut by Goathorn Creek, it is prone to sliding, flowing and creep (Plate 2-23). Deposits containing mainly coal fragments and coal dust, interbedded with fluvial material were encountered on 3 to 4 m high terraces along Goathorn Creek at and near the BV Horsemen's Camp, a former coal loading site operated by Bulkley Valley Collieries in the 1960s, where the deposits are now being eroded by Goathorn Creek (Plate 2-24; field site IW060a).

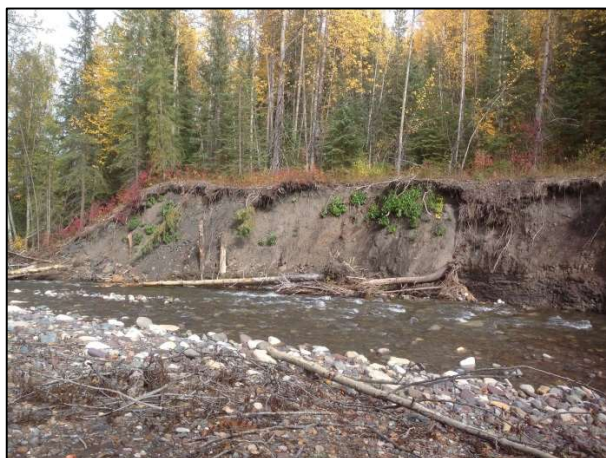
**Plate 2-25:** Fill material as an extension of a fluvial terrace; field site IW247.

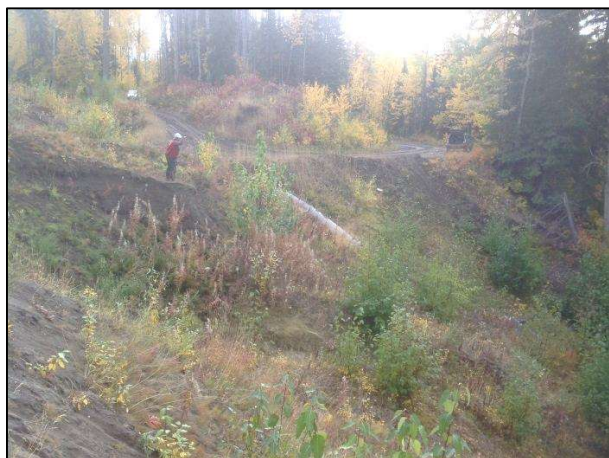
**Plate 2-26:** Start zone of the Coalmine Road landslide; field sites IW065, IW235.

A 115 m wide debris slide track (**-R"s**) exists at field site IW235 (Plate 2-26) adjacent to Coalmine Road near Bypass Road station 11+400. This slide started in the spring of 2012<sup>30</sup> when water appeared on the slope below Coalmine Road, saturating the weathered surface material on the slope and triggering a failure in the over-steepened, loose fill slope material of Coalmine Road. Ongoing seepage onto the slope subsequently increased the size of the failure (Fred Seychuck, MoTH Bulkley/Stikine Operations Manager; April 8, 2020, pers. communication). Numerous seepage sites were still active on the landslide track during the 2018 and 2019 field seasons, with water surfacing near the contact of the glaciofluvial sand and the underlying glacial till causing occasional small failures and oversteepening of the sandy sediments at the top of the landslide.

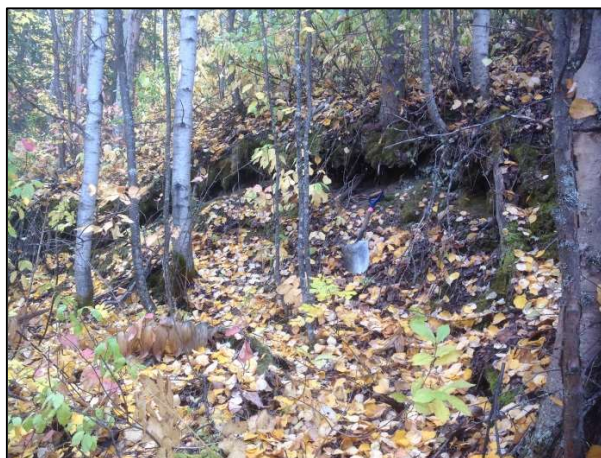
**Plate 2-27:** Shallow slide and soil creep above Coalmine Road; field site IW251.

Slow mass movement continues at the present time as creep (**-Fc**) at several valley wall sites of Goathorn Creek and Tenas Creek, including upslope of Coalmine Road, locally creating wide open, 1 m deep tension cracks in glacial till (Plate 2-27, Plate 2-28; field sites IW251, IW064). Creep also occurs in clay-rich mining waste material which starts to flow (**-Fe**) on slope gradients as low as 40 to 50% (21 to 27°) when saturated and undercut by Goathorn Creek (field site IW275; Plate 2-29).

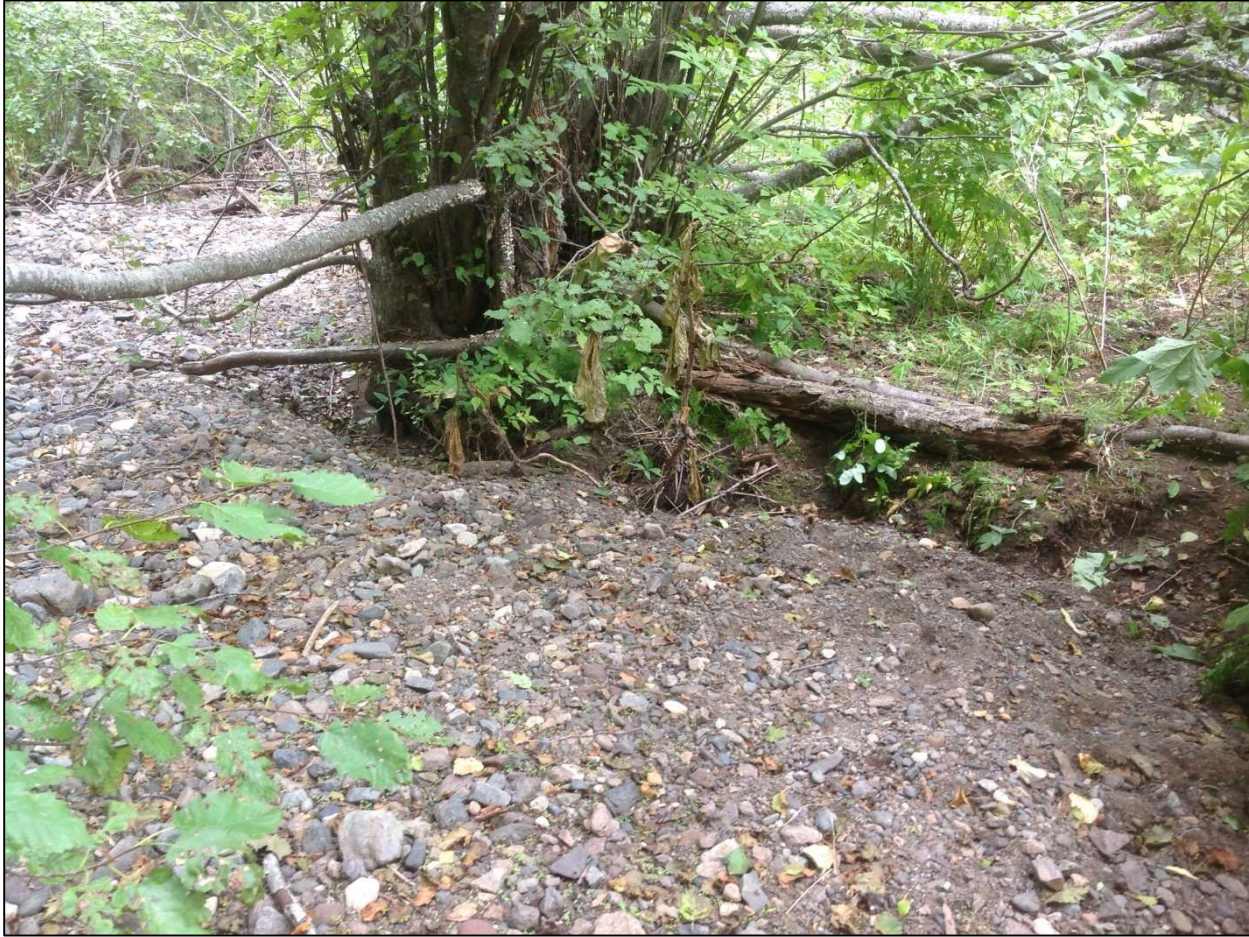
**Plate 2-30: De-watered channel of Helps Creek due to sediment aggradation near the proposed crossing of the Bypass Road.**

A hydrogeomorphic hazard was identified at the proposed crossing of Helps Creek, near station 5+500 along the Bypass Road. Sediment aggradation during the Oct 25, 2017 flood filled and dewatered the existing channel (Section 0). The upstream source for the deposited sediment was not determined as part of this assessment. It is possible that the event entrained upstream channel bed material rather than sediment input from a landslide into the upstream reaches of Helps Creek.

As the channel of Helps Creek becomes re-established in future high flow events, the aggraded gravel and cobble will likely be reworked (entrained and re-deposited). A new channel may become established anywhere within 10 to 20 m on either side of the filled-in channel. Large sediment pulses transporting residual bed material the disturbed upstream reaches of Helps Creek towards the Bypass Road crossing are unlikely, but possible.

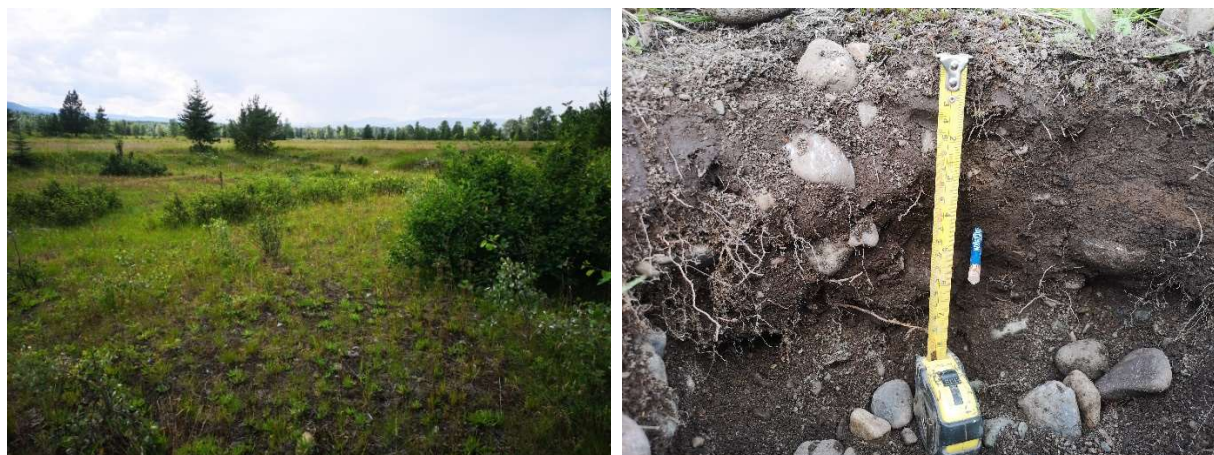
**Plate 3-1:** View of pasture looking east across Rail Infrastructure area and soil profile.

The Rail Infrastructure extends over roughly 50 hectares of inactive floodplain adjacent to the Bulkley River, characterized by sandy, often gravelly soil interspersed with narrow swales of poorly-drained silty-clays in old backchannel areas. Agriculture land capability is predominantly class 5 with limitations due to low soil fertility, stoniness and aridity. Coarse-textured, sandy, and often gravelly soil described by SMU 4.3 are typical. Most of the area has been cleared. A few fields are cultivated for hay production, but most fields are pasture. Forage is limited as the pasture is dominated by hawkweed and dandelion, as illustrated at plot IR255 in Plate 3-1.
